Profile/Photo Observation Report

| Street: | E NORTH ST | Flow Control: | Not Controlled |
| City: | Hobart, IN | Year Renewed: | |

| US MH: | M-803-008 | DS MH: | M-803-007 |

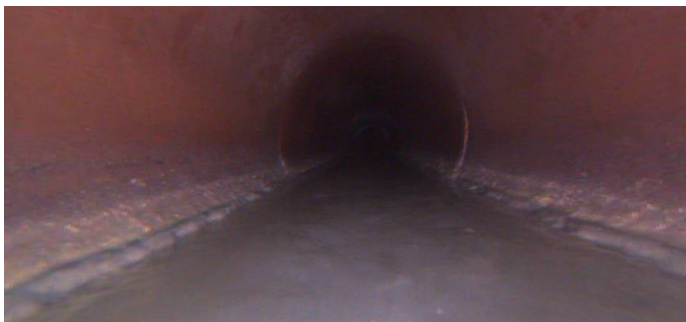
Code: **AMH**
Description: **Manhole**

Distance (ft): **.0**
Structural Grade: **0**
O&M Grade: **0**
Clock Start/From:
Clock To:
1st Value:
2nd Value:
Value Percent:
Continuous Index:
Within 8" of Joint: **NO**
Remarks: **M-803-008**

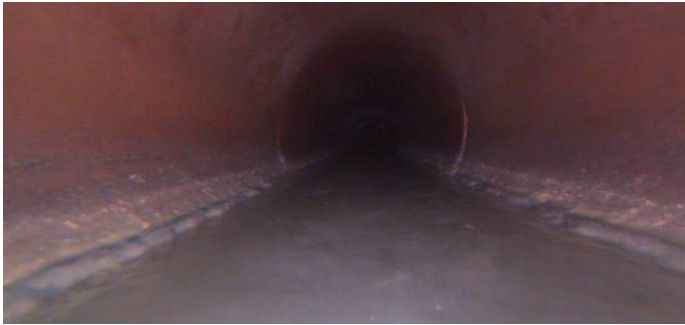
| Code: | MWL |
| Description: | Water Level |

| Value Percent: | 10.000 |

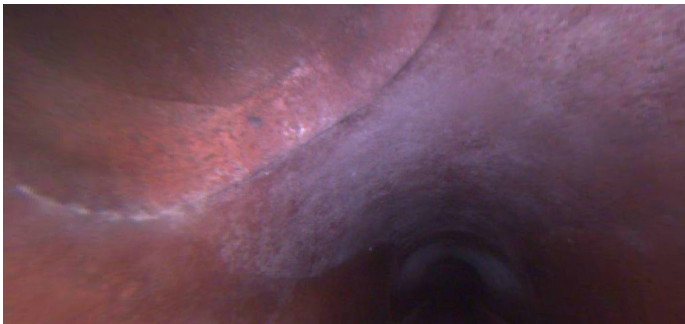
| Code: | TF |
| Description: | Tap Factory |

| Distance (ft): | 6.4 |

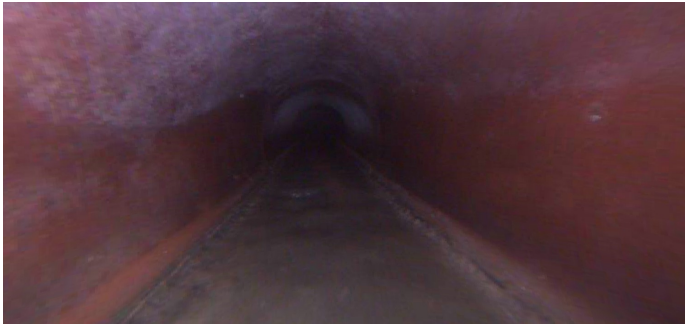
Code: **DAGS**
Description: **Deposits Attached Grease**

Distance (ft): **6.4**
Structural Grade: **0**
O&M Grade: **2**
Clock Start/From: **7**
Clock To: **5**
1st Value:
2nd Value:
Value Percent: **5.000**
Continuous Index: **S01**
Within 8" of Joint: **YES**
Remarks: **WANDER**

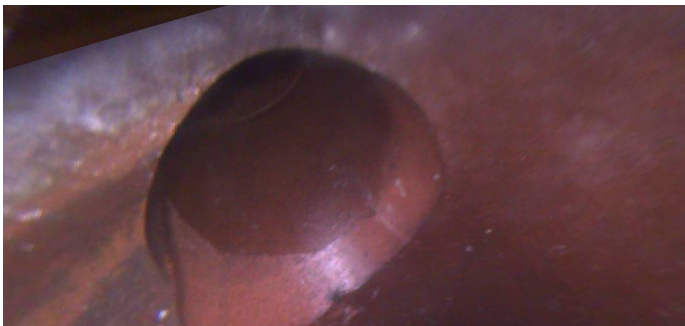
Code: **TF**
Description: **Tap Factory**

Distance (ft): **33.3**
Structural Grade: **0**
O&M Grade: **0**
Clock Start/From: **10**
Clock To:
1st Value: **4.000**
2nd Value:
Value Percent:
Continuous Index:
Within 8" of Joint:
Remarks:

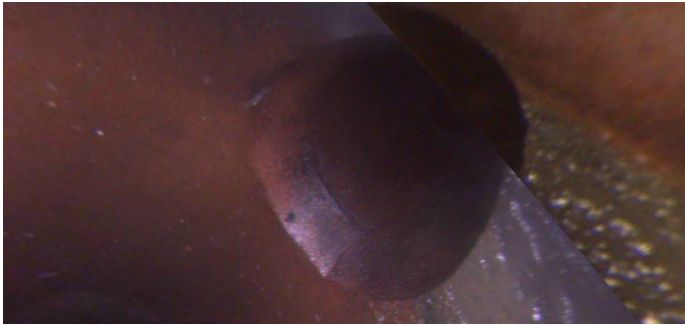
Code: **TF**
Description: **Tap Factory**

Distance (ft): **36.3**
Structural Grade: **0**
O&M Grade: **0**
Clock Start/From: **2**
Clock To:
1st Value: **4.000**
2nd Value:
Value Percent:
Continuous Index:
Within 8" of Joint:
Remarks:

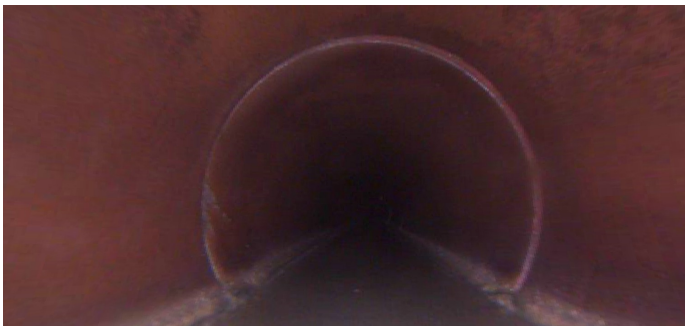
Code: **RFJ**
Description: **Roots Fine Joint**

Distance (ft): **43.9**
Structural Grade: **0**
O&M Grade: **1**
Clock Start/From: **8**
Clock To:
1st Value:
2nd Value:
Value Percent:
Continuous Index:
Within 8" of Joint: **YES**
Remarks:

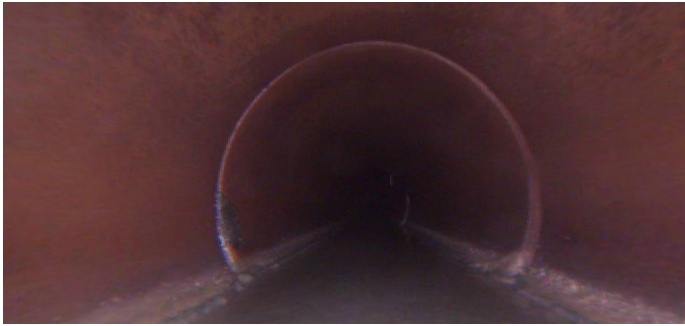
Code: **RFJ**
Description: **Roots Fine Joint**

Distance (ft): **46.9**
Structural Grade: **0**
O&M Grade: **1**
Clock Start/From: **7**
Clock To:
1st Value:
2nd Value:
Value Percent:
Continuous Index:
Within 8" of Joint: **YES**
Remarks:

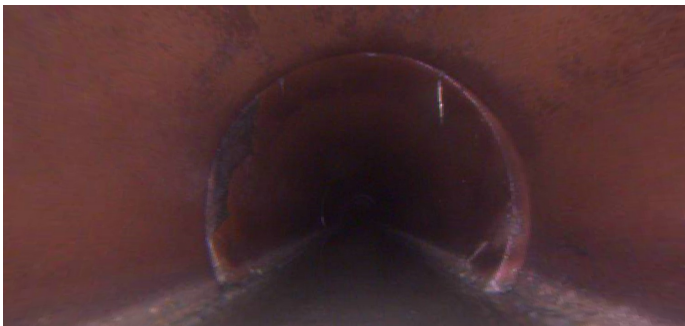
Code: **RFJ**
Description: **Roots Fine Joint**

Distance (ft): **50.0**
Structural Grade: **0**
O&M Grade: **1**
Clock Start/From: **8**
Clock To: **5**
1st Value:
2nd Value:
Value Percent:
Continuous Index:
Within 8" of Joint: **YES**
Remarks:

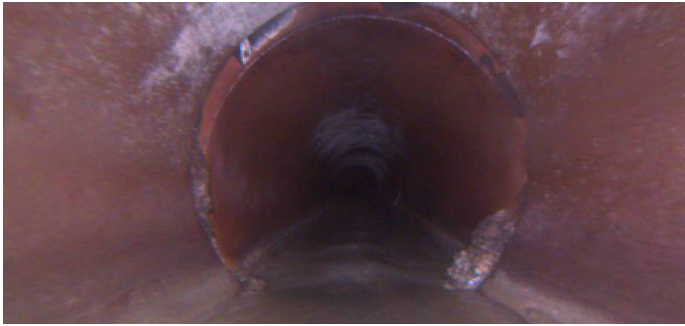
Code: **DAE**
Description: **Deposits Attached Encrustation**

Distance (ft): **59.1**
Structural Grade: **0**
O&M Grade: **2**
Clock Start/From: **8**
Clock To: **5**
1st Value:
2nd Value:
Value Percent: **5.000**
Continuous Index:
Within 8" of Joint: **YES**
Remarks:

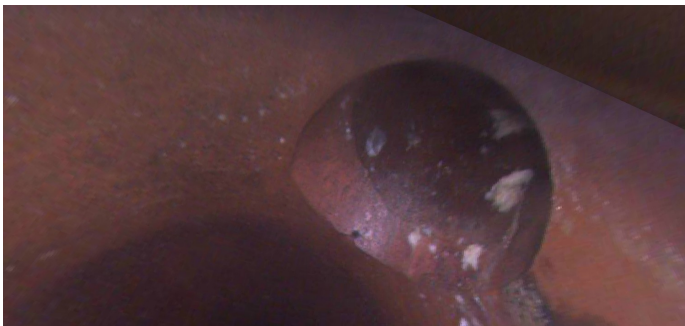
Code: **TF**
Description: **Tap Factory**

Distance (ft): **66.4**
Structural Grade: **0**
O&M Grade: **0**
Clock Start/From: **2**
Clock To:
1st Value: **4.000**
2nd Value:
Value Percent:
Continuous Index:
Within 8" of Joint:
Remarks:

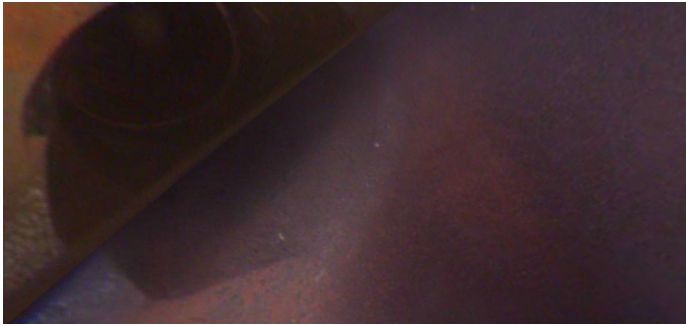
Code: **TF**
Description: **Tap Factory**

Distance (ft): **91.0**
Structural Grade: **0**
O&M Grade: **0**
Clock Start/From: **10**
Clock To:
1st Value: **4.000**
2nd Value:
Value Percent:
Continuous Index:
Within 8" of Joint:
Remarks:

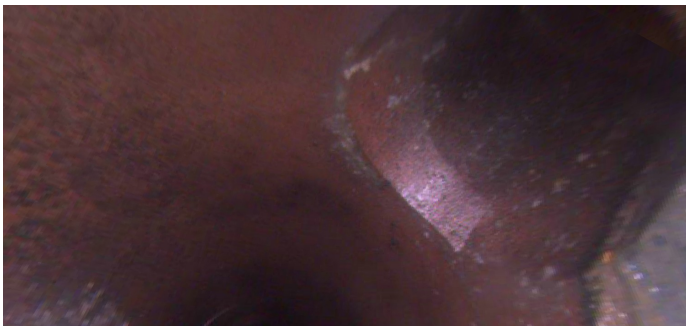
Code: **TF**
Description: **Tap Factory**

Distance (ft): **129.9**
Structural Grade: **0**
O&M Grade: **0**
Clock Start/From: **2**
Clock To:
1st Value: **4.000**
2nd Value:
Value Percent:
Continuous Index:
Within 8" of Joint:
Remarks:

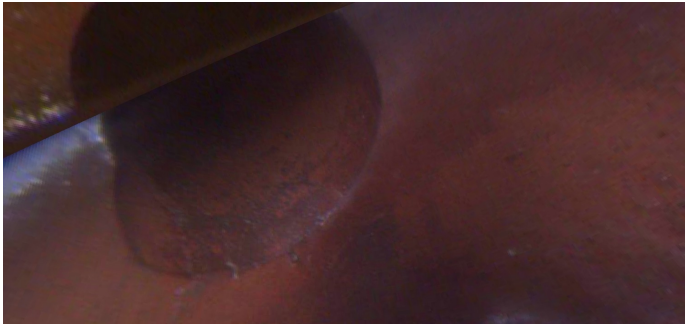
Code: **TF**
Description: **Tap Factory**

Distance (ft): **133.0**
Structural Grade: **0**
O&M Grade: **0**
Clock Start/From: **10**
Clock To:
1st Value: **4.000**
2nd Value:
Value Percent:
Continuous Index:
Within 8" of Joint:
Remarks:

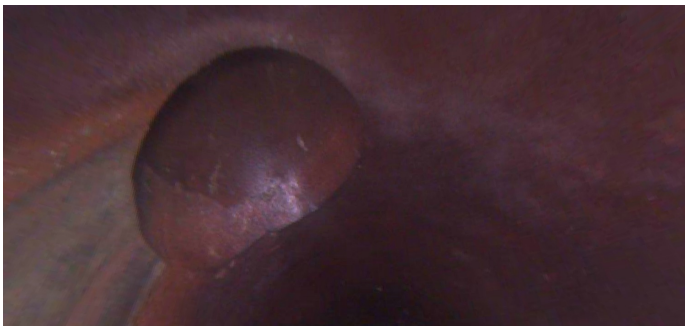
Code: **TF**
Description: **Tap Factory**

Distance (ft): **153.9**
Structural Grade: **0**
O&M Grade: **0**
Clock Start/From: **10**
Clock To:
1st Value: **4.000**
2nd Value:
Value Percent:
Continuous Index:
Within 8" of Joint:
Remarks:

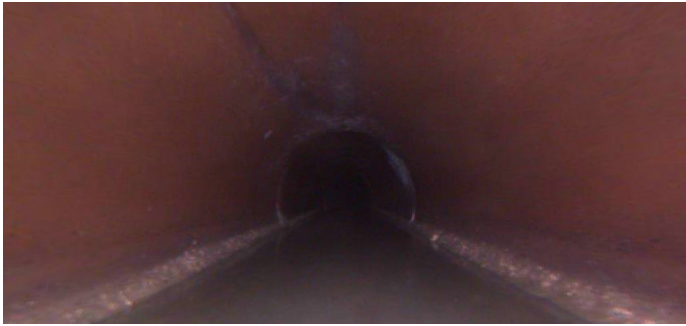
Code: **DAZ**
Description: **Deposits Attached Other**

Distance (ft): **163.6**
Structural Grade: **0**
O&M Grade: **2**
Clock Start/From: **11**
Clock To: **12**
1st Value:
2nd Value:
Value Percent: **5.000**
Continuous Index:
Within 8" of Joint: **YES**
Remarks:

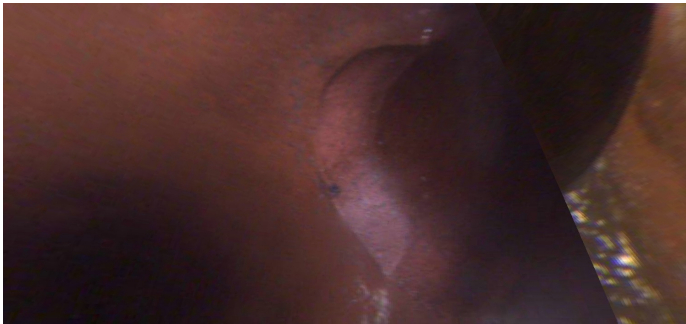
Code: **TF**
Description: **Tap Factory**

Distance (ft): **169.4**
Structural Grade: **0**
O&M Grade: **0**
Clock Start/From: **2**
Clock To:
1st Value: **4.000**
2nd Value:
Value Percent:
Continuous Index:
Within 8" of Joint:
Remarks:

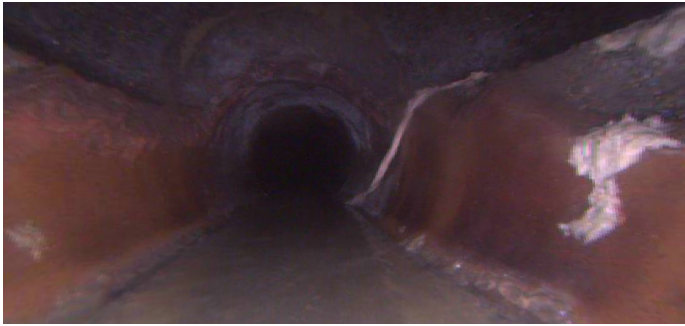
Code: **AMH**
Description: **Manhole**

Distance (ft): **223.2**
Structural Grade: **0**
O&M Grade: **0**
Clock Start/From:
Clock To:
1st Value:
2nd Value:
Value Percent:
Continuous Index:
Within 8" of Joint: **NO**
Remarks: **M-803-007**

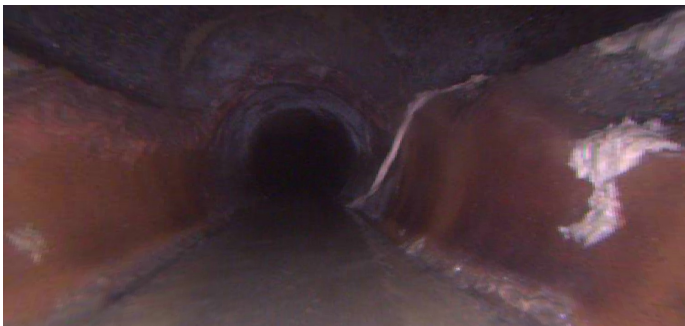
Code: **DAGS**
Description: **Deposits Attached Grease**

Distance (ft): **223.2**
Structural Grade: **0**
O&M Grade: **2**
Clock Start/From: **7**
Clock To: **5**
1st Value:
2nd Value:
Value Percent: **5.000**
Continuous Index: **F01**
Within 8" of Joint: **YES**
Remarks: **WANDER**
