Profile/Photo Observation Report

Date:	03/29/2018	Weather:		Coding:	PACP 6.0
Pipe Length (ft):	208.1	Owner:	NA	Pre Clean:	Not Known
P.O.#:		Surveyor:	Jen Costello	PSR:	P-803-009-008
Customer:		Clean Date:	01/01/1900	Shape:	C

Street:	ALLEY BETWEEN N LAWRENCE ST &	Flow Control:	Not Controlled
City:	Hobart, IN	Year Renewed:	
Location:	Other	Tape/Media #:	
Purpose:	Not Known	Dia/Height:	10"
Use:	Sanitary	Material:	VCP
Drain Area:	NA	Lining:	
Category:	NA		
Comment:

Location Details:		Direction of Survey:	Downstream
US MH:	M-803-009	DS MH:	M-803-008
		Total Length Surveyed (ft):	200.5

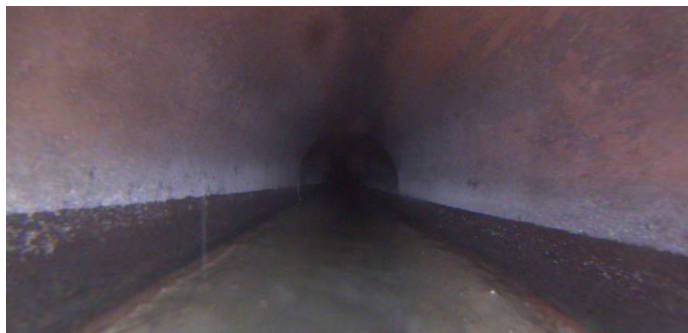
Code: **AMH**
Description: **Manhole**

Distance (ft): **.0**
Structural Grade: **0**
O&M Grade: **0**
Clock Start/From:
Clock To:
1st Value:
2nd Value:
Value Percent:
Continuous Index:
Within 8" of Joint: **NO**
Remarks: **M-803-009**

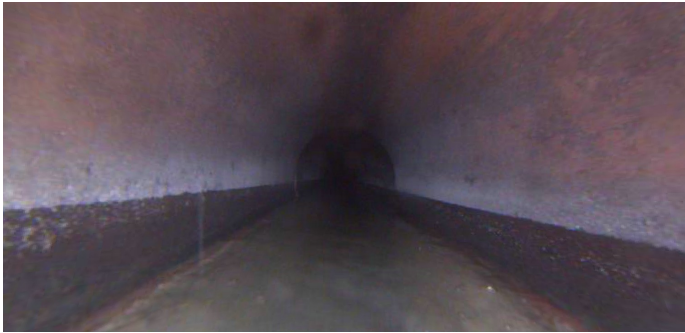
Code:	MWL
Description:	Water Level

Distance (ft):	.0
Structural Grade:	0
O&M Grade:	0
Clock Start/From:	
Clock To:	
1st Value:	
2nd Value:	
Value Percent:	10.000
Continuous Index:	
Within 8" of Joint:	NO
Remarks:

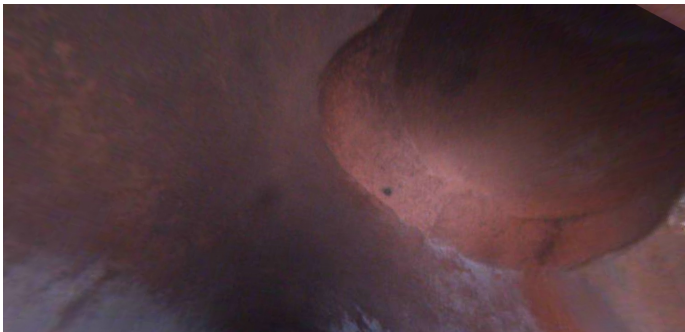
Code:	TF
Description:	Tap Factory

Distance (ft):	13.4
Structural Grade:	0
O&M Grade:	0
Clock Start/From:	2
Clock To:	
1st Value:	4.000
2nd Value:	
Value Percent:	
Continuous Index:	
Within 8" of Joint:	
Remarks:

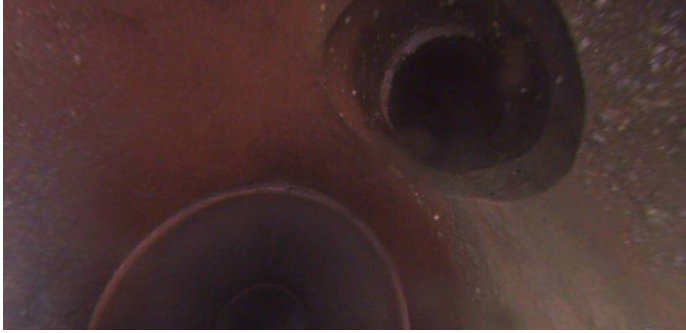
Code: **TF**
Description: **Tap Factory**

Distance (ft): **32.0**
Structural Grade: **0**
O&M Grade: **0**
Clock Start/From: **10**
Clock To:
1st Value: **4.000**
2nd Value:
Value Percent:
Continuous Index:
Within 8" of Joint:
Remarks:

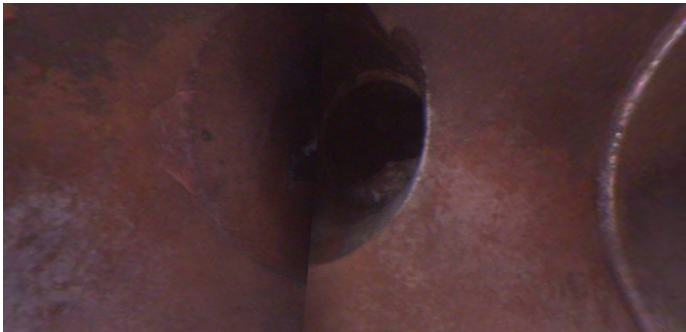
Code: **TF**
Description: **Tap Factory**

Distance (ft): **61.5**
Structural Grade: **0**
O&M Grade: **0**
Clock Start/From: **2**
Clock To:
1st Value: **4.000**
2nd Value:
Value Percent:
Continuous Index:
Within 8" of Joint:
Remarks:

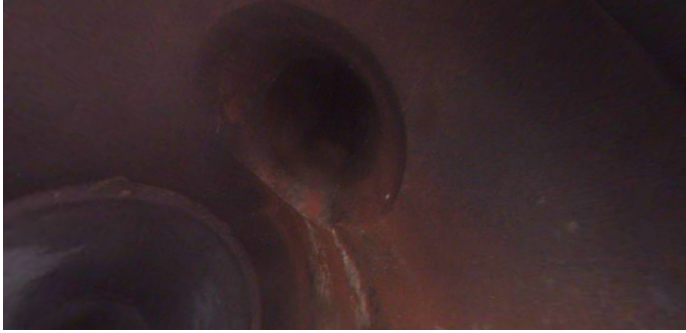
Code: **TF**
Description: **Tap Factory**

Distance (ft): **98.3**
Structural Grade: **0**
O&M Grade: **0**
Clock Start/From: **10**
Clock To:
1st Value: **4.000**
2nd Value:
Value Percent:
Continuous Index:
Within 8" of Joint:
Remarks:

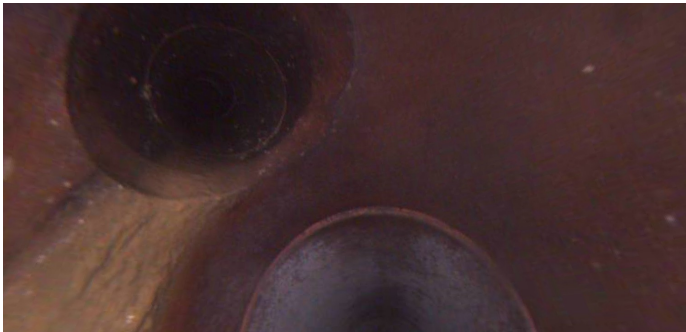
Code: **TF**
Description: **Tap Factory**

Distance (ft): **110.0**
Structural Grade: **0**
O&M Grade: **0**
Clock Start/From: **2**
Clock To:
1st Value: **4.000**
2nd Value:
Value Percent:
Continuous Index:
Within 8" of Joint:
Remarks:

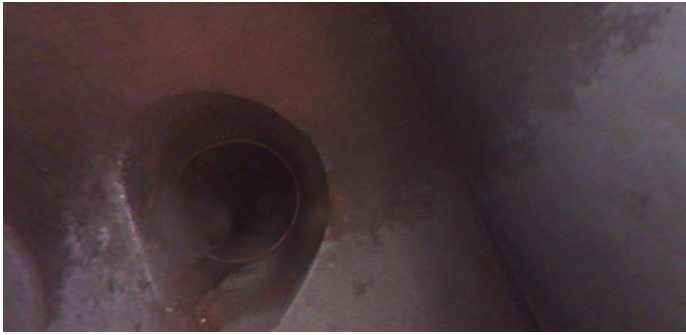
Code: **TF**
Description: **Tap Factory**

Distance (ft): **158.0**
Structural Grade: **0**
O&M Grade: **0**
Clock Start/From: **10**
Clock To:
1st Value: **4.000**
2nd Value:
Value Percent:
Continuous Index:
Within 8" of Joint:
Remarks:

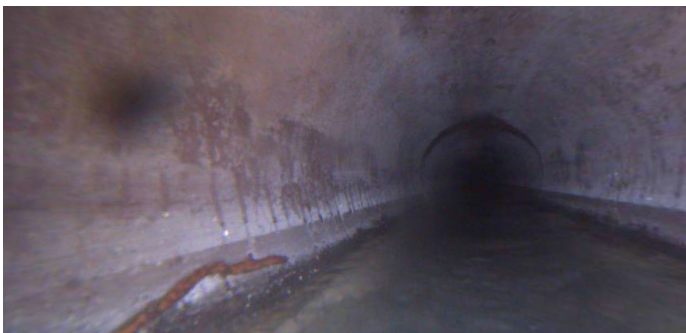
Code: **CL**
Description: **Crack Longitudinal**

Distance (ft): **160.0**
Structural Grade: **2**
O&M Grade: **0**
Clock Start/From: **8**
Clock To:
1st Value:
2nd Value:
Value Percent:
Continuous Index:
Within 8" of Joint:
Remarks:

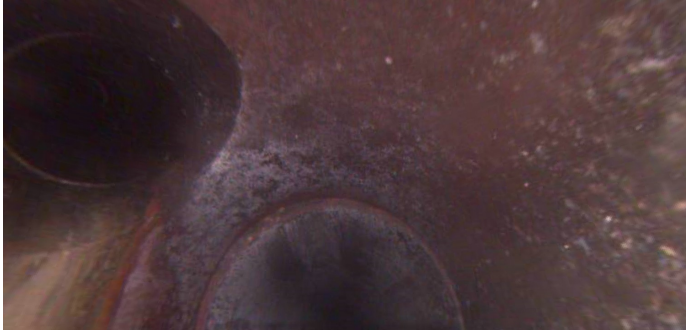
Code: **TF**
Description: **Tap Factory**

Distance (ft): **182.1**
Structural Grade: **0**
O&M Grade: **0**
Clock Start/From: **2**
Clock To:
1st Value: **4.000**
2nd Value:
Value Percent:
Continuous Index:
Within 8" of Joint:
Remarks:

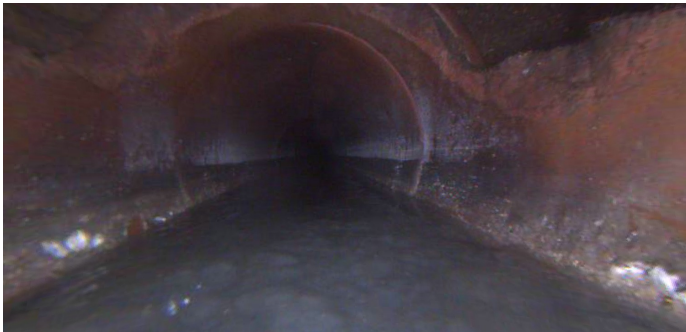
Code: **AMH**
Description: **Manhole**

Distance (ft): **200.5**
Structural Grade: **0**
O&M Grade: **0**
Clock Start/From:
Clock To:
1st Value:
2nd Value:
Value Percent:
Continuous Index:
Within 8" of Joint: **NO**
Remarks: **M-803-008**
