Profile/Photo Observation Report

Street:	ALLEY BETWEEN N LAWRENCE ST &	Flow Control:	Not Controlled
City:	Hobart, IN	Year Renewed:	
Location:	Other	Tape/Media #:	
Purpose:	Not Known	Dia/Height:	10"
Use:	Sanitary	Material:	VCP
Drain Area:	NA	Lining:	
Category:	NA		
Comment:

Location Details:		Direction of Survey:	Upstream
US MH:	M-803-010	DS MH:	M-803-009
		Total Length Surveyed (ft):	195.8

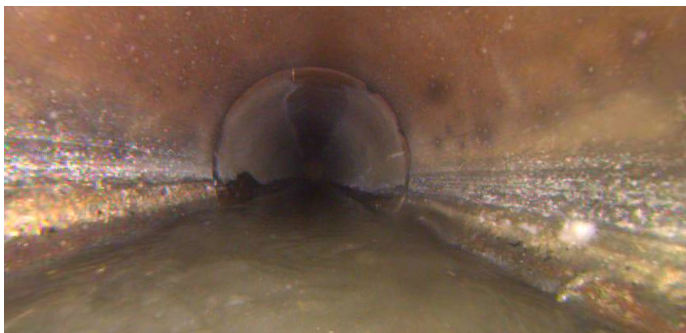
Code: **AMH**
Description: **Manhole**

Distance (ft): **.0**
Structural Grade: **0**
O&M Grade: **0**
Clock Start/From:
Clock To:
1st Value:
2nd Value:
Value Percent:
Continuous Index:
Within 8" of Joint: **NO**
Remarks: **M-803-010**

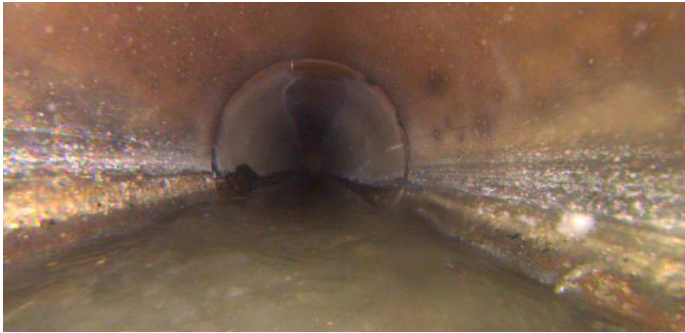
Code:	MWL
Description:	Water Level

Distance (ft):	.0
Structural Grade:	0
O&M Grade:	0
Clock Start/From:	
Clock To:	
1st Value:	
2nd Value:	
Value Percent:	30.000
Continuous Index:	
Within 8" of Joint:	NO
Remarks:

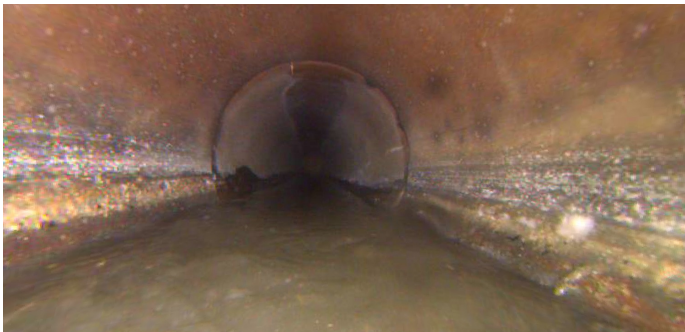
Code:	DAGS
Description:	Deposits Attached Grease

Distance (ft):	.0
Structural Grade:	0
O&M Grade:	2
Clock Start/From:	8
Clock To:	4
1st Value:	
2nd Value:	
Value Percent:	5.000
Continuous Index:	S01
Within 8" of Joint:	NO
Remarks:

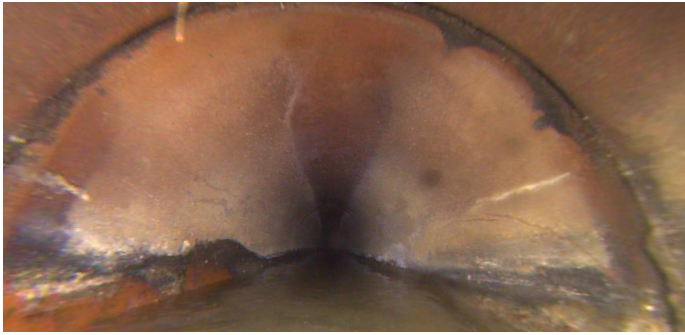
Code: **CM**
Description: **Crack Multiple**

Distance (ft): **2.4**
Structural Grade: **3**
O&M Grade: **0**
Clock Start/From: **8**
Clock To: **4**
1st Value:
2nd Value:
Value Percent:
Continuous Index:
Within 8" of Joint: **YES**
Remarks:

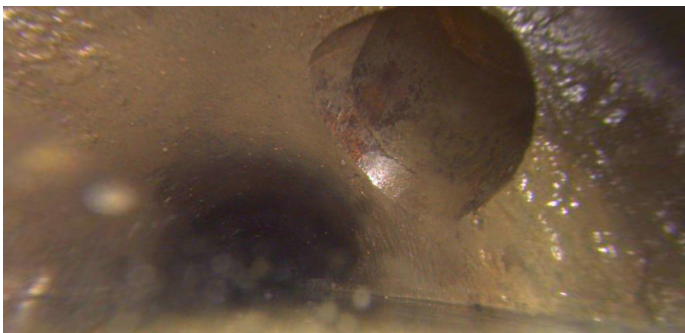
Code: **TF**
Description: **Tap Factory**

Distance (ft): **20.8**
Structural Grade: **0**
O&M Grade: **0**
Clock Start/From: **2**
Clock To:
1st Value: **4.000**
2nd Value:
Value Percent:
Continuous Index:
Within 8" of Joint:
Remarks:

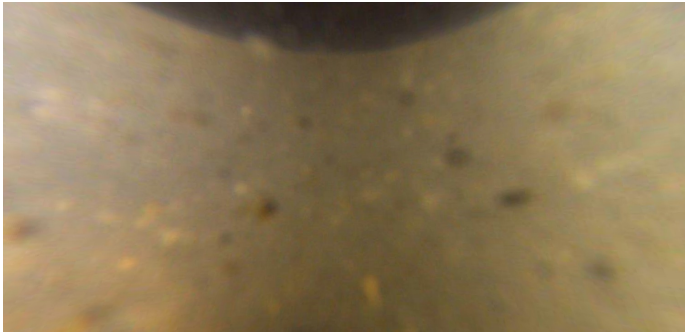
Code: **MWL**
Description: **Water Level**

Distance (ft): **24.9**
Structural Grade: **0**
O&M Grade: **0**
Clock Start/From:
Clock To:
1st Value:
2nd Value:
Value Percent: **60.000**
Continuous Index:
Within 8" of Joint: **NO**
Remarks:

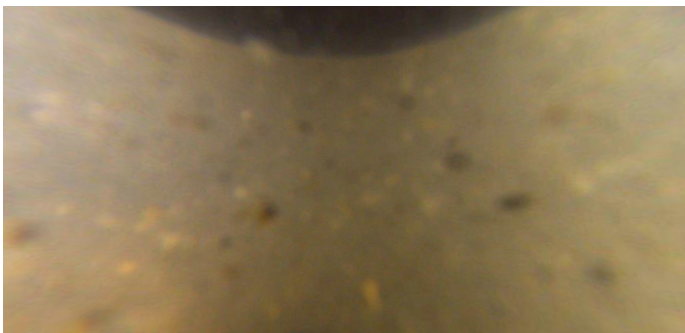
Code: **MCU**
Description: **Camera Underwater**

Distance (ft): **24.9**
Structural Grade: **0**
O&M Grade: **4**
Clock Start/From:
Clock To:
1st Value:
2nd Value:
Value Percent:
Continuous Index:
Within 8" of Joint: **NO**
Remarks:

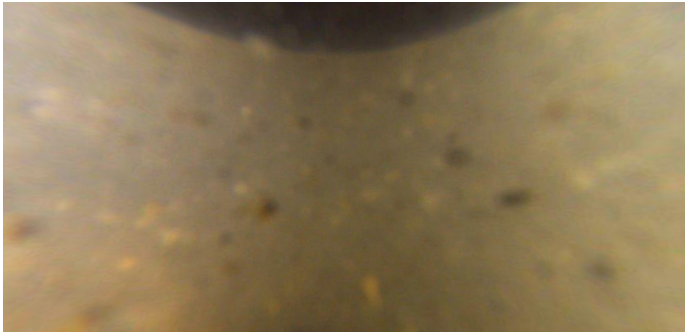
Code: **DAGS**
Description: **Deposits Attached Grease**

Distance (ft): **24.9**
Structural Grade: **0**
O&M Grade: **2**
Clock Start/From: **8**
Clock To: **4**
1st Value:
2nd Value:
Value Percent: **5.000**
Continuous Index: **F01**
Within 8" of Joint: **NO**
Remarks:

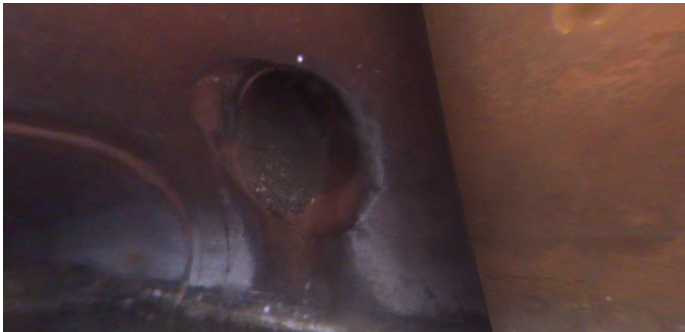
Code: **TF**
Description: **Tap Factory**

Distance (ft): **30.6**
Structural Grade: **0**
O&M Grade: **0**
Clock Start/From: **10**
Clock To:
1st Value: **4.000**
2nd Value:
Value Percent:
Continuous Index:
Within 8" of Joint:
Remarks:

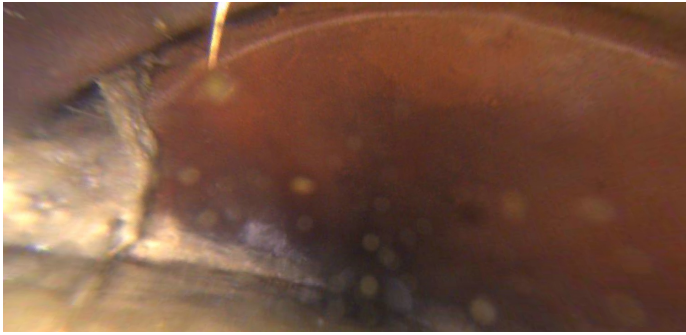
Code: **RFJ**
Description: **Roots Fine Joint**

Distance (ft): **47.0**
Structural Grade: **0**
O&M Grade: **1**
Clock Start/From: **9**
Clock To: **10**
1st Value:
2nd Value:
Value Percent:
Continuous Index:
Within 8" of Joint: **YES**
Remarks:

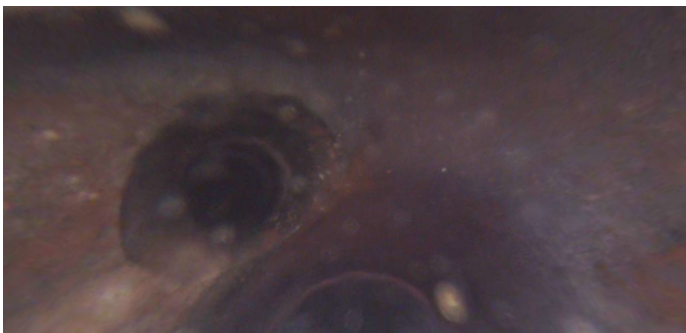
Code: **TF**
Description: **Tap Factory**

Distance (ft): **54.5**
Structural Grade: **0**
O&M Grade: **0**
Clock Start/From: **1**
Clock To:
1st Value: **4.000**
2nd Value:
Value Percent:
Continuous Index:
Within 8" of Joint:
Remarks:

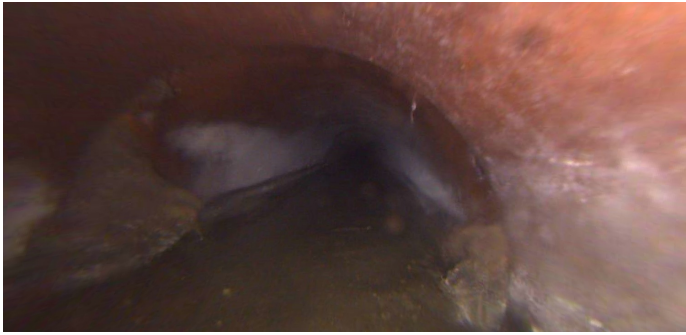
Code: **RMJ**
Description: **Roots Medium Joint**

Distance (ft): **61.8**
Structural Grade: **0**
O&M Grade: **3**
Clock Start/From: **8**
Clock To: **4**
1st Value:
2nd Value:
Value Percent: **5.000**
Continuous Index:
Within 8" of Joint: **YES**
Remarks:

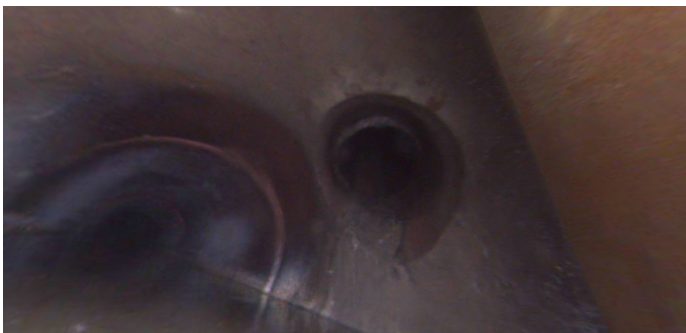
Code: **TF**
Description: **Tap Factory**

Distance (ft): **78.3**
Structural Grade: **0**
O&M Grade: **0**
Clock Start/From: **10**
Clock To:
1st Value: **4.000**
2nd Value:
Value Percent:
Continuous Index:
Within 8" of Joint:
Remarks:

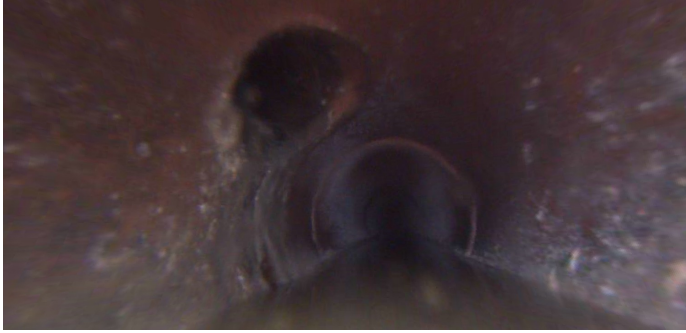
Code: **TF**
Description: **Tap Factory**

Distance (ft): **108.5**
Structural Grade: **0**
O&M Grade: **0**
Clock Start/From: **2**
Clock To:
1st Value: **4.000**
2nd Value:
Value Percent:
Continuous Index:
Within 8" of Joint:
Remarks:

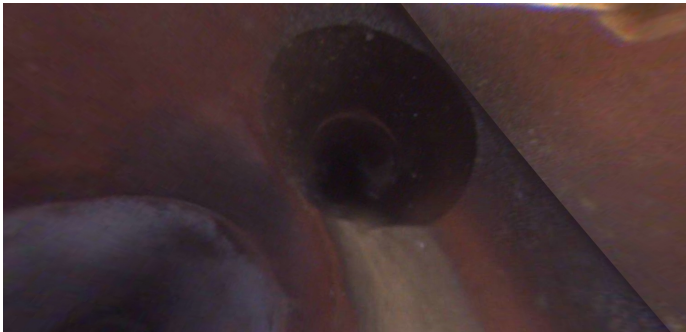
Code: **TF**
Description: **Tap Factory**

Distance (ft): **120.0**
Structural Grade: **0**
O&M Grade: **0**
Clock Start/From: **10**
Clock To:
1st Value: **4.000**
2nd Value:
Value Percent:
Continuous Index:
Within 8" of Joint:
Remarks:

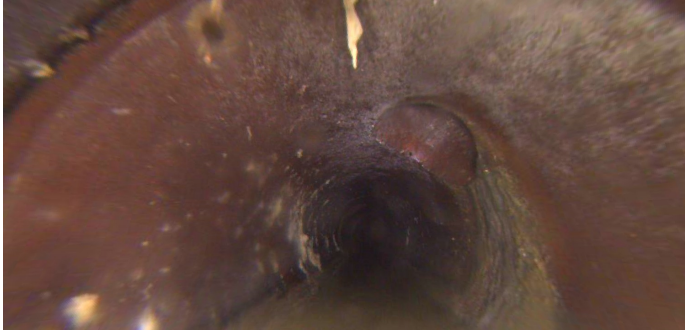
Code: **RFJ**
Description: **Roots Fine Joint**

Distance (ft): **181.5**
Structural Grade: **0**
O&M Grade: **1**
Clock Start/From: **12**
Clock To:
1st Value:
2nd Value:
Value Percent:
Continuous Index:
Within 8" of Joint: **YES**
Remarks:

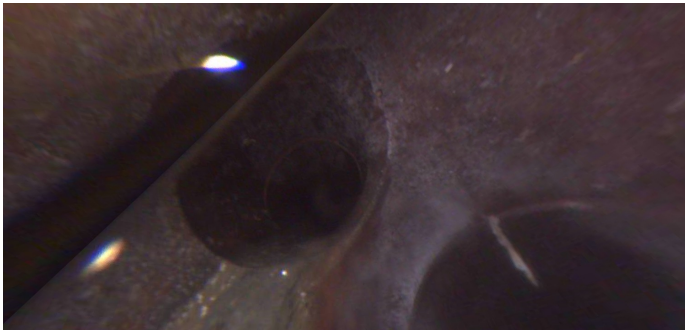
Code: **TF**
Description: **Tap Factory**

Distance (ft): **182.8**
Structural Grade: **0**
O&M Grade: **0**
Clock Start/From: **2**
Clock To:
1st Value: **4.000**
2nd Value:
Value Percent:
Continuous Index:
Within 8" of Joint:
Remarks:

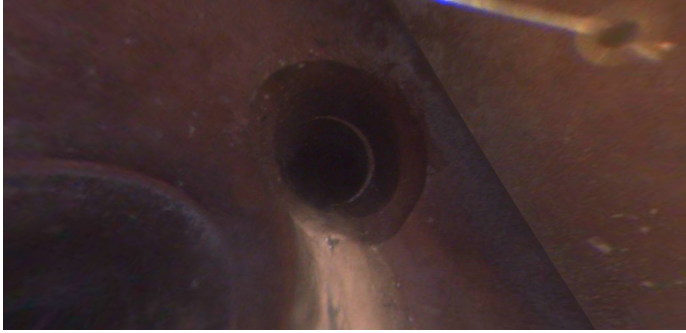
Code: **TF**
Description: **Tap Factory**

Distance (ft): **185.9**
Structural Grade: **0**
O&M Grade: **0**
Clock Start/From: **10**
Clock To:
1st Value: **4.000**
2nd Value:
Value Percent:
Continuous Index:
Within 8" of Joint:
Remarks:

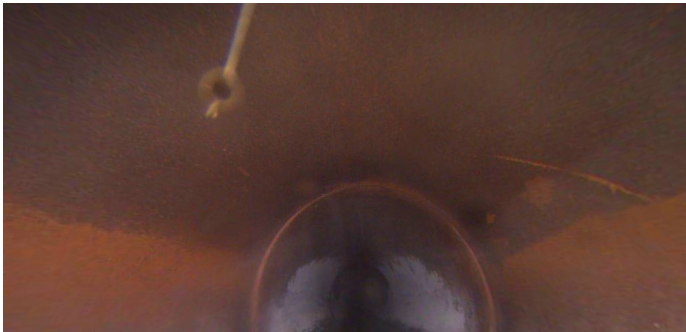
Code: **MSA**
Description: **Abandoned Survey**

Distance (ft): **195.8**
Structural Grade: **0**
O&M Grade: **0**
Clock Start/From:
Clock To:
1st Value:
2nd Value:
Value Percent:
Continuous Index:
Within 8" of Joint: **NO**
Remarks: **debris under water**
