Profile/Photo Observation Report

Date:	03/29/2018	Weather:		Coding:	PACP 6.0
Pipe Length (ft):	356.5	Owner:	NA	Pre Clean:	Not Known
P.O.#:		Surveyor:	Jen Costello	PSR:	P-803-012-010
Customer:		Clean Date:	01/01/1900	Shape:	C

Street:	E RAND ST	Flow Control:	Not Controlled
City:	Hobart, IN	Year Renewed:	
Location:	Other	Tape/Media #:	
Purpose:	Not Known	Dia/Height:	10"
Use:	Sanitary	Material:	VCP
Drain Area:	NA	Lining:	
Category:	NA		
Comment:

Location Details:		Direction of Survey:	Downstream
US MH:	M-803-010	DS MH:	M-803-012
		Total Length Surveyed (ft):	127.4

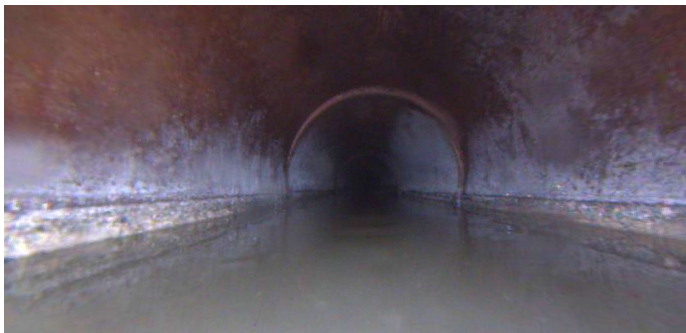
Code: **AMH**
Description: **Manhole**

Distance (ft): **.0**
Structural Grade: **0**
O&M Grade: **0**
Clock Start/From:
Clock To:
1st Value:
2nd Value:
Value Percent:
Continuous Index:
Within 8" of Joint: **NO**
Remarks: **M-803-010**

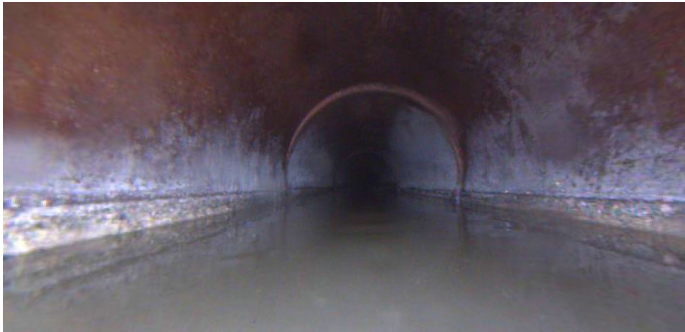
Code:	MWL
Description:	Water Level

Distance (ft):	.0
Structural Grade:	0
O&M Grade:	0
Clock Start/From:	
Clock To:	
1st Value:	
2nd Value:	
Value Percent:	40.000
Continuous Index:	
Within 8" of Joint:	NO
Remarks:

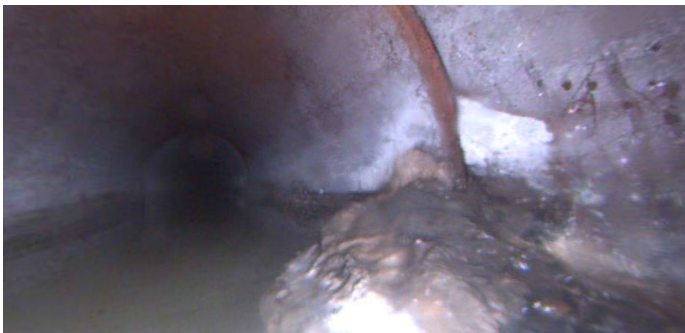
Code:	DAGS
Description:	Deposits Attached Grease

Distance (ft):	5.0
Structural Grade:	0
O&M Grade:	2
Clock Start/From:	3
Clock To:	4
1st Value:	
2nd Value:	
Value Percent:	10.000
Continuous Index:	
Within 8" of Joint:	YES
Remarks:

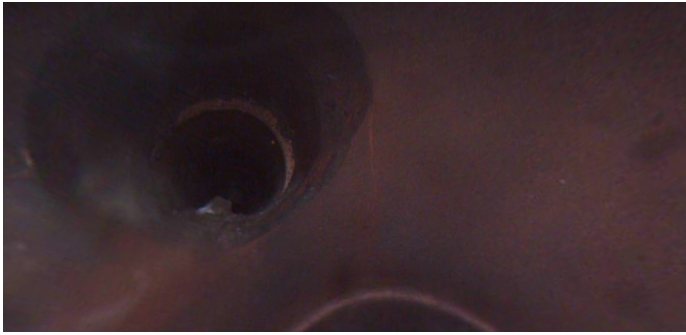
Code: **TF**
Description: **Tap Factory**

Distance (ft): **28.0**
Structural Grade: **0**
O&M Grade: **0**
Clock Start/From: **11**
Clock To:
1st Value: **4.000**
2nd Value:
Value Percent:
Continuous Index:
Within 8" of Joint:
Remarks:

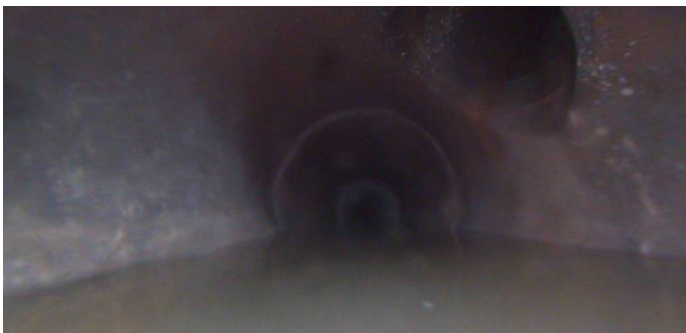
Code: **TF**
Description: **Tap Factory**

Distance (ft): **30.4**
Structural Grade: **0**
O&M Grade: **0**
Clock Start/From: **1**
Clock To:
1st Value: **4.000**
2nd Value:
Value Percent:
Continuous Index:
Within 8" of Joint:
Remarks:

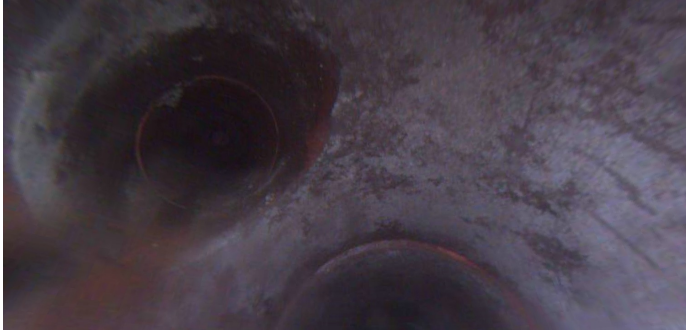
Code: **TF**
Description: **Tap Factory**

Distance (ft): **81.6**
Structural Grade: **0**
O&M Grade: **0**
Clock Start/From: **11**
Clock To:
1st Value: **4.000**
2nd Value:
Value Percent:
Continuous Index:
Within 8" of Joint:
Remarks:

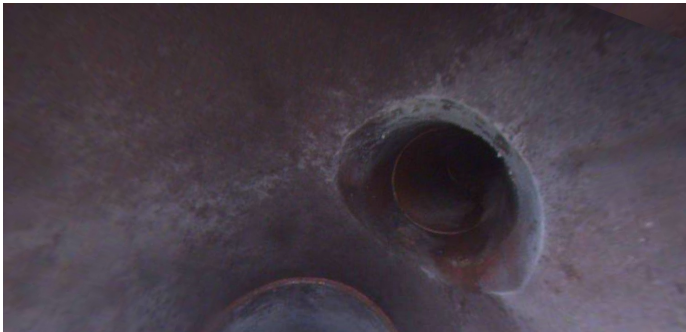
Code: **TF**
Description: **Tap Factory**

Distance (ft): **84.5**
Structural Grade: **0**
O&M Grade: **0**
Clock Start/From: **1**
Clock To:
1st Value: **4.000**
2nd Value:
Value Percent:
Continuous Index:
Within 8" of Joint:
Remarks:

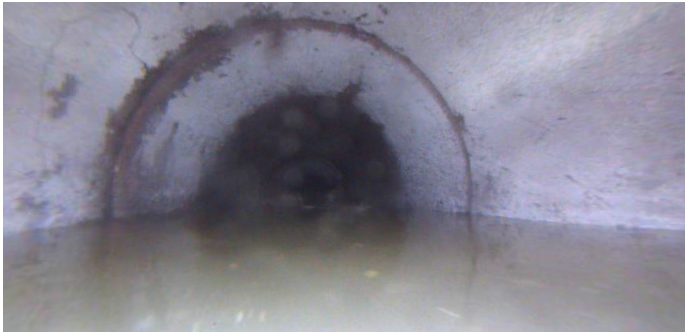
Code: **CM**
Description: **Crack Multiple**

Distance (ft): **123.9**
Structural Grade: **3**
O&M Grade: **0**
Clock Start/From: **8**
Clock To: **4**
1st Value:
2nd Value:
Value Percent:
Continuous Index:
Within 8" of Joint: **YES**
Remarks:

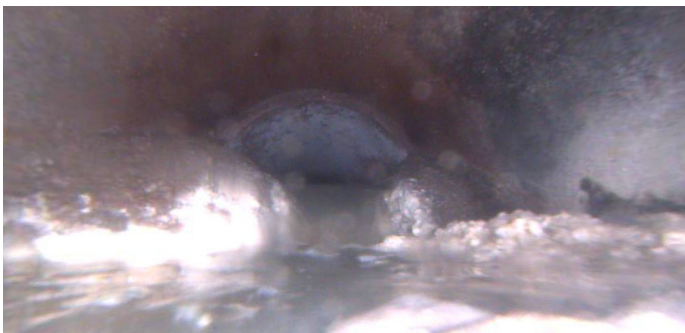
Code: **DAGS**
Description: **Deposits Attached Grease**

Distance (ft): **126.4**
Structural Grade: **0**
O&M Grade: **4**
Clock Start/From: **8**
Clock To: **4**
1st Value:
2nd Value:
Value Percent: **30.000**
Continuous Index:
Within 8" of Joint: **YES**
Remarks:

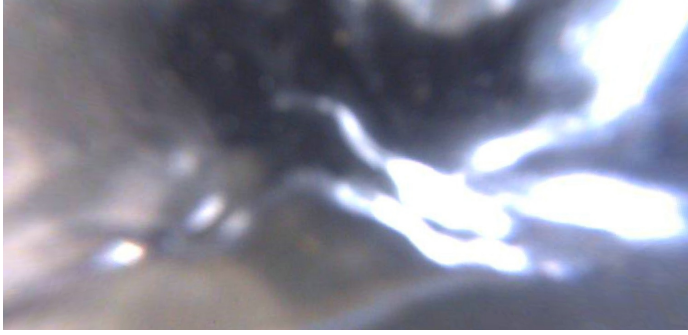
Code:	MSA
Description:	Abandoned Survey
Distance (ft):	127.4
Structural Grade:	0
O&M Grade:	0
Clock Start/From:	
Clock To:	
1st Value:	
2nd Value:	
Value Percent:	
Continuous Index:	
Within 8" of Joint:	NO
Remarks:	DAGS
