## Profile/Photo Observation Report

Date:	<b>03/29/2018</b>	Weather:		Coding:	<b>PACP 6.0</b>
Pipe Length (ft):	<b>356.5</b>	Owner:	<b>NA</b>	Pre Clean:	<b>Not Known</b>
P.O.#:		Surveyor:	<b>Jen Costello</b>	PSR:	<b>P-803-012-010</b>
Customer:		Clean Date:	<b>01/01/1900</b>	Shape:	<b>C</b>

Street:	<b>ALLEY</b>	Flow Control:	<b>Not Controlled</b>
City:	<b>Hobart, IN</b>	Year Renewed:	
Location:	<b>Other</b>	Tape/Media #:	
Purpose:	<b>Not Known</b>	Dia/Height:	<b>10"</b>
Use:	<b>Sanitary</b>	Material:	<b>VCP</b>
Drain Area:	<b>NA</b>	Lining:	
Category:	<b>NA</b>		
Comment:

Location Details:		Direction of Survey:	<b>Downstream</b>
US MH:	<b>M-803-010</b>	DS MH:	<b>M-803-012</b>
		Total Length Surveyed (ft):	<b>127.4</b>

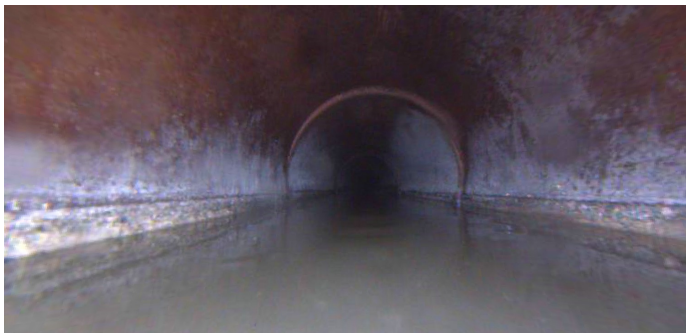
Code: **AMH**  
Description: **Manhole**

Distance (ft): **.0**  
Structural Grade: **0**  
O&M Grade: **0**  
Clock Start/From:  
Clock To:  
1st Value:  
2nd Value:  
Value Percent:  
Continuous Index:  
Within 8" of Joint: **NO**  
Remarks: **M-803-010**

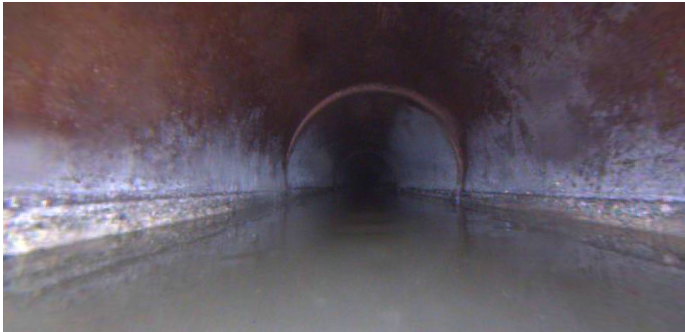
Code:	<b>MWL</b>
Description:	<b>Water Level</b>

Distance (ft):	<b>.0</b>
Structural Grade:	<b>0</b>
O&M Grade:	<b>0</b>
Clock Start/From:	
Clock To:	
1st Value:	
2nd Value:	
Value Percent:	<b>40.000</b>
Continuous Index:	
Within 8" of Joint:	<b>NO</b>
Remarks:

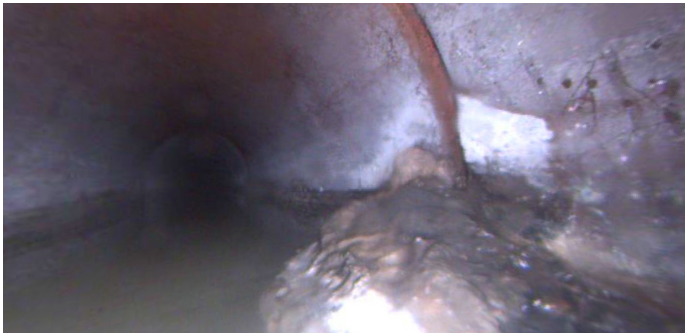
Code:	<b>DAGS</b>
Description:	<b>Deposits Attached Grease</b>

Distance (ft):	<b>5.0</b>
Structural Grade:	<b>0</b>
O&M Grade:	<b>2</b>
Clock Start/From:	<b>3</b>
Clock To:	<b>4</b>
1st Value:	
2nd Value:	
Value Percent:	<b>10.000</b>
Continuous Index:	
Within 8" of Joint:	<b>YES</b>
Remarks:

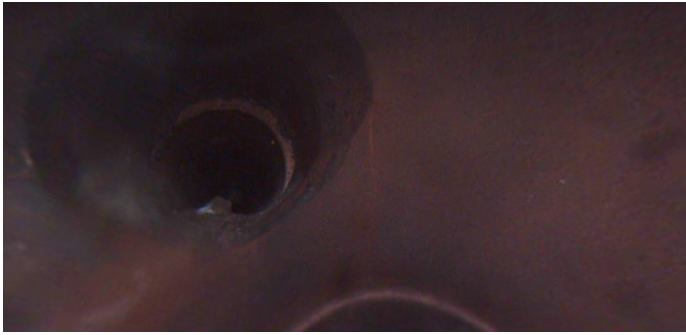
Code: **TF**  
Description: **Tap Factory**

Distance (ft): **28.0**  
Structural Grade: **0**  
O&M Grade: **0**  
Clock Start/From: **11**  
Clock To:  
1st Value: **4.000**  
2nd Value:  
Value Percent:  
Continuous Index:  
Within 8" of Joint:  
Remarks:

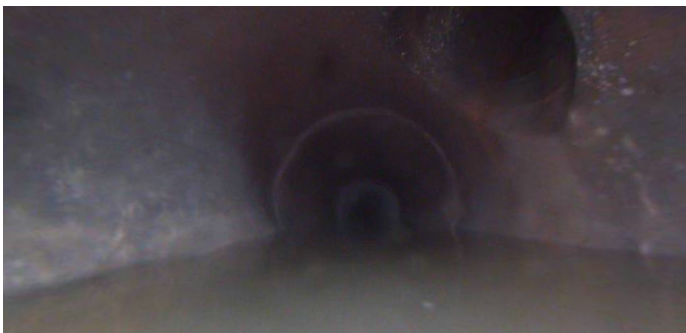
Code: **TF**  
Description: **Tap Factory**

Distance (ft): **30.4**  
Structural Grade: **0**  
O&M Grade: **0**  
Clock Start/From: **1**  
Clock To:  
1st Value: **4.000**  
2nd Value:  
Value Percent:  
Continuous Index:  
Within 8" of Joint:  
Remarks:

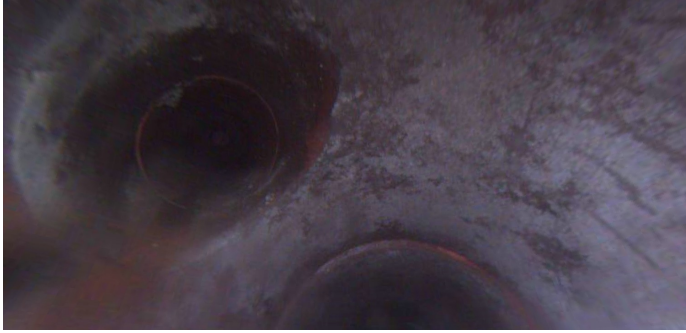
Code: **TF**  
Description: **Tap Factory**

Distance (ft): **81.6**  
Structural Grade: **0**  
O&M Grade: **0**  
Clock Start/From: **11**  
Clock To:  
1st Value: **4.000**  
2nd Value:  
Value Percent:  
Continuous Index:  
Within 8" of Joint:  
Remarks:

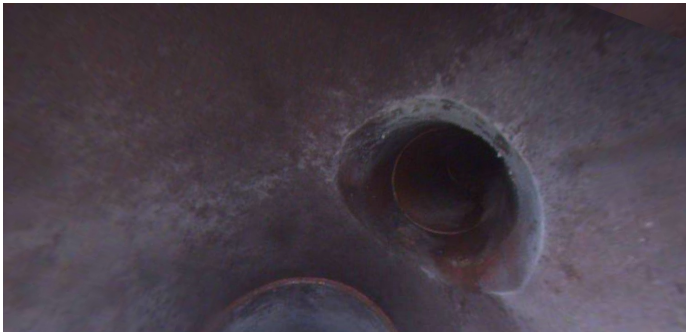
Code: **TF**  
Description: **Tap Factory**

Distance (ft): **84.5**  
Structural Grade: **0**  
O&M Grade: **0**  
Clock Start/From: **1**  
Clock To:  
1st Value: **4.000**  
2nd Value:  
Value Percent:  
Continuous Index:  
Within 8" of Joint:  
Remarks:

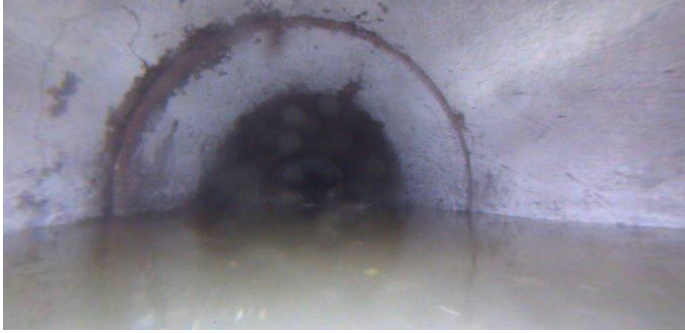
Code: **CM**  
Description: **Crack Multiple**

Distance (ft): **123.9**  
Structural Grade: **3**  
O&M Grade: **0**  
Clock Start/From: **8**  
Clock To: **4**  
1st Value:  
2nd Value:  
Value Percent:  
Continuous Index:  
Within 8" of Joint: **YES**  
Remarks:

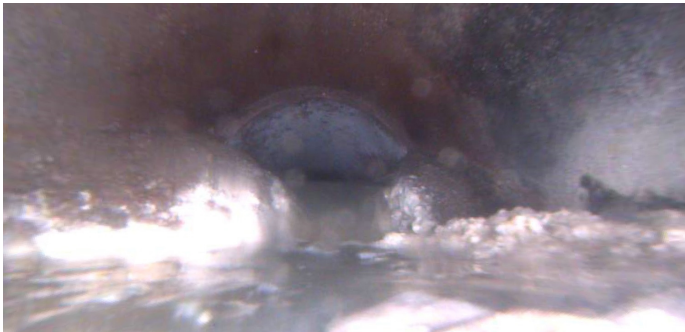
Code: **DAGS**  
Description: **Deposits Attached Grease**

Distance (ft): **126.4**  
Structural Grade: **0**  
O&M Grade: **4**  
Clock Start/From: **8**  
Clock To: **4**  
1st Value:  
2nd Value:  
Value Percent: **30.000**  
Continuous Index:  
Within 8" of Joint: **YES**  
Remarks:

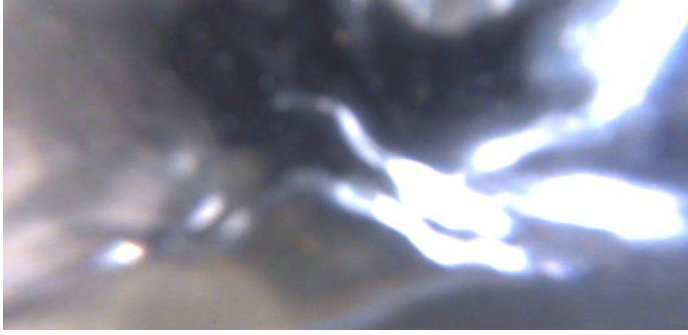
Code:	<b>MSA</b>
Description:	<b>Abandoned Survey</b>
Distance (ft):	<b>127.4</b>
Structural Grade:	<b>0</b>
O&M Grade:	<b>0</b>
Clock Start/From:	
Clock To:	
1st Value:	
2nd Value:	
Value Percent:	
Continuous Index:	
Within 8" of Joint:	<b>NO</b>
Remarks:	<b>DAGS</b>
