## Profile/Photo Observation Report

Street:	<b>RAND AV</b>	Flow Control:	<b>Not Controlled</b>
City:	<b>Hobart, IN</b>	Year Renewed:	
Location:	<b>Other</b>	Tape/Media #:	
Purpose:	<b>Not Known</b>	Dia/Height:	<b>10"</b>
Use:	<b>Sanitary</b>	Material:	<b>VCP</b>
Drain Area:	<b>NA</b>	Lining:	
Category:	<b>NA</b>		
Comment:

Location Details:		Direction of Survey:	<b>Upstream</b>
US MH:	<b>M-803-010</b>	DS MH:	<b>M-803-012</b>
		Total Length Surveyed (ft):	<b>72.5</b>

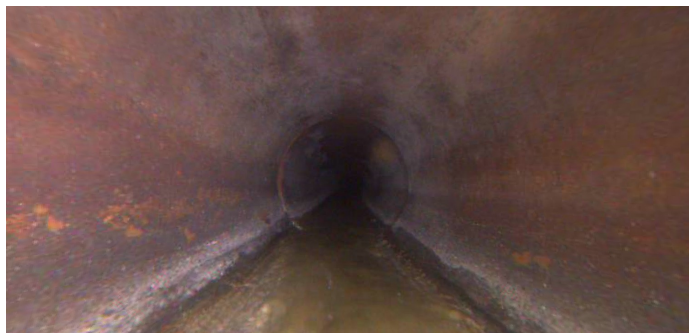
Code: **AMH**  
Description: **Manhole**

Distance (ft): **.0**  
Structural Grade: **0**  
O&M Grade: **0**  
Clock Start/From:  
Clock To:  
1st Value:  
2nd Value:  
Value Percent:  
Continuous Index:  
Within 8" of Joint: **NO**  
Remarks: **M-803-012**

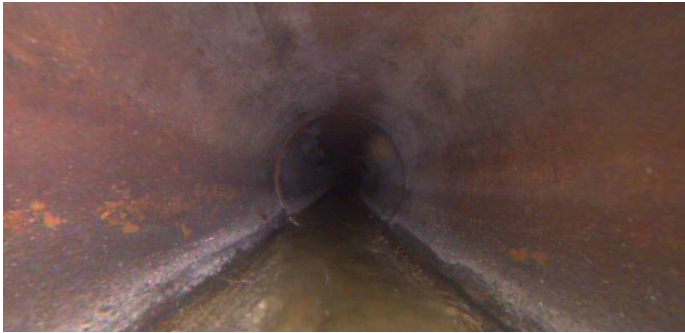
Code:	<b>MWL</b>
Description:	<b>Water Level</b>

Distance (ft):	<b>.0</b>
Structural Grade:	<b>0</b>
O&M Grade:	<b>0</b>
Clock Start/From:	
Clock To:	
1st Value:	
2nd Value:	
Value Percent:	<b>5.000</b>
Continuous Index:	
Within 8" of Joint:	<b>NO</b>
Remarks:

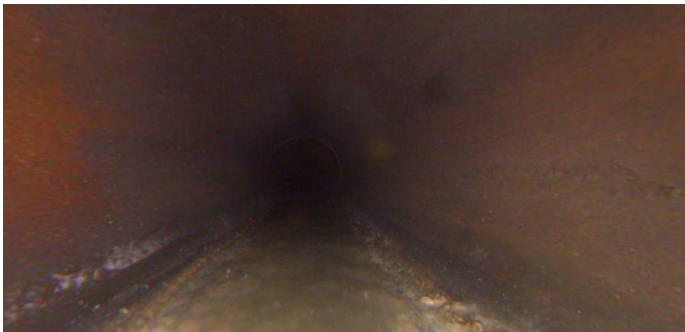
Code:	<b>MSA</b>
Description:	<b>Abandoned Survey</b>

Distance (ft):	<b>72.5</b>
Structural Grade:	<b>0</b>
O&M Grade:	<b>0</b>
Clock Start/From:	
Clock To:	
1st Value:	
2nd Value:	
Value Percent:	
Continuous Index:	
Within 8" of Joint:	<b>NO</b>
Remarks:	<b>unknown</b>
