Profile/Photo Observation Report

Street:	E RAND ST	Flow Control:	Not Controlled
City:	Hobart, IN	Year Renewed:	
Location:	Other	Tape/Media #:	
Purpose:	Not Known	Dia/Height:	12"
Use:	Sanitary	Material:	VCP
Drain Area:	NA	Lining:	
Category:	NA		
Comment:

Location Details:		Direction of Survey:	Downstream
US MH:	M-803-012	DS MH:	M-803-011
		Total Length Surveyed (ft):	83.0

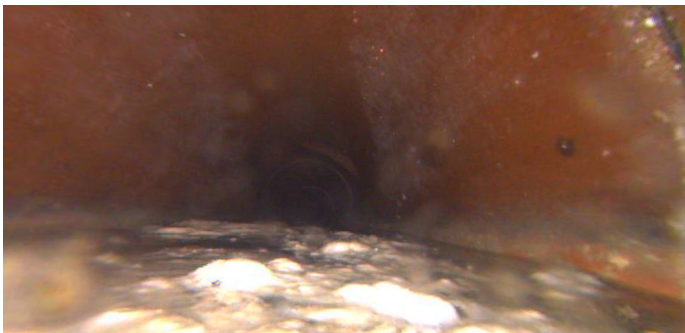
Code: **AMH**
Description: **Manhole**

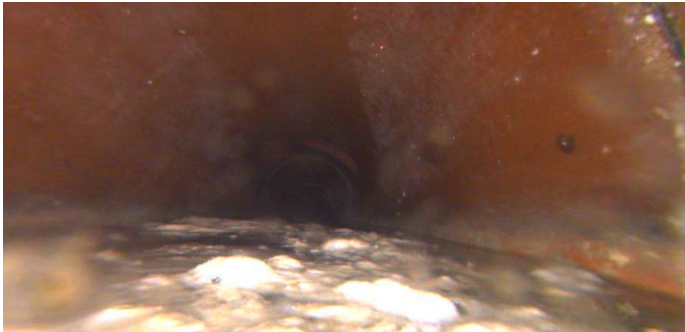
Code:	MWL
Description:	Water Level

Distance (ft):	.0
Structural Grade:	0
O&M Grade:	0
Clock Start/From:	
Clock To:	
1st Value:	
2nd Value:	
Value Percent:	40.000
Continuous Index:	
Within 8" of Joint:	NO
Remarks:

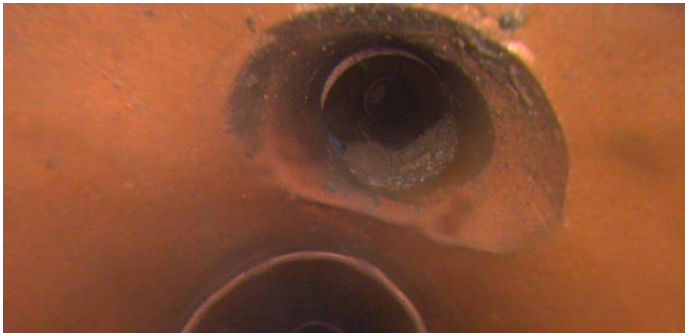
Code:	TF
Description:	Tap Factory

Distance (ft):	2.9
Structural Grade:	0
O&M Grade:	0
Clock Start/From:	1
Clock To:	
1st Value:	4.000
2nd Value:	
Value Percent:	
Continuous Index:	
Within 8" of Joint:	
Remarks:

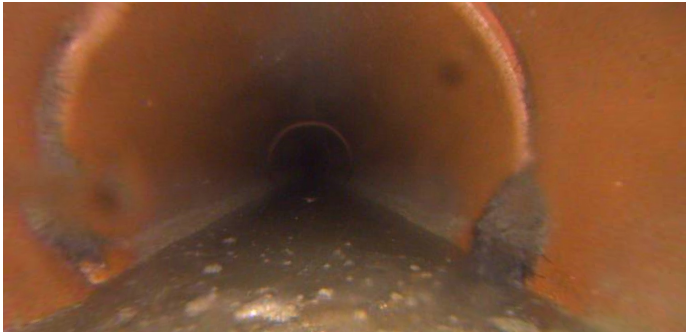
Code: **DAZ**
Description: **Deposits Attached Other**

Distance (ft): **15.6**
Structural Grade: **0**
O&M Grade: **2**
Clock Start/From: **8**
Clock To: **4**
1st Value:
2nd Value:
Value Percent: **5.000**
Continuous Index:
Within 8" of Joint: **YES**
Remarks:

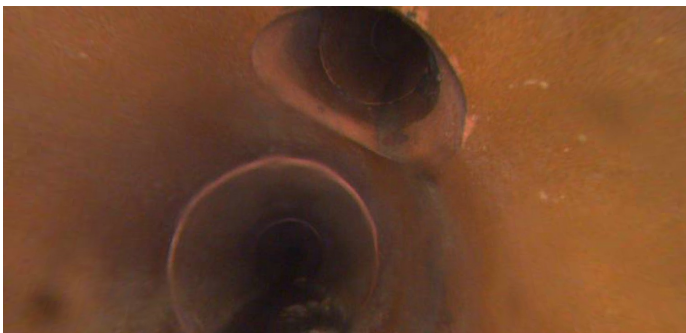
Code: **TF**
Description: **Tap Factory**

Distance (ft): **59.8**
Structural Grade: **0**
O&M Grade: **0**
Clock Start/From: **1**
Clock To:
1st Value: **4.000**
2nd Value:
Value Percent:
Continuous Index:
Within 8" of Joint:
Remarks:

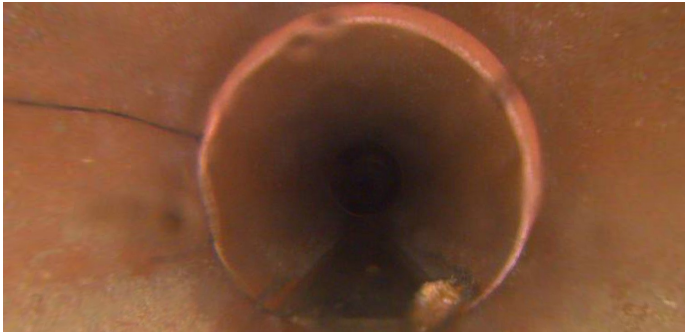
Code: **FL**
Description: **Fracture Longitudinal**

Distance (ft): **72.7**
Structural Grade: **3**
O&M Grade: **0**
Clock Start/From: **9**
Clock To:
1st Value:
2nd Value:
Value Percent:
Continuous Index:
Within 8" of Joint: **YES**
Remarks:

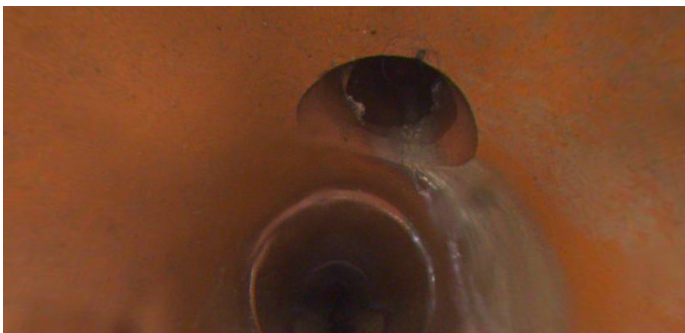
Code: **TFA**
Description: **Tap Factory Active**

Distance (ft): **78.0**
Structural Grade: **0**
O&M Grade: **0**
Clock Start/From: **1**
Clock To:
1st Value: **4.000**
2nd Value:
Value Percent:
Continuous Index:
Within 8" of Joint:
Remarks:

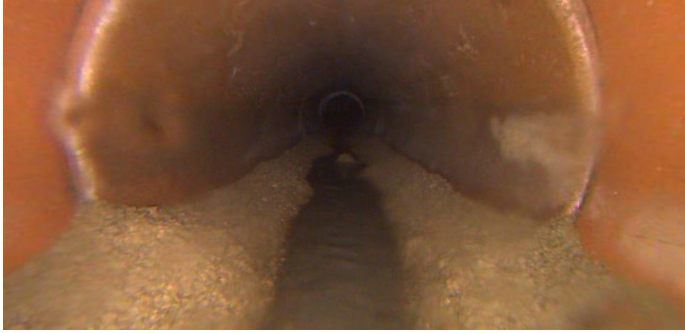
Code: **DAZ**
Description: **Deposits Attached Other**

Distance (ft): **82.1**
Structural Grade: **0**
O&M Grade: **3**
Clock Start/From: **4**
Clock To: **8**
1st Value:
2nd Value:
Value Percent: **20.000**
Continuous Index:
Within 8" of Joint: **NO**
Remarks:

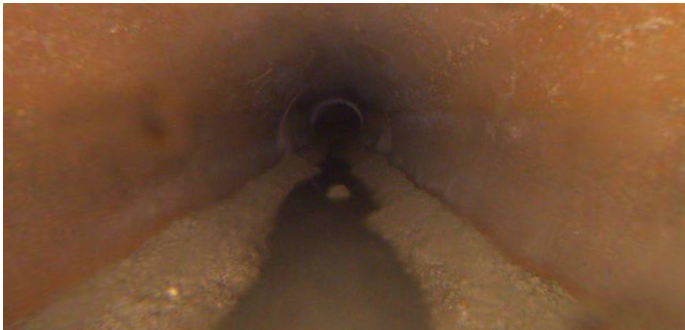
Code: **MSA**
Description: **Abandoned Survey**

Distance (ft): **83.0**
Structural Grade: **0**
O&M Grade: **0**
Clock Start/From:
Clock To:
1st Value:
2nd Value:
Value Percent:
Continuous Index:
Within 8" of Joint: **NO**
Remarks: **SOIL**
