## Profile/Photo Observation Report

Street:	<b>Rand St.</b>	Flow Control:	<b>Not Controlled</b>
City:	<b>Hobart, IN</b>	Year Renewed:	
Location:	<b>Other</b>	Tape/Media #:	
Purpose:	<b>Not Known</b>	Dia/Height:	<b>12"</b>
Use:	<b>Sanitary</b>	Material:	<b>VCP</b>
Drain Area:	<b>NA</b>	Lining:	
Category:	<b>NA</b>		
Comment:

Location Details:		Direction of Survey:	<b>Downstream</b>
US MH:	<b>M-803-012</b>	DS MH:	<b>M-803-011</b>
		Total Length Surveyed (ft):	<b>83.0</b>

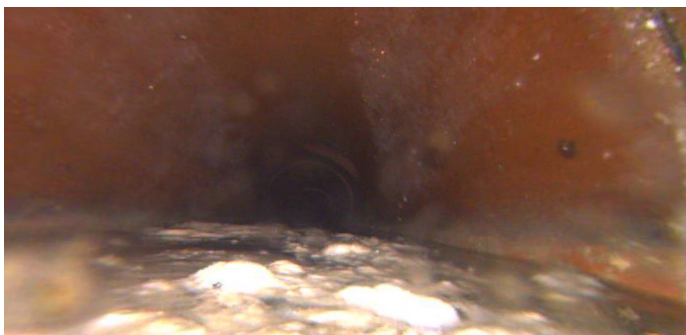
Code: **AMH**  
Description: **Manhole**

Distance (ft): **.0**  
Structural Grade: **0**  
O&M Grade: **0**  
Clock Start/From:  
Clock To:  
1st Value:  
2nd Value:  
Value Percent:  
Continuous Index:  
Within 8" of Joint: **NO**  
Remarks: **M-803-012**

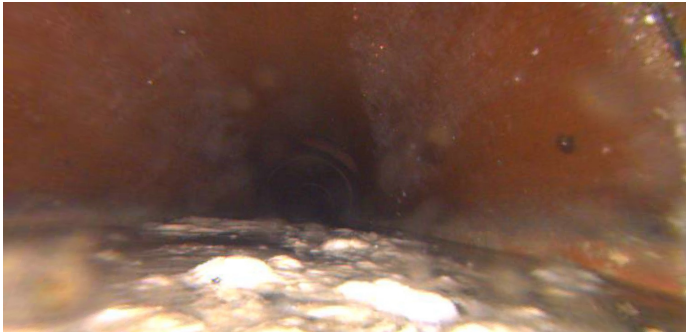
Code: **MWL**  
Description: **Water Level**

Distance (ft): **.0**  
Structural Grade: **0**  
O&M Grade: **0**  
Clock Start/From:  
Clock To:  
1st Value:  
2nd Value:  
Value Percent: **40.000**  
Continuous Index:  
Within 8" of Joint: **NO**  
Remarks:

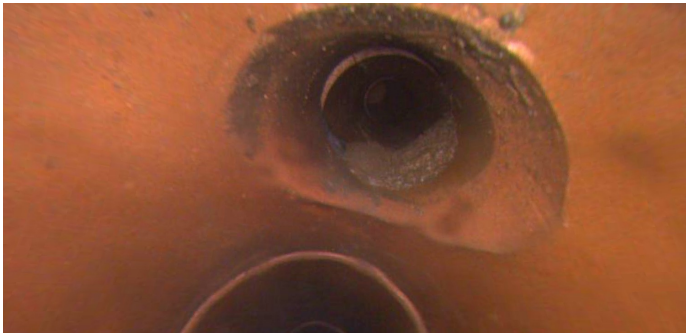
Code: **TF**  
Description: **Tap Factory**

Distance (ft): **2.9**  
Structural Grade: **0**  
O&M Grade: **0**  
Clock Start/From: **1**  
Clock To:  
1st Value: **4.000**  
2nd Value:  
Value Percent:  
Continuous Index:  
Within 8" of Joint:  
Remarks:

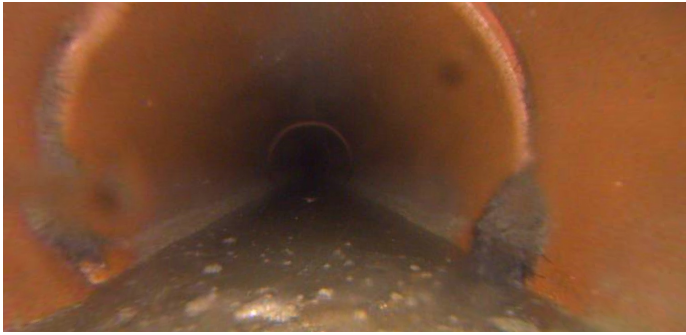
Code: **DAZ**  
Description: **Deposits Attached Other**

Distance (ft): **15.6**  
Structural Grade: **0**  
O&M Grade: **2**  
Clock Start/From: **8**  
Clock To: **4**  
1st Value:  
2nd Value:  
Value Percent: **5.000**  
Continuous Index:  
Within 8" of Joint: **YES**  
Remarks:

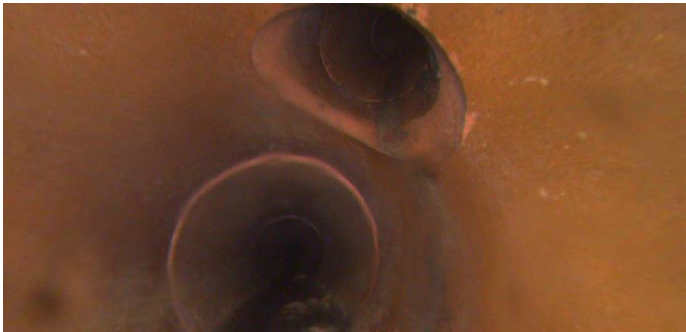
Code: **TF**  
Description: **Tap Factory**

Distance (ft): **59.8**  
Structural Grade: **0**  
O&M Grade: **0**  
Clock Start/From: **1**  
Clock To:  
1st Value: **4.000**  
2nd Value:  
Value Percent:  
Continuous Index:  
Within 8" of Joint:  
Remarks:

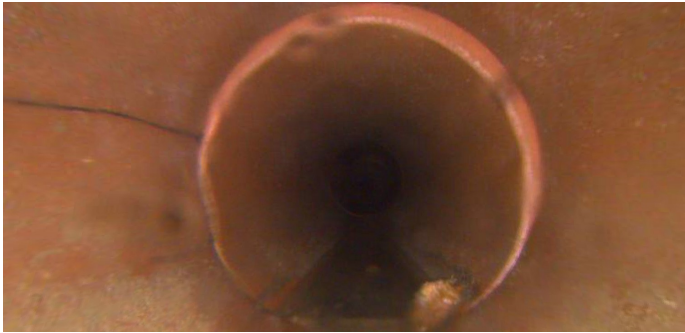
Code: **FL**  
Description: **Fracture Longitudinal**

Distance (ft): **72.7**  
Structural Grade: **3**  
O&M Grade: **0**  
Clock Start/From: **9**  
Clock To:  
1st Value:  
2nd Value:  
Value Percent:  
Continuous Index:  
Within 8" of Joint: **YES**  
Remarks:

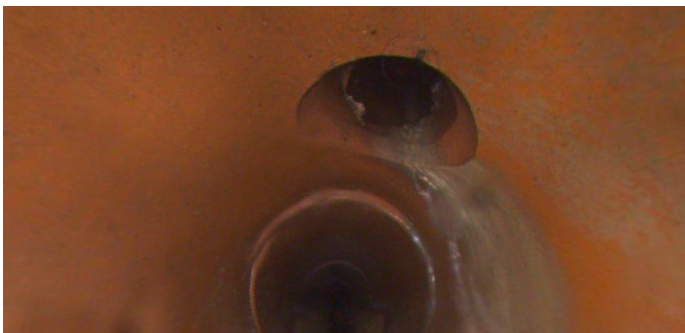
Code: **TFA**  
Description: **Tap Factory Active**

Distance (ft): **78.0**  
Structural Grade: **0**  
O&M Grade: **0**  
Clock Start/From: **1**  
Clock To:  
1st Value: **4.000**  
2nd Value:  
Value Percent:  
Continuous Index:  
Within 8" of Joint:  
Remarks:

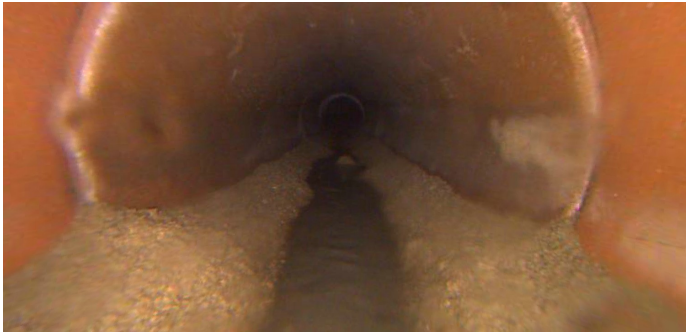
Code: **DAZ**  
Description: **Deposits Attached Other**

Distance (ft): **82.1**  
Structural Grade: **0**  
O&M Grade: **3**  
Clock Start/From: **4**  
Clock To: **8**  
1st Value:  
2nd Value:  
Value Percent: **20.000**  
Continuous Index:  
Within 8" of Joint: **NO**  
Remarks:

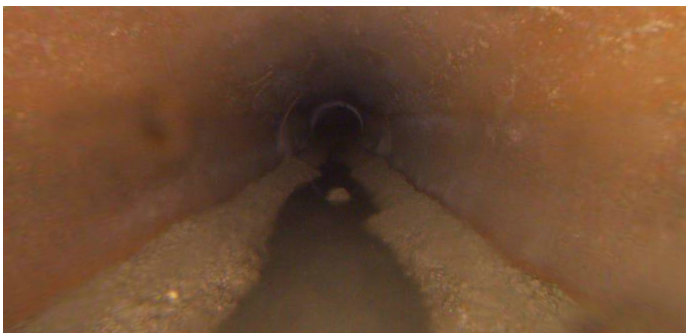
Code: **MSA**  
Description: **Abandoned Survey**

Distance (ft): **83.0**  
Structural Grade: **0**  
O&M Grade: **0**  
Clock Start/From:  
Clock To:  
1st Value:  
2nd Value:  
Value Percent:  
Continuous Index:  
Within 8" of Joint: **NO**  
Remarks: **SOIL**
