Profile/Photo Observation Report

Date:	10/02/2018	Weather:		Coding:	PACP 6.0
Pipe Length (ft):	225.0	Owner:	NA	Pre Clean:	Not Known
P.O.#:		Surveyor:	Justin Gonzales	PSR:	P-903-032-013
Customer:		Clean Date:	01/01/1900	Shape:	C

Street:	Hobart Rd.	Flow Control:	Not Controlled
City:	Hobart, IN	Year Renewed:	
Location:	Light Highway	Tape/Media #:	
Purpose:	Routine Assessment	Dia/Height:	12"
Use:	Sanitary	Material:	VCP
Drain Area:	NA	Lining:	
Category:	NA		
Comment:

Location Details:		Direction of Survey:	Downstream
US MH:	M-803-013	DS MH:	M-903-032
		Total Length Surveyed (ft):	180.6

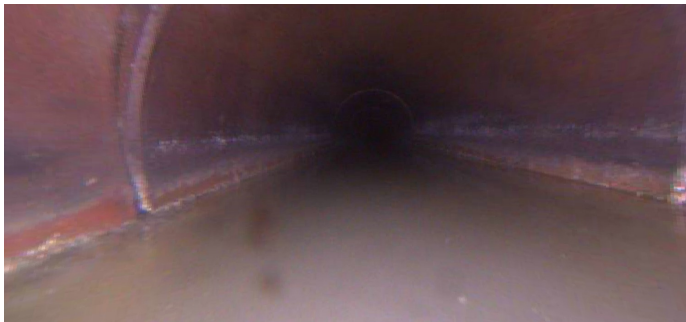
Code: **AMH**
Description: **Manhole**

Distance (ft): **.0**
Structural Grade: **0**
O&M Grade: **0**
Clock Start/From:
Clock To:
1st Value:
2nd Value:
Value Percent:
Continuous Index:
Within 8" of Joint: **NO**
Remarks: **M-803-013**

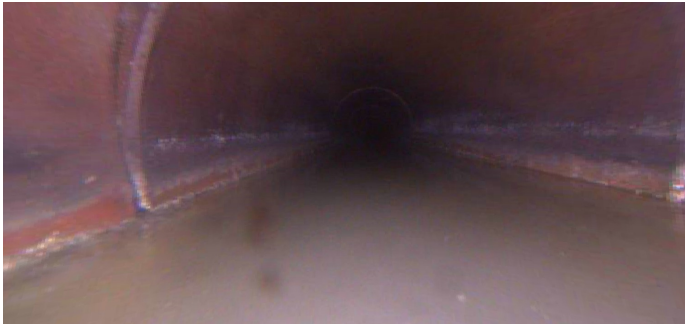
Code:	MWL
Description:	Water Level

Distance (ft):	.0
Structural Grade:	0
O&M Grade:	0
Clock Start/From:	
Clock To:	
1st Value:	
2nd Value:	
Value Percent:	10.000
Continuous Index:	
Within 8" of Joint:	NO
Remarks:

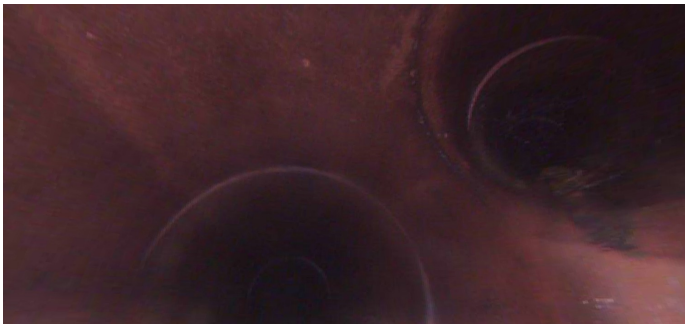
Code:	TF
Description:	Tap Factory

Distance (ft):	52.0
Structural Grade:	0
O&M Grade:	0
Clock Start/From:	2
Clock To:	
1st Value:	4.000
2nd Value:	
Value Percent:	
Continuous Index:	
Within 8" of Joint:	
Remarks:

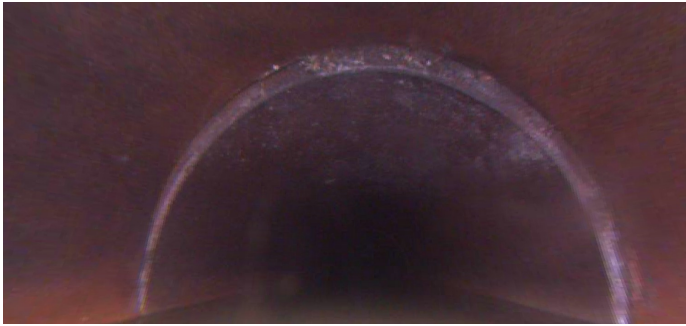
Code: **RFJ**
Description: **Roots Fine Joint**

Distance (ft): **67.6**
Structural Grade: **0**
O&M Grade: **1**
Clock Start/From: **1**
Clock To: **1**
1st Value:
2nd Value:
Value Percent:
Continuous Index:
Within 8" of Joint: **YES**
Remarks:

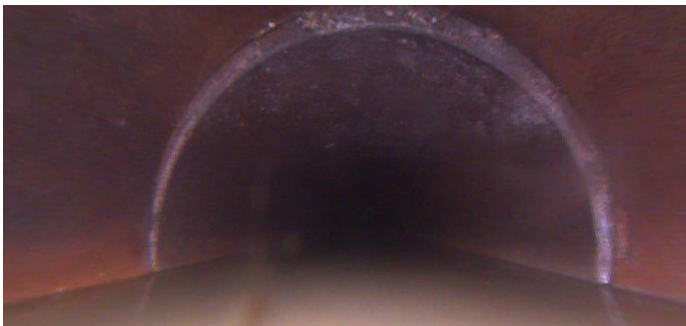
Code: **DAGS**
Description: **Deposits Attached Grease**

Distance (ft): **67.6**
Structural Grade: **0**
O&M Grade: **2**
Clock Start/From: **10**
Clock To: **2**
1st Value:
2nd Value:
Value Percent: **5.000**
Continuous Index:
Within 8" of Joint: **YES**
Remarks:

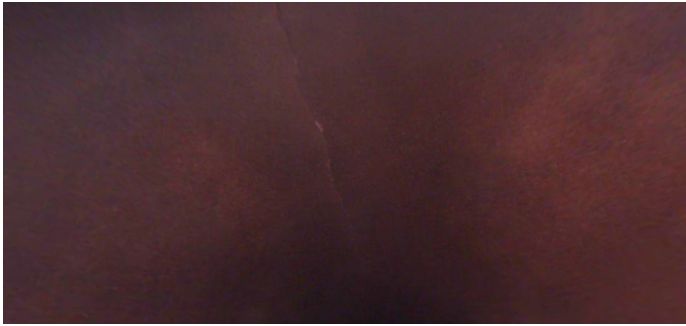
Code: **CL**
Description: **Crack Longitudinal**

Distance (ft): **77.3**
Structural Grade: **2**
O&M Grade: **0**
Clock Start/From: **12**
Clock To:
1st Value:
2nd Value:
Value Percent:
Continuous Index:
Within 8" of Joint: **YES**
Remarks:

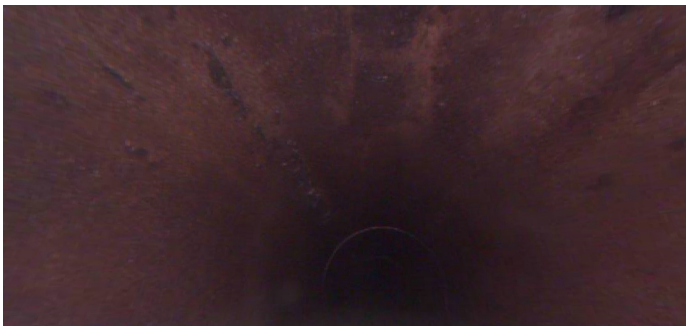
Code: **DAZ**
Description: **Deposits Attached Other**

Distance (ft): **141.6**
Structural Grade: **0**
O&M Grade: **2**
Clock Start/From: **9**
Clock To: **3**
1st Value:
2nd Value:
Value Percent: **5.000**
Continuous Index:
Within 8" of Joint: **NO**
Remarks:

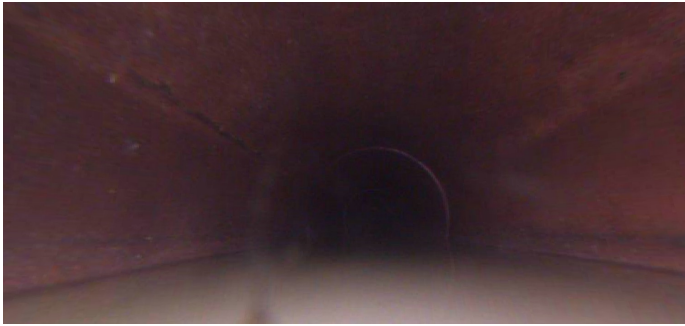
Code: **DAZ**
Description: **Deposits Attached Other**

Distance (ft): **157.0**
Structural Grade: **0**
O&M Grade: **2**
Clock Start/From: **10**
Clock To: **2**
1st Value:
2nd Value:
Value Percent: **5.000**
Continuous Index:
Within 8" of Joint: **NO**
Remarks:

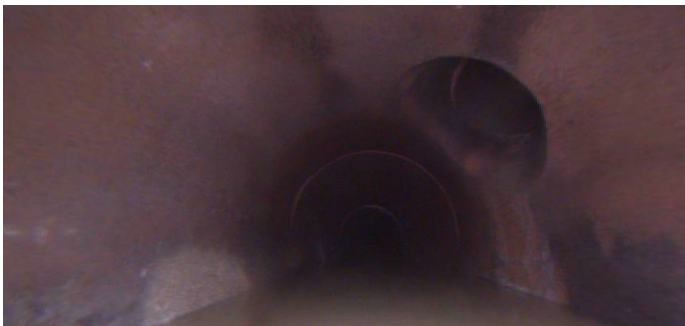
Code: **TF**
Description: **Tap Factory**

Distance (ft): **163.3**
Structural Grade: **0**
O&M Grade: **0**
Clock Start/From: **2**
Clock To:
1st Value: **4.000**
2nd Value:
Value Percent:
Continuous Index:
Within 8" of Joint:
Remarks:

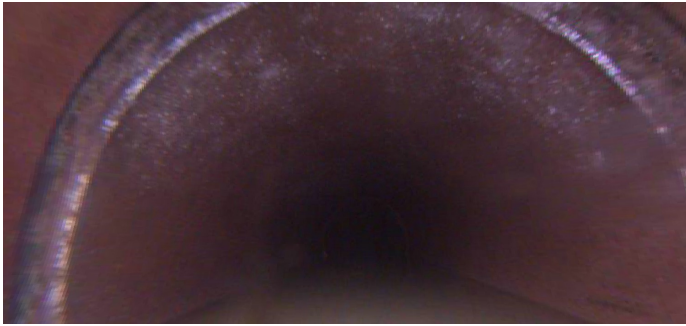
Code: **DAGS**
Description: **Deposits Attached Grease**

Distance (ft): **167.6**
Structural Grade: **0**
O&M Grade: **2**
Clock Start/From: **10**
Clock To: **2**
1st Value:
2nd Value:
Value Percent: **5.000**
Continuous Index:
Within 8" of Joint: **NO**
Remarks:

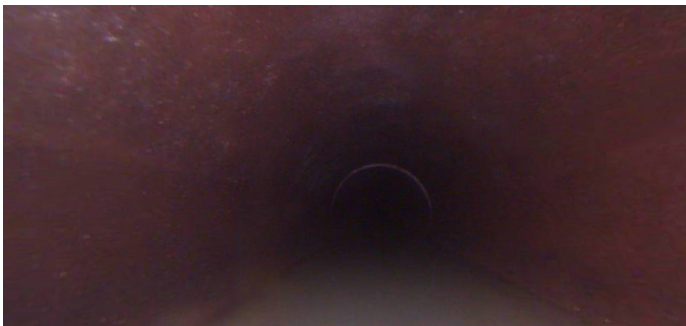
Code: **MSA**
Description: **Abandoned Survey**

Distance (ft): **180.6**
Structural Grade: **0**
O&M Grade: **0**
Clock Start/From:
Clock To:
1st Value:
2nd Value:
Value Percent:
Continuous Index:
Within 8" of Joint: **NO**
Remarks: **ROBOT HAS STOPPED**
