## Profile/Photo Observation Report

Street:	<b>E RAND ST &amp; N HOBART RD</b>	Flow Control:	<b>Not Controlled</b>
City:	<b>Hobart, IN</b>	Year Renewed:	
Location:	<b>Light Highway</b>	Tape/Media #:	
Purpose:	<b>Routine Assessment</b>	Dia/Height:	<b>12"</b>
Use:	<b>Sanitary</b>	Material:	<b>VCP</b>
Drain Area:	<b>NA</b>	Lining:	
Category:	<b>NA</b>		
Comment:

Location Details:		Direction of Survey:	<b>Upstream</b>
US MH:	<b>M-803-013</b>	DS MH:	<b>M-903-032</b>
		Total Length Surveyed (ft):	<b>221.2</b>

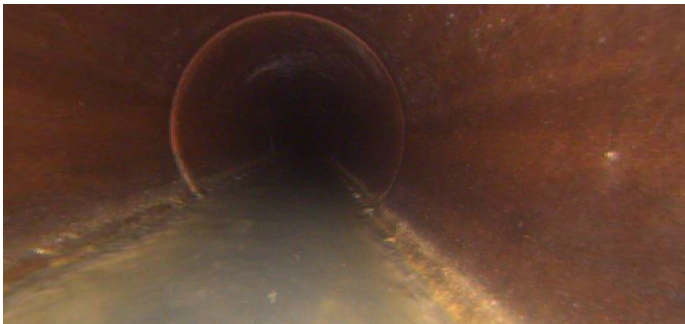
Code: **AMH**  
Description: **Manhole**

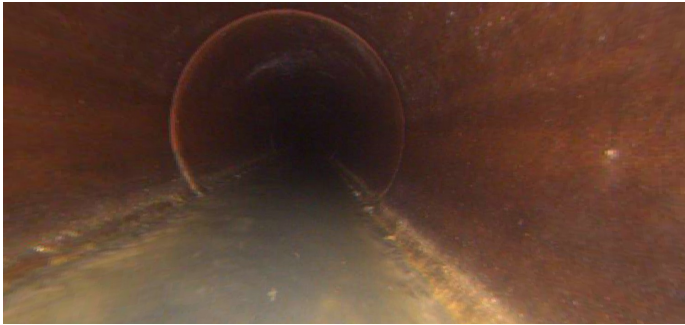
Code:	<b>MWL</b>
Description:	<b>Water Level</b>

Distance (ft):	<b>.0</b>
Structural Grade:	<b>0</b>
O&M Grade:	<b>0</b>
Clock Start/From:	
Clock To:	
1st Value:	
2nd Value:	
Value Percent:	<b>10.000</b>
Continuous Index:	
Within 8" of Joint:	<b>NO</b>
Remarks:

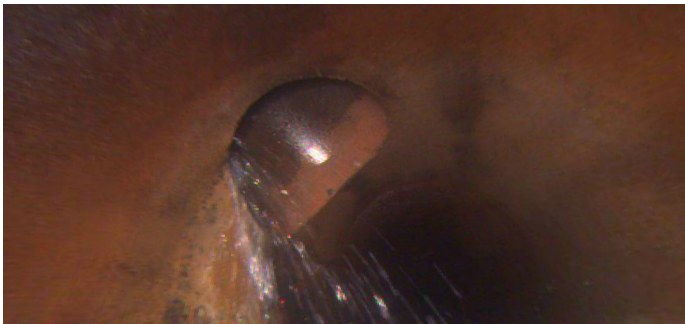
Code:	<b>TFA</b>
Description:	<b>Tap Factory Active</b>

Distance (ft):	<b>53.6</b>
Structural Grade:	<b>0</b>
O&M Grade:	<b>0</b>
Clock Start/From:	<b>10</b>
Clock To:	
1st Value:	<b>4.000</b>
2nd Value:	
Value Percent:	
Continuous Index:	
Within 8" of Joint:	
Remarks:

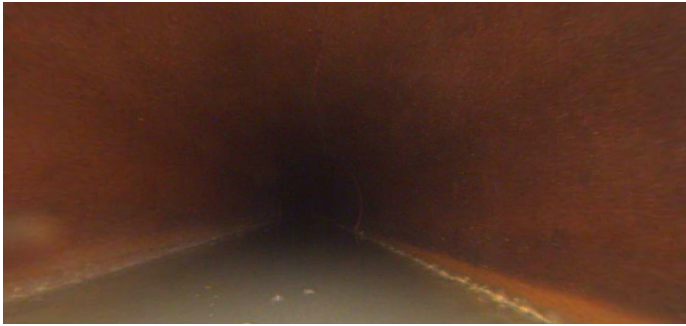
Code: **CL**  
Description: **Crack Longitudinal**

Distance (ft): **139.0**  
Structural Grade: **2**  
O&M Grade: **0**  
Clock Start/From: **1**  
Clock To:  
1st Value:  
2nd Value:  
Value Percent:  
Continuous Index:  
Within 8" of Joint: **YES**  
Remarks:

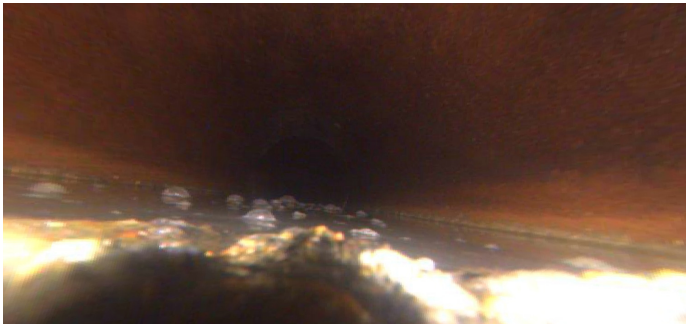
Code: **MWLS**  
Description: **Water Level Sag**

Distance (ft): **147.6**  
Structural Grade: **3**  
O&M Grade: **3**  
Clock Start/From:  
Clock To:  
1st Value:  
2nd Value:  
Value Percent: **40.000**  
Continuous Index:  
Within 8" of Joint: **NO**  
Remarks:

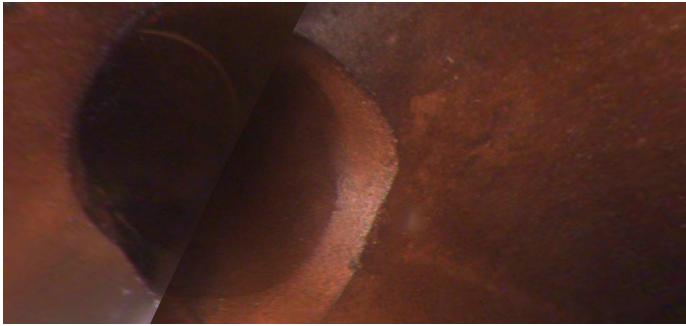
Code: **TF**  
Description: **Tap Factory**

Distance (ft): **166.1**  
Structural Grade: **0**  
O&M Grade: **0**  
Clock Start/From: **10**  
Clock To:  
1st Value: **4.000**  
2nd Value:  
Value Percent:  
Continuous Index:  
Within 8" of Joint:  
Remarks:

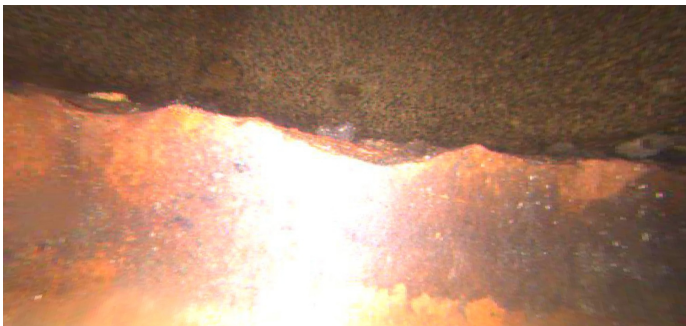
Code: **AMH**  
Description: **Manhole**

Distance (ft): **221.2**  
Structural Grade: **0**  
O&M Grade: **0**  
Clock Start/From:  
Clock To:  
1st Value:  
2nd Value:  
Value Percent:  
Continuous Index:  
Within 8" of Joint: **NO**  
Remarks: **M-803-013**
