Profile/Photo Observation Report

Date:	03/28/2018	Weather:		Coding:	PACP 6.0
Pipe Length (ft):	203.9	Owner:	NA	Pre Clean:	Not Known
P.O.#:		Surveyor:	Selasie Honu	PSR:	P-803-015-014
Customer:		Clean Date:	01/01/1900	Shape:	C

Street:	N LIBERTY	Flow Control:	Not Controlled
City:	Hobart, IN	Year Renewed:	
Location:	Other	Tape/Media #:	
Purpose:	Not Known	Dia/Height:	10"
Use:	Sanitary	Material:	VCP
Drain Area:	NA	Lining:	
Category:	NA		
Comment:			
Location Details:		Direction of Survey:	Downstream
US MH:	M-803-014	DS MH:	M-803-015
		Total Length Surveyed (ft):	160.4

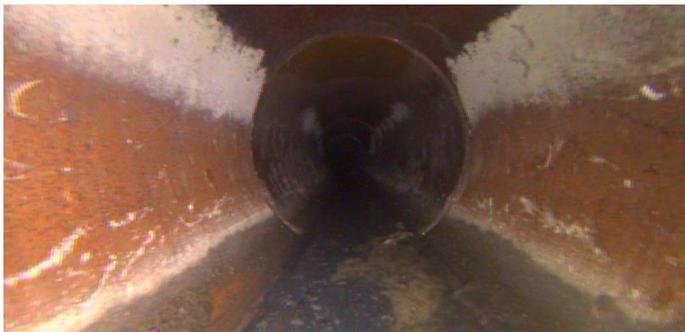
Code: **AMH**
Description: **Manhole**

Distance (ft): **.0**
Structural Grade: **0**
O&M Grade: **0**
Clock Start/From:
Clock To:
1st Value:
2nd Value:
Value Percent:
Continuous Index:
Within 8" of Joint: **NO**
Remarks: **M-803-014**

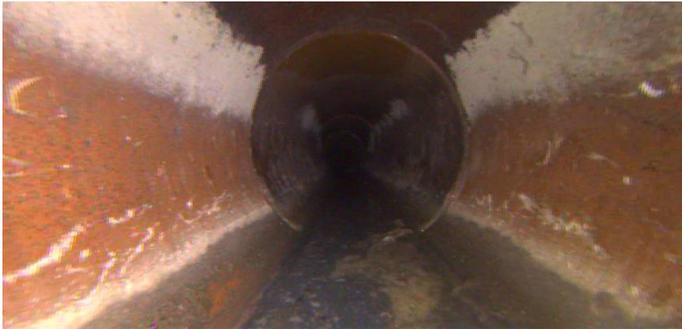
Code: **MWL**
Description: **Water Level**

Distance (ft): **.0**
Structural Grade: **0**
O&M Grade: **0**
Clock Start/From:
Clock To:
1st Value:
2nd Value:
Value Percent: **5.000**
Continuous Index:
Within 8" of Joint: **NO**
Remarks:

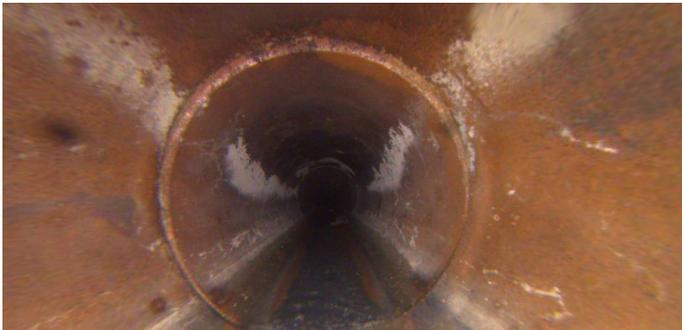
Code: **CM**
Description: **Crack Multiple**

Distance (ft): **4.7**
Structural Grade: **3**
O&M Grade: **0**
Clock Start/From: **8**
Clock To: **4**
1st Value:
2nd Value:
Value Percent:
Continuous Index: **S01**
Within 8" of Joint: **YES**
Remarks:

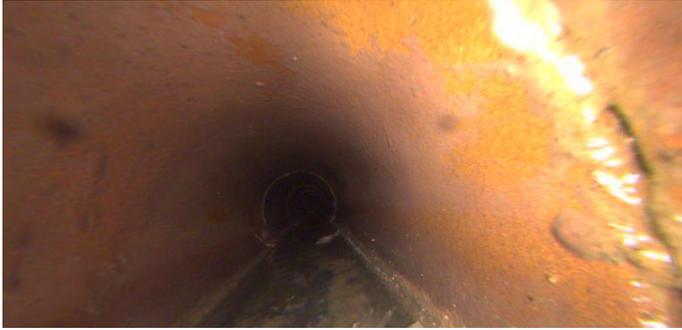
Code: **CM**
Description: **Crack Multiple**

Distance (ft): **31.9**
Structural Grade: **3**
O&M Grade: **0**
Clock Start/From: **8**
Clock To: **4**
1st Value:
2nd Value:
Value Percent:
Continuous Index: **F01**
Within 8" of Joint: **YES**
Remarks:

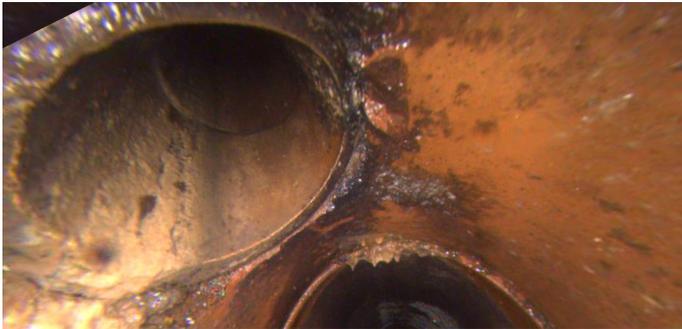
Code: **TBI**
Description: **Tap Break-in Intruding**

Distance (ft): **48.9**
Structural Grade: **0**
O&M Grade: **2**
Clock Start/From: **11**
Clock To:
1st Value: **4.000**
2nd Value: **1.000**
Value Percent:
Continuous Index:
Within 8" of Joint:
Remarks:

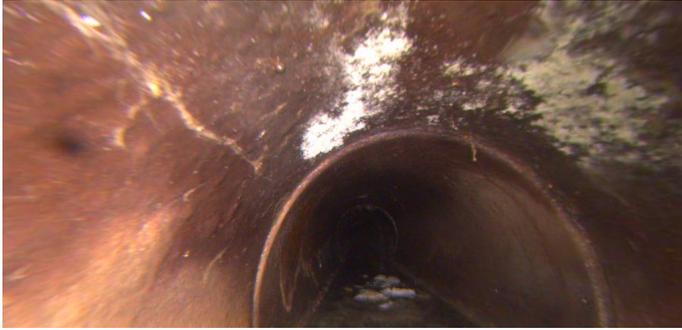
Code: **FM**
Description: **Fracture Multiple**

Distance (ft): **52.2**
Structural Grade: **4**
O&M Grade: **0**
Clock Start/From: **8**
Clock To: **12**
1st Value:
2nd Value:
Value Percent:
Continuous Index:
Within 8" of Joint: **YES**
Remarks:

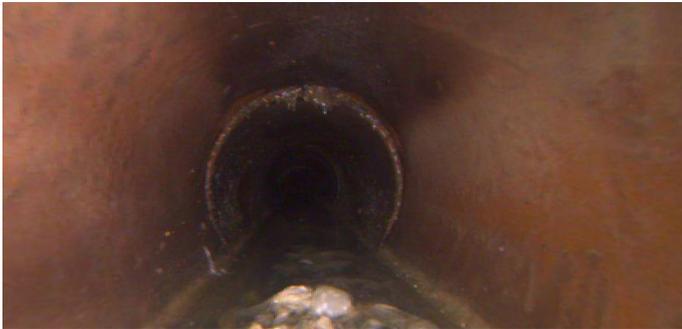
Code: **RFJ**
Description: **Roots Fine Joint**

Distance (ft): **54.3**
Structural Grade: **0**
O&M Grade: **1**
Clock Start/From: **10**
Clock To: **2**
1st Value:
2nd Value:
Value Percent:
Continuous Index:
Within 8" of Joint: **YES**
Remarks:

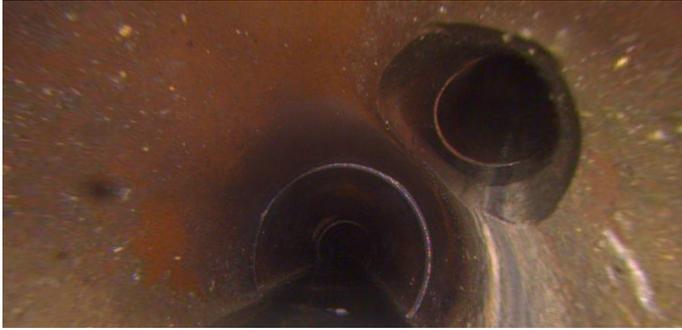
Code: **TF**
Description: **Tap Factory**

Distance (ft): **57.5**
Structural Grade: **0**
O&M Grade: **0**
Clock Start/From: **2**
Clock To:
1st Value: **4.000**
2nd Value:
Value Percent:
Continuous Index:
Within 8" of Joint:
Remarks:

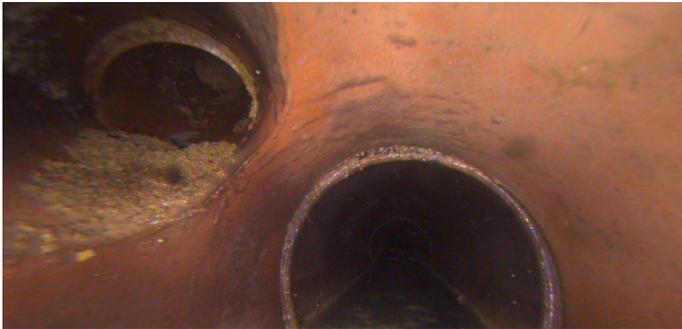
Code: **TF**
Description: **Tap Factory**

Distance (ft): **60.8**
Structural Grade: **0**
O&M Grade: **0**
Clock Start/From: **10**
Clock To:
1st Value: **4.000**
2nd Value:
Value Percent:
Continuous Index:
Within 8" of Joint:
Remarks:

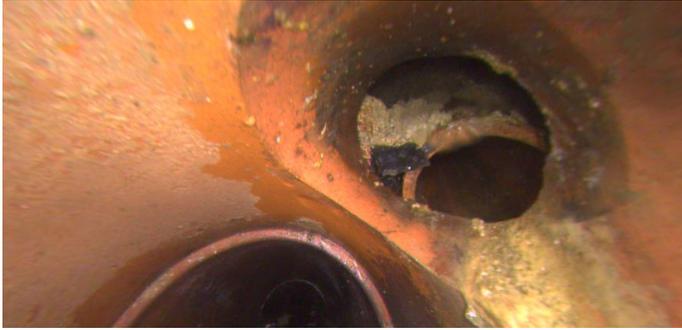
Code: **TF**
Description: **Tap Factory**

Distance (ft): **78.8**
Structural Grade: **0**
O&M Grade: **0**
Clock Start/From: **2**
Clock To:
1st Value: **4.000**
2nd Value:
Value Percent:
Continuous Index:
Within 8" of Joint:
Remarks:

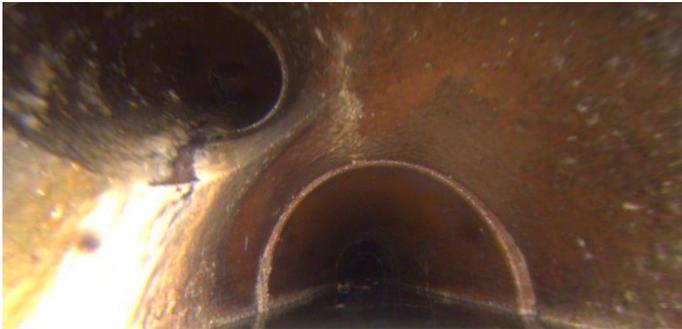
Code: **TF**
Description: **Tap Factory**

Distance (ft): **87.7**
Structural Grade: **0**
O&M Grade: **0**
Clock Start/From: **10**
Clock To:
1st Value: **4.000**
2nd Value:
Value Percent:
Continuous Index:
Within 8" of Joint:
Remarks:

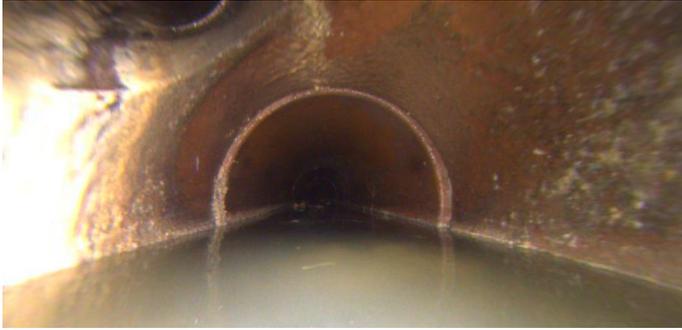
Code: **MWL**
Description: **Water Level**

Distance (ft): **87.7**
Structural Grade: **0**
O&M Grade: **0**
Clock Start/From:
Clock To:
1st Value:
2nd Value:
Value Percent: **40.000**
Continuous Index:
Within 8" of Joint: **NO**
Remarks:

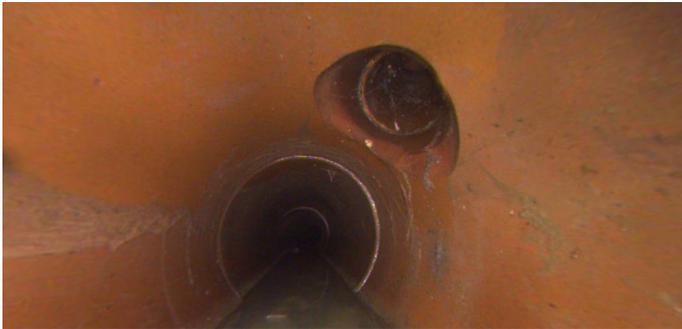
Code: **TF**
Description: **Tap Factory**

Distance (ft): **108.1**
Structural Grade: **0**
O&M Grade: **0**
Clock Start/From: **2**
Clock To:
1st Value: **4.000**
2nd Value:
Value Percent:
Continuous Index:
Within 8" of Joint:
Remarks:

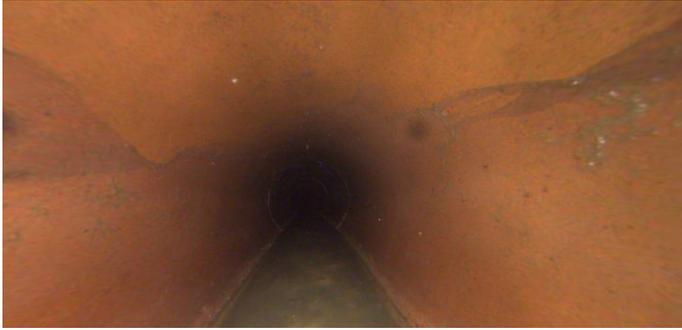
Code: **MWL**
Description: **Water Level**

Distance (ft): **121.8**
Structural Grade: **0**
O&M Grade: **0**
Clock Start/From:
Clock To:
1st Value:
2nd Value:
Value Percent: **5.000**
Continuous Index:
Within 8" of Joint: **NO**
Remarks:

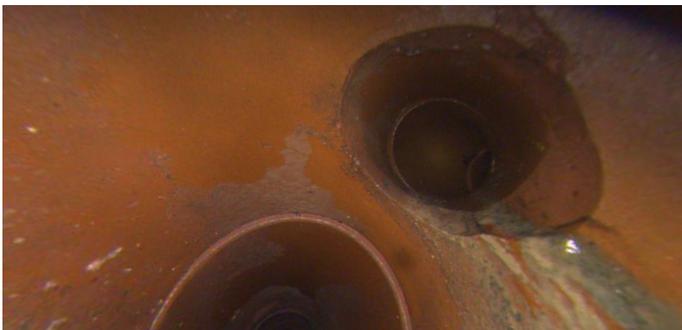
Code: **TF**
Description: **Tap Factory**

Distance (ft): **138.5**
Structural Grade: **0**
O&M Grade: **0**
Clock Start/From: **1**
Clock To:
1st Value: **4.000**
2nd Value:
Value Percent:
Continuous Index:
Within 8" of Joint:
Remarks:

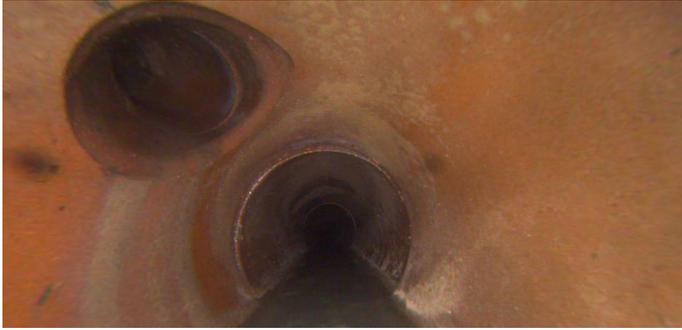
Code: **TF**
Description: **Tap Factory**

Distance (ft): **141.3**
Structural Grade: **0**
O&M Grade: **0**
Clock Start/From: **10**
Clock To:
1st Value: **4.000**
2nd Value:
Value Percent:
Continuous Index:
Within 8" of Joint:
Remarks:

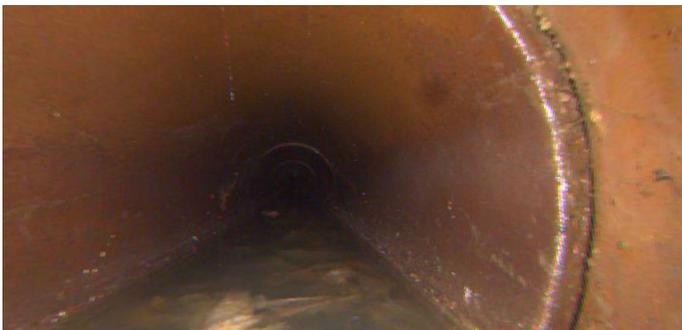
Code: **MSA**
Description: **Abandoned Survey**

Distance (ft): **160.4**
Structural Grade: **0**
O&M Grade: **0**
Clock Start/From:
Clock To:
1st Value:
2nd Value:
Value Percent:
Continuous Index:
Within 8" of Joint: **NO**
Remarks: **debris**
