## Profile/Photo Observation Report

Street:	<b>E NORTH ST</b>	Flow Control:	<b>Not Controlled</b>
City:	<b>Hobart, IN</b>	Year Renewed:	
Location:	<b>Other</b>	Tape/Media #:	
Purpose:	<b>Not Known</b>	Dia/Height:	<b>10"</b>
Use:	<b>Sanitary</b>	Material:	<b>VCP</b>
Drain Area:	<b>NA</b>	Lining:	
Category:	<b>NA</b>		
Comment:

Location Details:		Direction of Survey:	<b>Upstream</b>
US MH:	<b>M-803-014</b>	DS MH:	<b>M-803-015</b>
		Total Length Surveyed (ft):	<b>24.4</b>

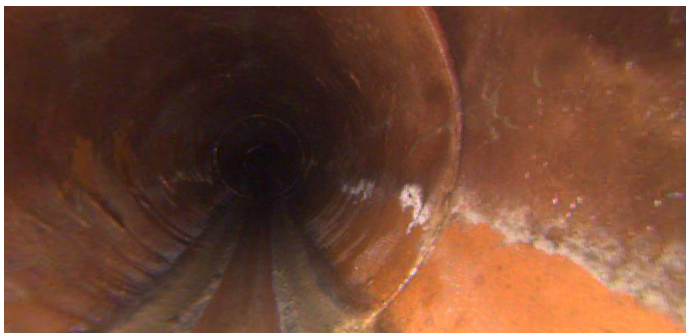
Code: **AMH**  
Description: **Manhole**

Distance (ft): **.0**  
Structural Grade: **0**  
O&M Grade: **0**  
Clock Start/From:  
Clock To:  
1st Value:  
2nd Value:  
Value Percent:  
Continuous Index:  
Within 8" of Joint: **NO**  
Remarks: **M-803-015**

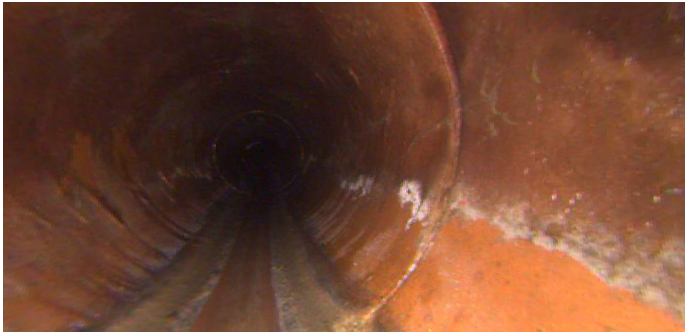
Code:	<b>MWL</b>
Description:	<b>Water Level</b>

Distance (ft):	<b>.0</b>
Structural Grade:	<b>0</b>
O&M Grade:	<b>0</b>
Clock Start/From:	
Clock To:	
1st Value:	
2nd Value:	
Value Percent:	<b>5.000</b>
Continuous Index:	
Within 8" of Joint:	<b>NO</b>
Remarks:

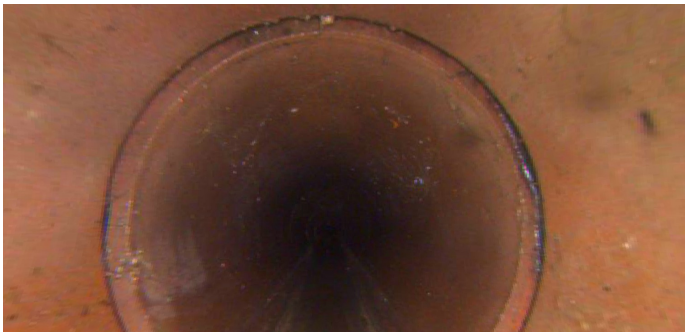
Code:	<b>RFJ</b>
Description:	<b>Roots Fine Joint</b>

Distance (ft):	<b>12.8</b>
Structural Grade:	<b>0</b>
O&M Grade:	<b>1</b>
Clock Start/From:	<b>9</b>
Clock To:	<b>3</b>
1st Value:	
2nd Value:	
Value Percent:	
Continuous Index:	
Within 8" of Joint:	<b>YES</b>
Remarks:

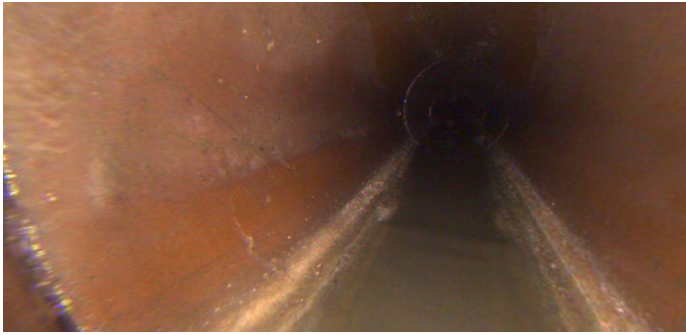
Code: **CM**  
Description: **Crack Multiple**

Distance (ft): **16.3**  
Structural Grade: **3**  
O&M Grade: **0**  
Clock Start/From: **8**  
Clock To: **9**  
1st Value:  
2nd Value:  
Value Percent:  
Continuous Index:  
Within 8" of Joint: **YES**  
Remarks:

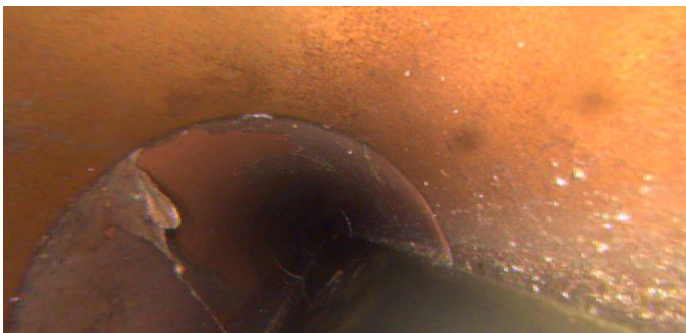
Code: **MSA**  
Description: **Abandoned Survey**

Distance (ft): **24.4**  
Structural Grade: **0**  
O&M Grade: **0**  
Clock Start/From:  
Clock To:  
1st Value:  
2nd Value:  
Value Percent:  
Continuous Index:  
Within 8" of Joint: **NO**  
Remarks: **debris**
