Profile/Photo Observation Report

Street:	ALLEY BETWEEN N LIBERTY ST & N L	Flow Control:	Not Controlled
City:	Hobart, IN	Year Renewed:	
Location:	Light Highway	Tape/Media #:	
Purpose:	Routine Assessment	Dia/Height:	12"
Use:	Sanitary	Material:	VCP
Drain Area:	NA	Lining:	
Category:	NA		
Comment:

Location Details:		Direction of Survey:	Upstream
US MH:	M-803-015	DS MH:	M-803-016
		Total Length Surveyed (ft):	7.3

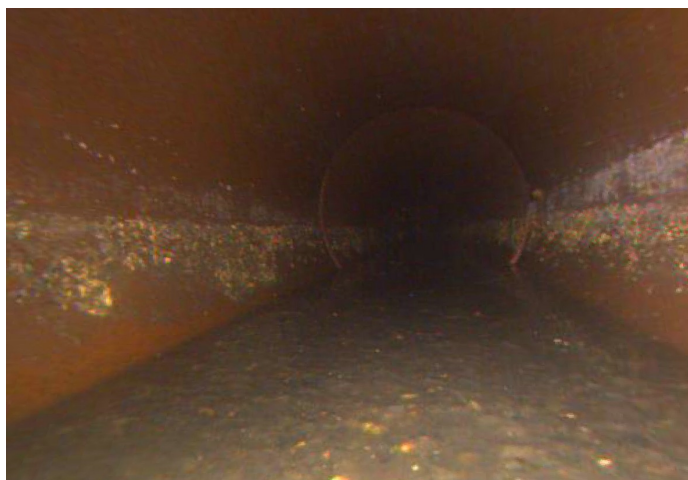
Code: **AMH**
Description: **Manhole**

Distance (ft): **.0**
Structural Grade: **0**
O&M Grade: **0**
Clock Start/From:
Clock To:
1st Value:
2nd Value:
Value Percent:
Continuous Index:
Within 8" of Joint: **NO**
Remarks: **M-803-016**

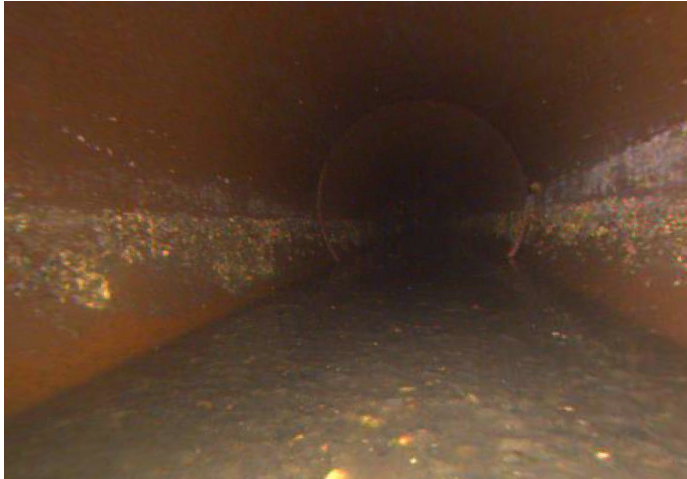
Code: **MWL**
Description: **Water Level**

Distance (ft): **.0**
Structural Grade: **0**
O&M Grade: **0**
Clock Start/From:
Clock To:
1st Value:
2nd Value:
Value Percent: **20.000**
Continuous Index:
Within 8" of Joint: **NO**
Remarks:

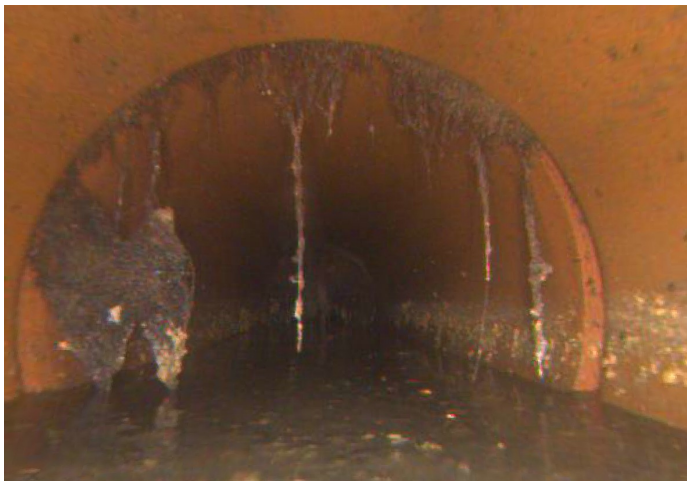
Code: **RFJ**
Description: **Roots Fine Joint**

Distance (ft): **5.1**
Structural Grade: **0**
O&M Grade: **1**
Clock Start/From: **9**
Clock To: **2**
1st Value:
2nd Value:
Value Percent:
Continuous Index:
Within 8" of Joint: **YES**
Remarks:

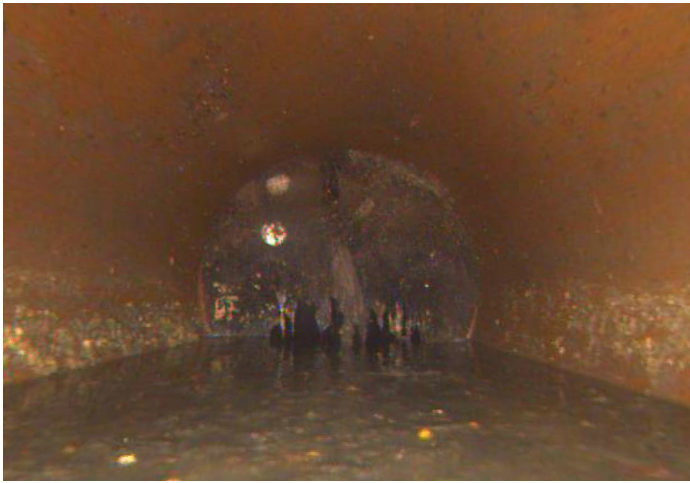
Code:	MSA
Description:	Abandoned Survey
Distance (ft):	7.3
Structural Grade:	0
O&M Grade:	0
Clock Start/From:	
Clock To:	
1st Value:	
2nd Value:	
Value Percent:	
Continuous Index:	
Within 8" of Joint:	NO
Remarks:	Possible Debris
