Profile/Photo Observation Report

Date:	10/01/2018	Weather:		Coding:	PACP 6.0
Pipe Length (ft):	209.4	Owner:	NA	Pre Clean:	Not Known
P.O.#:		Surveyor:	Michael Carlino	PSR:	P-803-016-015
Customer:		Clean Date:	01/01/1900	Shape:	C

Street:	40th. Ave.	Flow Control:	Not Controlled
City:	Hobart, IN	Year Renewed:	
Location:	Light Highway	Tape/Media #:	
Purpose:	Routine Assessment	Dia/Height:	12"
Use:	Sanitary	Material:	VCP
Drain Area:	NA	Lining:	
Category:	NA		
Comment:

Location Details:		Direction of Survey:	Upstream
US MH:	M-803-015	DS MH:	M-803-016
		Total Length Surveyed (ft):	7.3

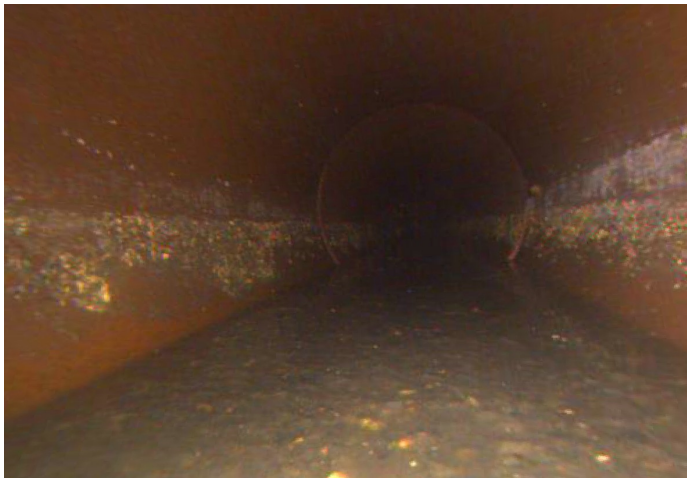
Code: **AMH**
Description: **Manhole**

Distance (ft): **.0**
Structural Grade: **0**
O&M Grade: **0**
Clock Start/From:
Clock To:
1st Value:
2nd Value:
Value Percent:
Continuous Index:
Within 8" of Joint: **NO**
Remarks: **M-803-016**

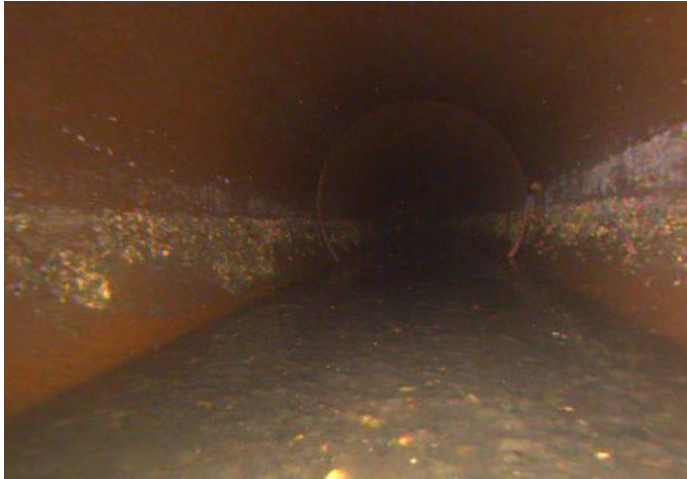
Code: **MWL**
Description: **Water Level**

Distance (ft): **.0**
Structural Grade: **0**
O&M Grade: **0**
Clock Start/From:
Clock To:
1st Value:
2nd Value:
Value Percent: **20.000**
Continuous Index:
Within 8" of Joint: **NO**
Remarks:

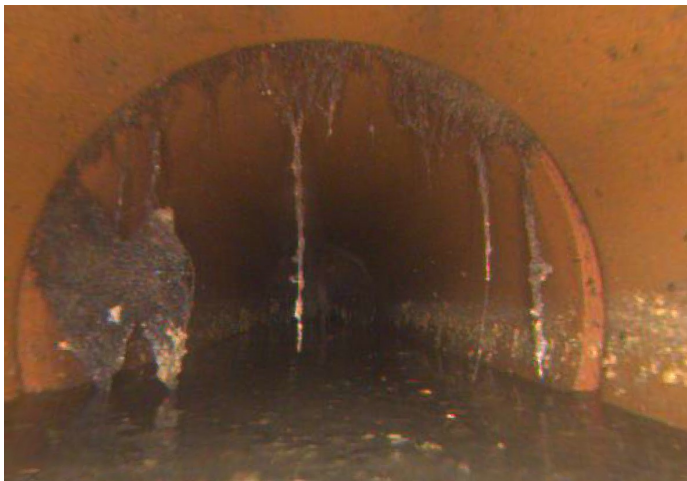
Code: **RFJ**
Description: **Roots Fine Joint**

Distance (ft): **5.1**
Structural Grade: **0**
O&M Grade: **1**
Clock Start/From: **9**
Clock To: **2**
1st Value:
2nd Value:
Value Percent:
Continuous Index:
Within 8" of Joint: **YES**
Remarks:

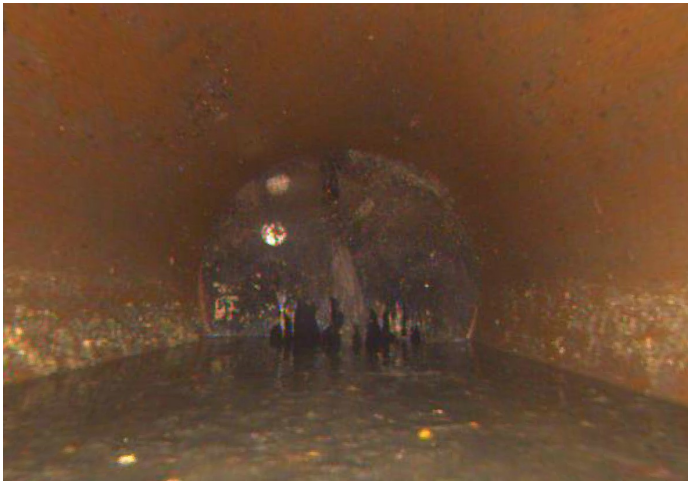
Code:	MSA
Description:	Abandoned Survey
Distance (ft):	7.3
Structural Grade:	0
O&M Grade:	0
Clock Start/From:	
Clock To:	
1st Value:	
2nd Value:	
Value Percent:	
Continuous Index:	
Within 8" of Joint:	NO
Remarks:	Possible Debris
