Profile/Photo Observation Report

City: Hobart, IN Year Renewed:

US MH: Total Length Surveyed (ft): M-803-015 DS MH: M-803-016 29.7

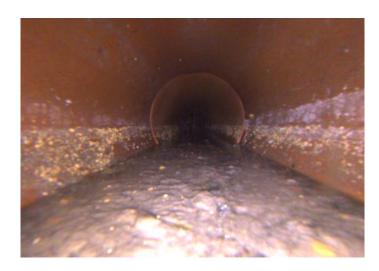
Code: MWL
Description: Water Level

Distance (ft): .0
Structural Grade: 0
O&M Grade: 0
Clock Start/From:

Value Percent: 20.000

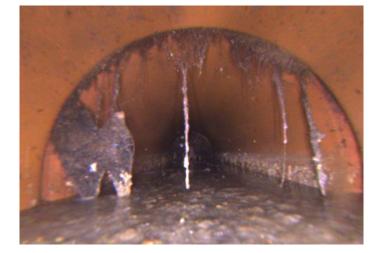
Description: Roots Fine Joint

Distance (ft): 5.1
Structural Grade: 0
O&M Grade: 1
Clock Start/From: 9
Clock To: 1
1st Value:
2nd Value:
Value Percent:

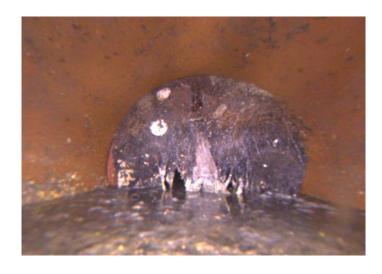
Code: RMJ

Description: Roots Medium Joint

Distance (ft): 7.9
Structural Grade: 0
O&M Grade: 3
Clock Start/From: 9
Clock To: 4

Value Percent: 25.000

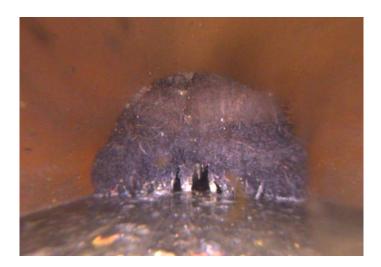
Code: RMJ

Description: Roots Medium Joint

Distance (ft): 10.7
Structural Grade: 0

O&M Grade: 3

Value Percent: 30.000

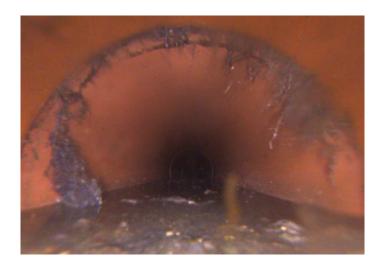
Code: RFJ

Description: Roots Fine Joint

Distance (ft): 14.0
Structural Grade: 0
O&M Grade: 1
Clock Start/From: 10
Clock To: 2

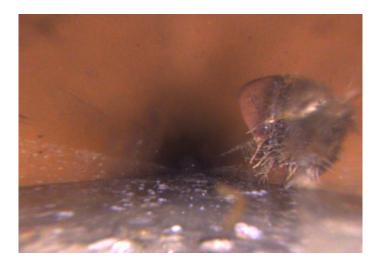
Code: **TFD**

Description: Tap Factory Defective

Distance (ft): 20.4
Structural Grade: 0

O&M Grade: 2

1st Value: **6.000**

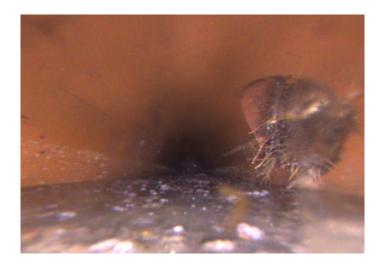
Code: RFL

Description: Roots Fine Lateral

Distance (ft): 20.4
Structural Grade: 0

O&M Grade: 1

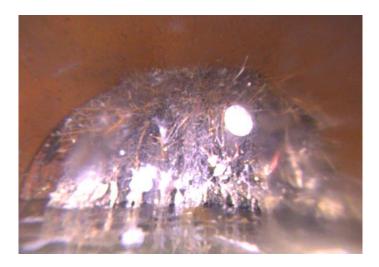
Code: RMJ

Description: Roots Medium Joint

Distance (ft): 25.8
Structural Grade: 0

O&M Grade: 3

Value Percent: 25.000

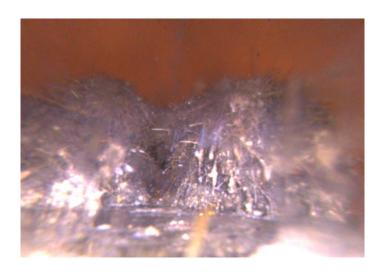
Code: RBB

Description: Roots Ball Barrel

Distance (ft): 28.7
Structural Grade: 0
O&M Grade: 5
Clock Start/From: 9
Clock To: 3

Value Percent: 85.000
