Profile/Photo Observation Report

Street: 40th. Ave. Flow Control: Not Controlled

City: Hobart, IN Year Renewed:
Location: Light Highway Tape/Media #:

US MH: M-803-015 DS MH: M-803-016 Total Length Surveyed (ft): 29.7

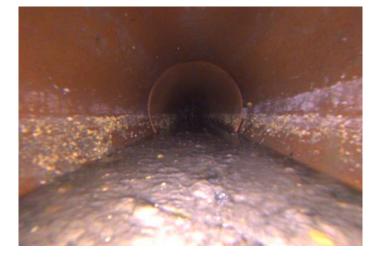
Code: Description:	AMH Manhole
Distance (ft):	.0
Structural Grade:	0
O&M Grade:	0
Clock Start/From:	
Clock To:	
1st Value:	
2nd Value:	
Value Percent:	
Continuous Index:	
Within 8" of Joint:	NO
Remarks:	M-803-016

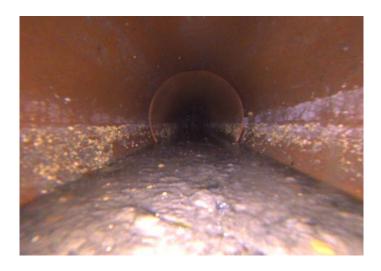
Code: MWL Description: **Water Level**

Distance (ft): .0 Structural Grade: 0 O&M Grade: 0 Clock Start/From:

Value Percent: 20.000

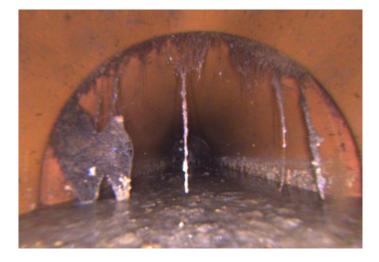
Code: RFJ

Description: **Roots Fine Joint**

Distance (ft): 5.1 Structural Grade: 0 O&M Grade: 1 Clock Start/From: 9 Clock To: 1 1st Value: 2nd Value: Value Percent: Continuous Index:

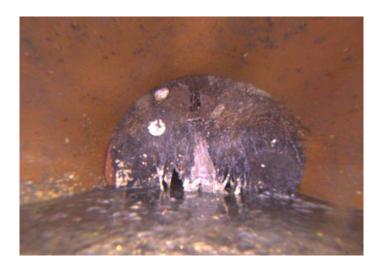
Code: RMJ

Description: **Roots Medium Joint**

Distance (ft): 7.9 Structural Grade: 0 3 O&M Grade: Clock Start/From: 9 Clock To: 4

Value Percent: 25.000

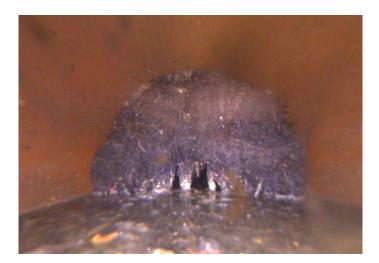
Code: RMJ

Description: **Roots Medium Joint**

Distance (ft): 10.7 Structural Grade: 0 O&M Grade: 3 Clock Start/From: 9 3 Clock To: 1st Value:

30.000 Value Percent:

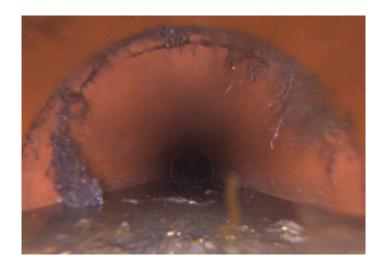
Code: RFJ

Description: Roots Fine Joint

Distance (ft): 14.0
Structural Grade: 0
O&M Grade: 1
Clock Start/From: 10
Clock To: 2
1st Value:

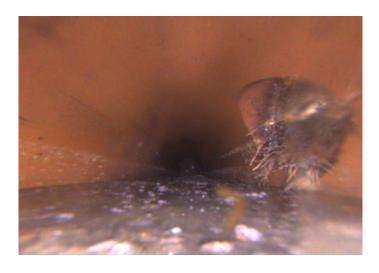
Code: **TFD**

Description: Tap Factory Defective

Distance (ft): 20.4
Structural Grade: 0

O&M Grade: 2

1st Value: **6.000**

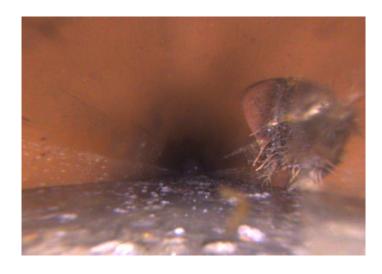
Code: RFL

Description: Roots Fine Lateral

Distance (ft): 20.4
Structural Grade: 0

O&M Grade: 1

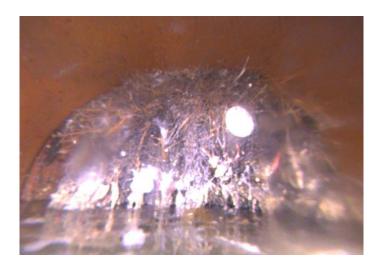
Code: RMJ

Description: Roots Medium Joint

Distance (ft): 25.8
Structural Grade: 0

O&M Grade: 3

Value Percent: 25.000

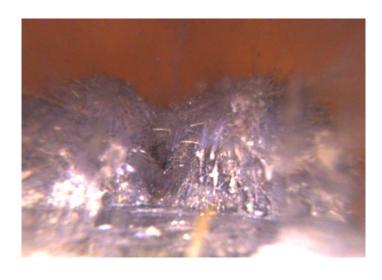
Code: RBB

Description: Roots Ball Barrel

Distance (ft): 28.7
Structural Grade: 0

O&M Grade: 5

Value Percent: 85.000
