Profile/Ph	oto Observation	Report				RedZone
Date:	10/01/2018	Weather:			Coding:	PACP 6.0
Pipe Length (ft)	: 213.4	Owner:	NA		Pre Clean:	Not Known
P.O.#:		Surveyor:	Michael Carl	ino	PSR:	P-803-017-016
Customer:		Clean Date:	01/01/1900		Shape:	с
Street:	40th. Ave.		Flow Control:		Not Controlled	
City:	Hobart, IN		Year Renewed	:		
Location:	Light Highway		Tape/Media #			
Purpose:	Routine Assessment	:	Dia/Height:		12"	
Use:	Sanitary		Material:		VCP	
Drain Area:	NA		Lining:			
Category:	NA					
Comment:						
Location Details	s:		Direction of Su	irvey:	Downstream	
US MH:	M-803-016	DS MH:	M-803-017	Total	Length Surveyed (ft):	24.1
0&M Index:	1.00	O&M Quick:	1	200	O&M Rating:	2.00
structural Index:	0.00	 Structural Qu	iick: 0	000	Structural Rating:	0.00
Overall Index:	1.00	Overall Quick	1	200	Overall Rating:	2.00

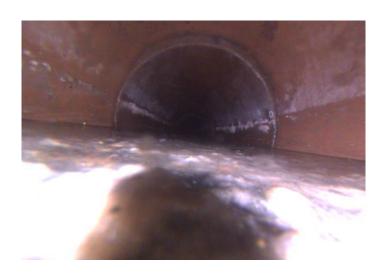
Code: Description:	AMH Manhole
Distance (ft):	.0
Structural Grade:	0
O&M Grade:	0
Clock Start/From:	
Clock To:	
1st Value:	
2nd Value:	
Value Percent:	
Continuous Index:	
Within 8" of Joint:	NO
Remarks:	M-803-016

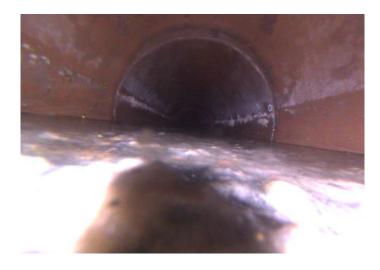
Code:	MWL
Description:	Water Level
Distance (ft):	.0
Structural Grade:	0
O&M Grade:	0
Clock Start/From:	
Clock To:	
1st Value:	
2nd Value:	
Value Percent:	25.000
Continuous Index:	
Within 8" of Joint:	NO
Remarks:

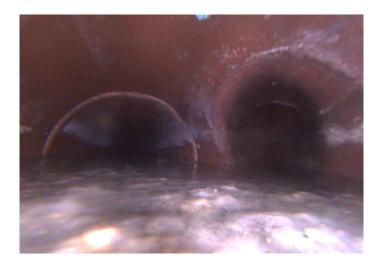
Code: Description:	TF Tap Factory
Distance (ft):	3.8
Structural Grade:	0
O&M Grade:	0
Clock Start/From:	3
Clock To:	
1st Value:	6.000
2nd Value:	
Value Percent:	
Continuous Index:	
Within 8" of Joint:	
Remarks:

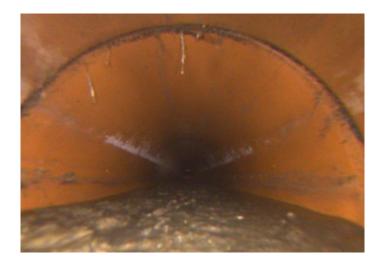
Code:	RFJ
Description:	Roots Fine Joint
Distance (ft):	10.4
Structural Grade:	0
O&M Grade:	1
Clock Start/From:	11
Clock To:	12
1st Value:	
2nd Value:	
Value Percent:	
Continuous Index:	
Within 8" of Joint:	YES
Remarks:

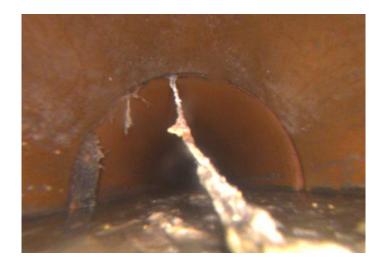
Code: Description:	RFJ Roots Fine Joint
Distance (ft): Structural Grade: O&M Grade: Clock Start/From: Clock To: 1st Value: 2nd Value: Value Percent: Continuous Index:	19.3 0 1 9 12
Within 8" of Joint: Remarks:	YES

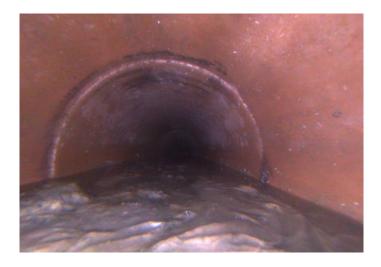
Code: Description:	MSA Abandoned Survey
Distance (ft):	24.1
Structural Grade:	0
O&M Grade:	0
Clock Start/From:	
Clock To:	
1st Value:	
2nd Value:	
Value Percent:	
Continuous Index:	
Within 8" of Joint:	NO
Remarks:	Possible Debris
