Profile/Photo Observation Report

Date:	03/28/2018	Weather:		Coding:	PACP 6.0
Pipe Length (ft):	233.0	Owner:	NA	Pre Clean:	Not Known
P.O.#:		Surveyor:	Selasie Honu	PSR:	P-804-044-018
Customer:		Clean Date:	01/01/1900	Shape:	C

Street:	HIGH ST	Flow Control:	Not Controlled
City:	Hobart, IN	Year Renewed:	
Location:	Other	Tape/Media #:	
Purpose:	Not Known	Dia/Height:	10"
Use:	Sanitary	Material:	VCP
Drain Area:	NA	Lining:	
Category:	NA		
Comment:

Location Details:		Direction of Survey:	Downstream
US MH:	M-803-018	DS MH:	M-804-044
		Total Length Surveyed (ft):	65.3

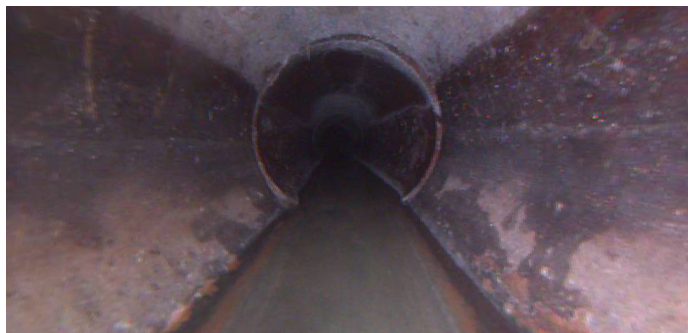
Code: **AMH**
Description: **Manhole**

Distance (ft): **.0**
Structural Grade: **0**
O&M Grade: **0**
Clock Start/From:
Clock To:
1st Value:
2nd Value:
Value Percent:
Continuous Index:
Within 8" of Joint: **NO**
Remarks: **M-803-018**

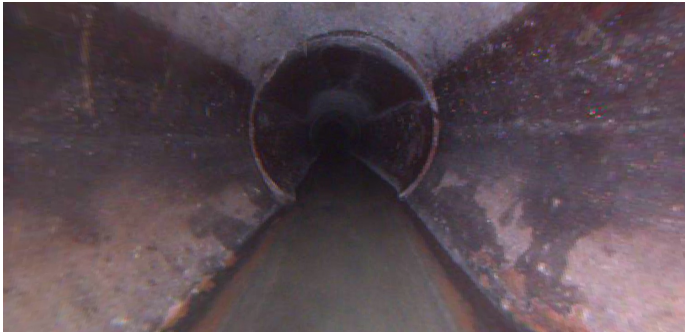
Code:	MWL
Description:	Water Level

Distance (ft):	.0
Structural Grade:	0
O&M Grade:	0
Clock Start/From:	
Clock To:	
1st Value:	
2nd Value:	
Value Percent:	5.000
Continuous Index:	
Within 8" of Joint:	NO
Remarks:

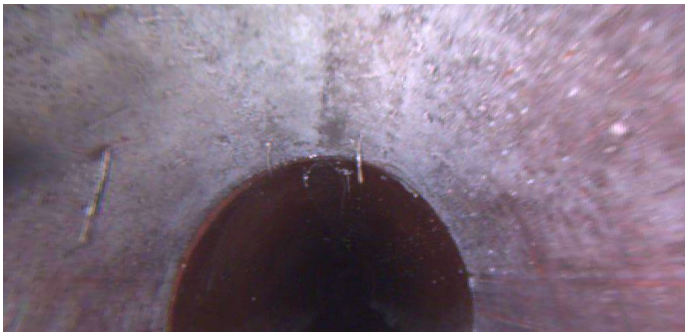
Code:	RFB
Description:	Roots Fine Barrel

Distance (ft):	9.7
Structural Grade:	0
O&M Grade:	2
Clock Start/From:	11
Clock To:	12
1st Value:	
2nd Value:	
Value Percent:	
Continuous Index:	
Within 8" of Joint:	NO
Remarks:

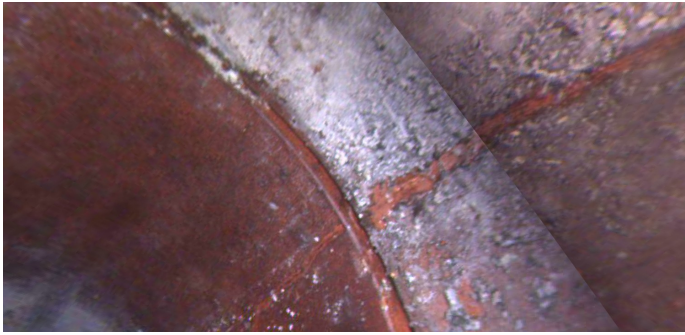
Code: **FL**
Description: **Fracture Longitudinal**

Distance (ft): **22.3**
Structural Grade: **3**
O&M Grade: **0**
Clock Start/From: **2**
Clock To:
1st Value:
2nd Value:
Value Percent:
Continuous Index:
Within 8" of Joint: **YES**
Remarks:

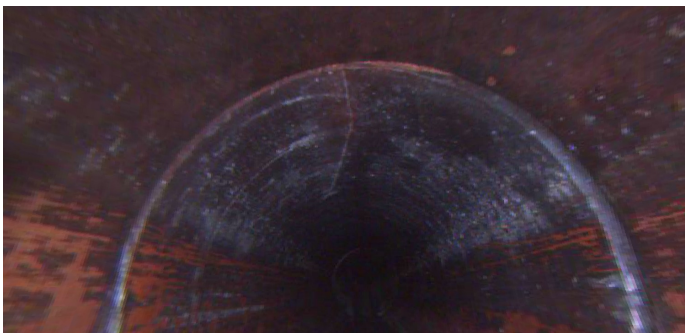
Code: **FL**
Description: **Fracture Longitudinal**

Distance (ft): **41.5**
Structural Grade: **3**
O&M Grade: **0**
Clock Start/From: **12**
Clock To:
1st Value: **4.000**
2nd Value:
Value Percent:
Continuous Index:
Within 8" of Joint:
Remarks:

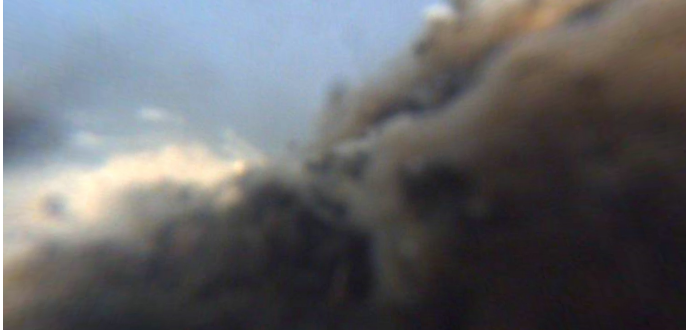
Code: **MWL**
Description: **Water Level**

Distance (ft): **65.3**
Structural Grade: **0**
O&M Grade: **0**
Clock Start/From:
Clock To:
1st Value:
2nd Value:
Value Percent: **100.000**
Continuous Index:
Within 8" of Joint: **NO**
Remarks:

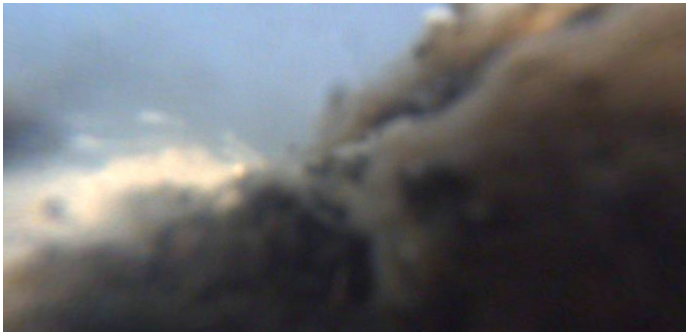
Code: **MCU**
Description: **Camera Underwater**

Distance (ft): **65.3**
Structural Grade: **0**
O&M Grade: **4**
Clock Start/From:
Clock To:
1st Value:
2nd Value:
Value Percent:
Continuous Index:
Within 8" of Joint: **NO**
Remarks:

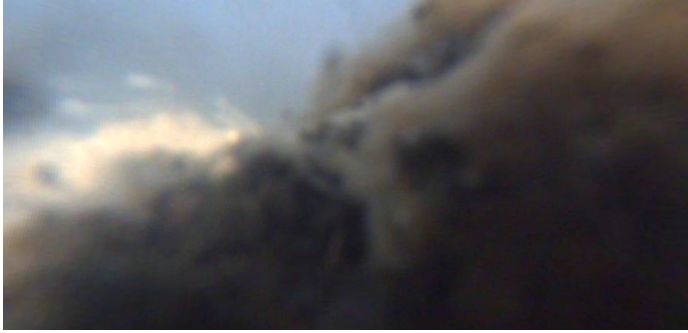
Code:	MSA
Description:	Abandoned Survey
Distance (ft):	65.3
Structural Grade:	0
O&M Grade:	0
Clock Start/From:	
Clock To:	
1st Value:	
2nd Value:	
Value Percent:	
Continuous Index:	
Within 8" of Joint:	NO
Remarks:	camera underwater
