## Profile/Photo Observation Report

Street:	<b>ALLEY</b>	Flow Control:	<b>Not Controlled</b>
City:	<b>Hobart, IN</b>	Year Renewed:	
Location:	<b>Other</b>	Tape/Media #:	
Purpose:	<b>Not Known</b>	Dia/Height:	<b>10"</b>
Use:	<b>Sanitary</b>	Material:	<b>VCP</b>
Drain Area:	<b>NA</b>	Lining:	
Category:	<b>NA</b>		
Comment:

Location Details:		Direction of Survey:	<b>Downstream</b>
US MH:	<b>M-803-018</b>	DS MH:	<b>M-804-044</b>
		Total Length Surveyed (ft):	<b>65.3</b>

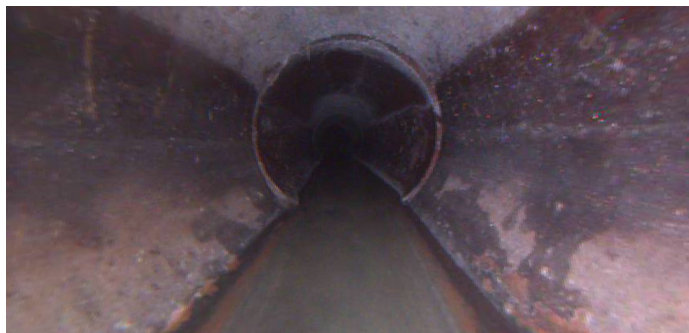
Code: **AMH**  
Description: **Manhole**

Distance (ft): **.0**  
Structural Grade: **0**  
O&M Grade: **0**  
Clock Start/From:  
Clock To:  
1st Value:  
2nd Value:  
Value Percent:  
Continuous Index:  
Within 8" of Joint: **NO**  
Remarks: **M-803-018**

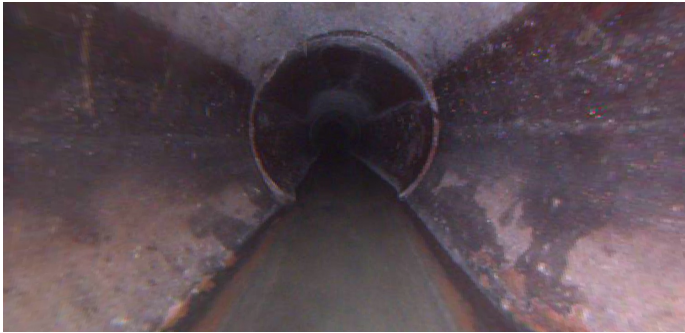
Code:	<b>MWL</b>
Description:	<b>Water Level</b>

Distance (ft):	<b>.0</b>
Structural Grade:	<b>0</b>
O&M Grade:	<b>0</b>
Clock Start/From:	
Clock To:	
1st Value:	
2nd Value:	
Value Percent:	<b>5.000</b>
Continuous Index:	
Within 8" of Joint:	<b>NO</b>
Remarks:

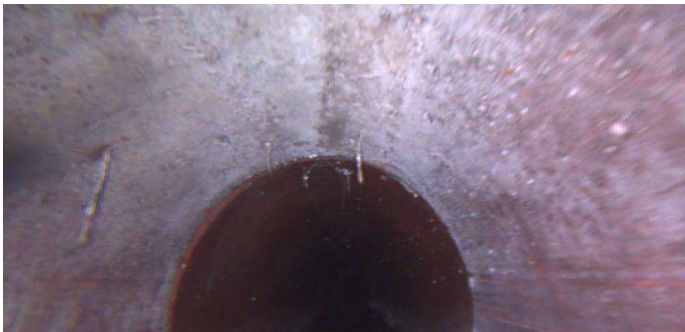
Code:	<b>RFB</b>
Description:	<b>Roots Fine Barrel</b>

Distance (ft):	<b>9.7</b>
Structural Grade:	<b>0</b>
O&M Grade:	<b>2</b>
Clock Start/From:	<b>11</b>
Clock To:	<b>12</b>
1st Value:	
2nd Value:	
Value Percent:	
Continuous Index:	
Within 8" of Joint:	<b>NO</b>
Remarks:

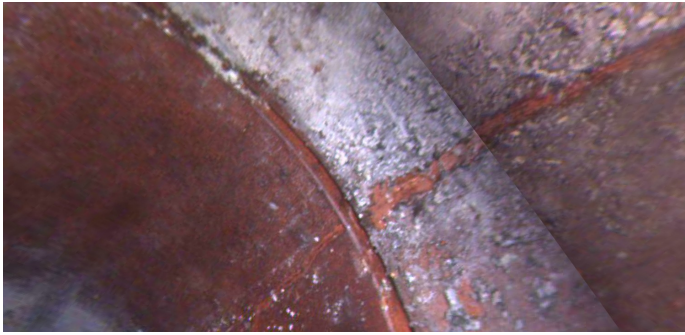
Code: **FL**  
Description: **Fracture Longitudinal**

Distance (ft): **22.3**  
Structural Grade: **3**  
O&M Grade: **0**  
Clock Start/From: **2**  
Clock To:  
1st Value:  
2nd Value:  
Value Percent:  
Continuous Index:  
Within 8" of Joint: **YES**  
Remarks:

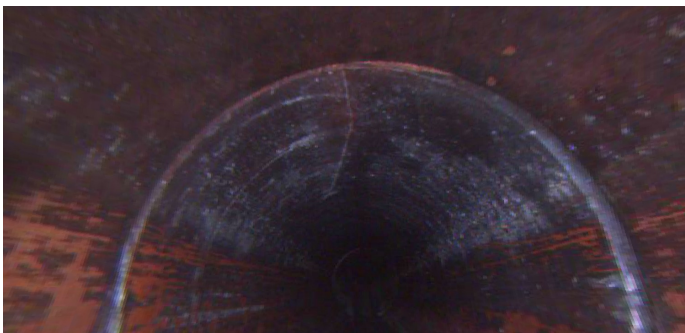
Code: **FL**  
Description: **Fracture Longitudinal**

Distance (ft): **41.5**  
Structural Grade: **3**  
O&M Grade: **0**  
Clock Start/From: **12**  
Clock To:  
1st Value: **4.000**  
2nd Value:  
Value Percent:  
Continuous Index:  
Within 8" of Joint:  
Remarks:

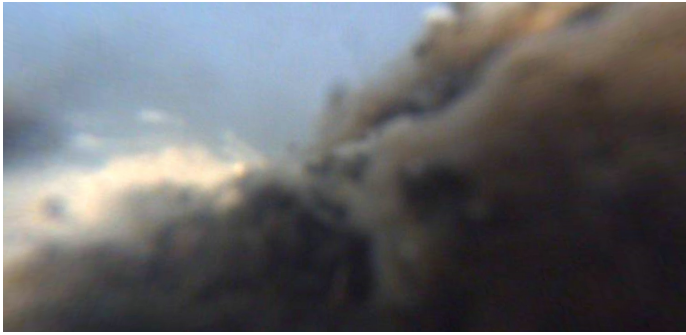
Code: **MWL**  
Description: **Water Level**

Distance (ft): **65.3**  
Structural Grade: **0**  
O&M Grade: **0**  
Clock Start/From:  
Clock To:  
1st Value:  
2nd Value:  
Value Percent: **100.000**  
Continuous Index:  
Within 8" of Joint: **NO**  
Remarks:

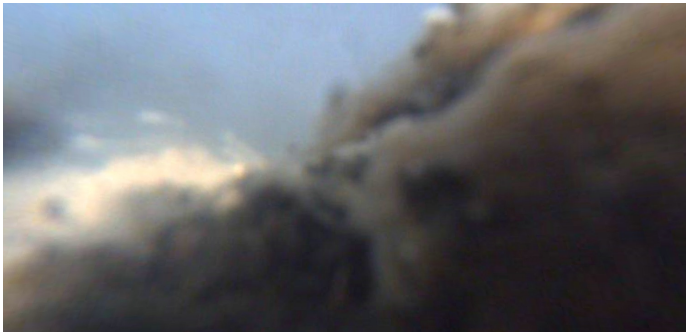
Code: **MCU**  
Description: **Camera Underwater**

Distance (ft): **65.3**  
Structural Grade: **0**  
O&M Grade: **4**  
Clock Start/From:  
Clock To:  
1st Value:  
2nd Value:  
Value Percent:  
Continuous Index:  
Within 8" of Joint: **NO**  
Remarks:

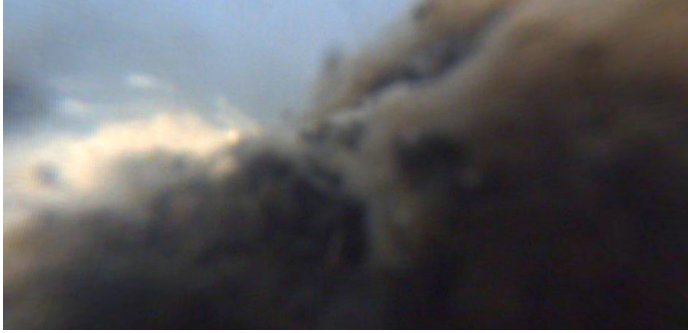
Code:	<b>MSA</b>
Description:	<b>Abandoned Survey</b>
Distance (ft):	<b>65.3</b>
Structural Grade:	<b>0</b>
O&M Grade:	<b>0</b>
Clock Start/From:	
Clock To:	
1st Value:	
2nd Value:	
Value Percent:	
Continuous Index:	
Within 8" of Joint:	<b>NO</b>
Remarks:	<b>camera underwater</b>
