Profile/Photo Observation Report

Date:	03/28/2018	Weather:		Coding:	PACP 6.0
Pipe Length (ft):	233.0	Owner:	NA	Pre Clean:	Not Known
P.O.#:		Surveyor:	Selasie Honu	PSR:	P-804-044-018
Customer:		Clean Date:	01/01/1900	Shape:	C

Location Details:		Direction of Survey:	Upstream
US MH:	M-803-018	DS MH:	M-804-044
		Total Length Surveyed (ft):	4.5

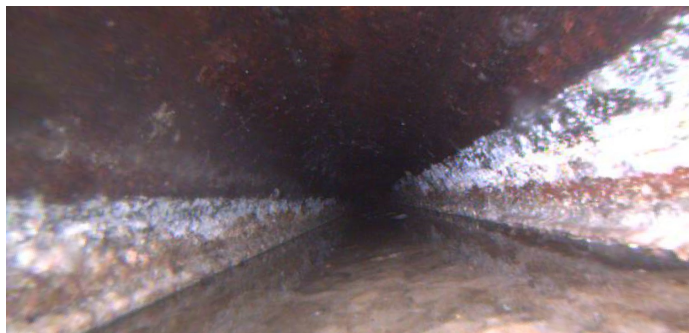
Code: **DAGS**
Description: **Deposits Attached Grease**

Distance (ft): **.0**
Structural Grade: **0**
O&M Grade: **2**
Clock Start/From: **8**
Clock To: **4**
1st Value:
2nd Value:
Value Percent: **5.000**
Continuous Index:
Within 8" of Joint: **NO**
Remarks:

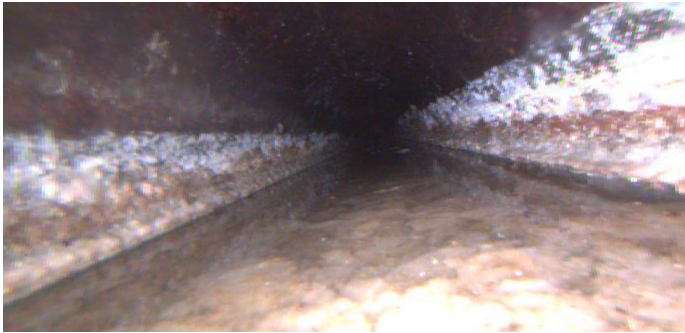
Code:	AMH
Description:	Manhole

Distance (ft):	.0
Structural Grade:	0
O&M Grade:	0
Clock Start/From:	
Clock To:	
1st Value:	
2nd Value:	
Value Percent:	
Continuous Index:	
Within 8" of Joint:	NO
Remarks:	M-804-044

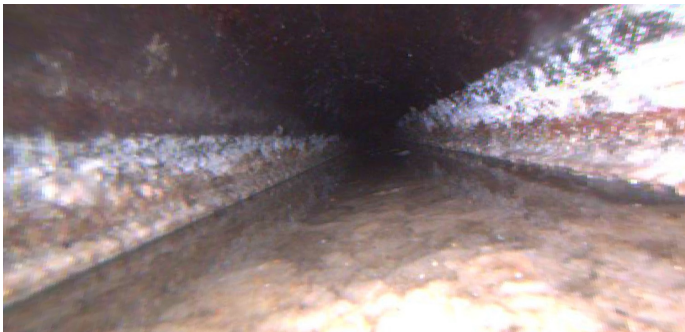
Code:	MWL
Description:	Water Level

Distance (ft):	.0
Structural Grade:	0
O&M Grade:	0
Clock Start/From:	
Clock To:	
1st Value:	
2nd Value:	
Value Percent:	5.000
Continuous Index:	
Within 8" of Joint:	NO
Remarks:

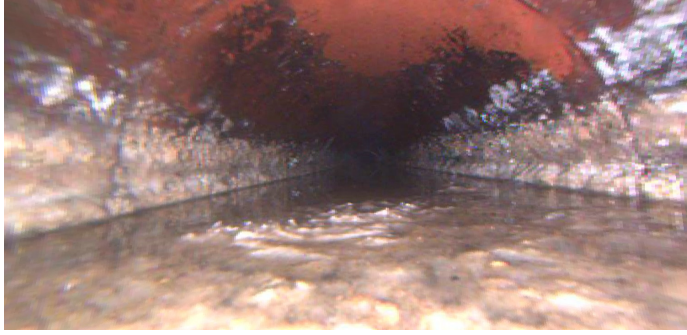
Code:	MSA
Description:	Abandoned Survey
Distance (ft):	4.5
Structural Grade:	0
O&M Grade:	0
Clock Start/From:	
Clock To:	
1st Value:	
2nd Value:	
Value Percent:	
Continuous Index:	
Within 8" of Joint:	NO
Remarks:	camera stopped
