## Profile/Photo Observation Report

Street:	<b>HIGH ST</b>	Flow Control:	<b>Not Controlled</b>
City:	<b>Hobart, IN</b>	Year Renewed:	
Location:	<b>Light Highway</b>	Tape/Media #:	
Purpose:	<b>Routine Assessment</b>	Dia/Height:	<b>12"</b>
Use:	<b>Sanitary</b>	Material:	<b>VCP</b>
Drain Area:	<b>NA</b>	Lining:	
Category:	<b>NA</b>		
Comment:

Location Details:		Direction of Survey:	<b>Downstream</b>
US MH:	<b>M-803-018</b>	DS MH:	<b>M-804-044</b>
		Total Length Surveyed (ft):	<b>63.5</b>

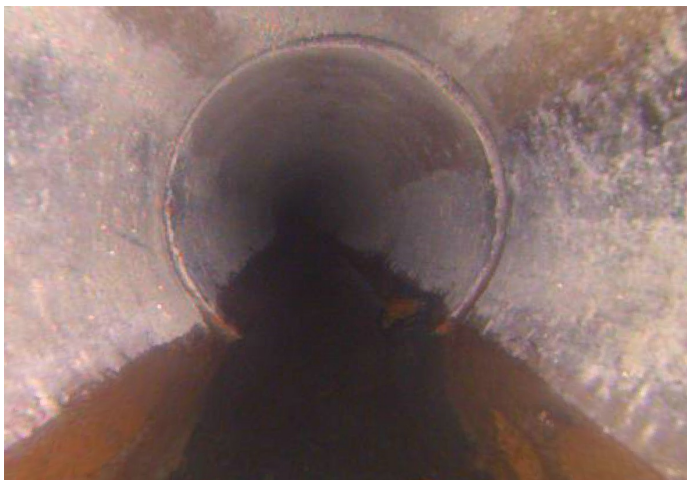
Code: **AMH**  
Description: **Manhole**

Distance (ft): **.0**  
Structural Grade: **0**  
O&M Grade: **0**  
Clock Start/From:  
Clock To:  
1st Value:  
2nd Value:  
Value Percent:  
Continuous Index:  
Within 8" of Joint: **NO**  
Remarks: **M-803-018**

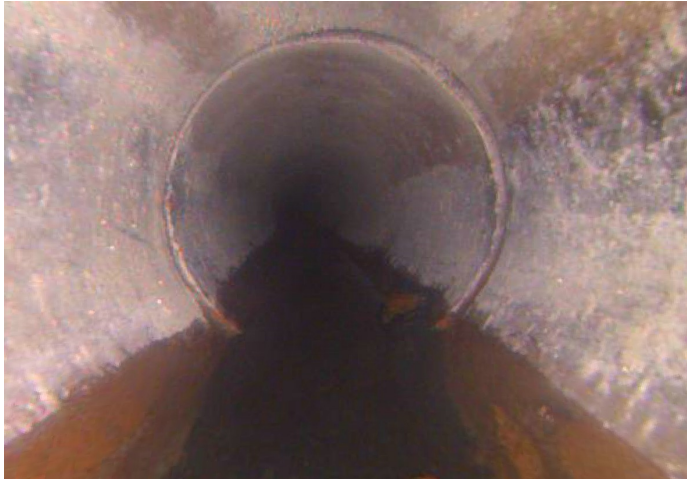
Code: **MWL**  
Description: **Water Level**

Distance (ft): **.0**  
Structural Grade: **0**  
O&M Grade: **0**  
Clock Start/From:  
Clock To:  
1st Value:  
2nd Value:  
Value Percent: **10.000**  
Continuous Index:  
Within 8" of Joint: **NO**  
Remarks:

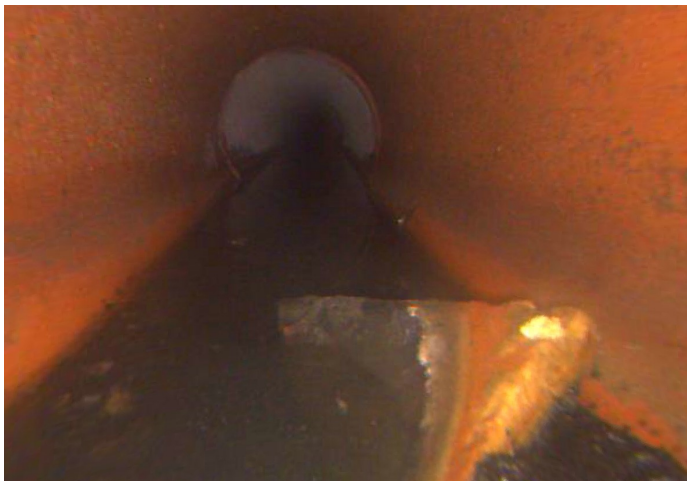
Code: **OBM**  
Description: **Obstacle Pipe Material**

Distance (ft): **15.0**  
Structural Grade: **0**  
O&M Grade: **2**  
Clock Start/From: **5**  
Clock To:  
1st Value:  
2nd Value:  
Value Percent: **5.000**  
Continuous Index:  
Within 8" of Joint: **NO**  
Remarks:

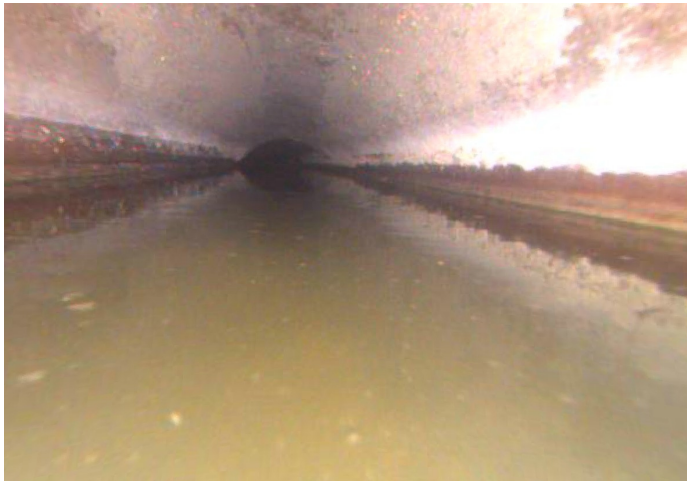
Code: **MWL**  
Description: **Water Level**

Distance (ft): **60.1**  
Structural Grade: **0**  
O&M Grade: **0**  
Clock Start/From:  
Clock To:  
1st Value:  
2nd Value:  
Value Percent: **65.000**  
Continuous Index:  
Within 8" of Joint: **NO**  
Remarks:
