## Profile/Photo Observation Report

Street:	<b>41st. Ave.</b>	Flow Control:	<b>Not Controlled</b>
City:	<b>Hobart, IN</b>	Year Renewed:	
Location:	<b>Light Highway</b>	Tape/Media #:	
Purpose:	<b>Routine Assessment</b>	Dia/Height:	<b>12"</b>
Use:	<b>Sanitary</b>	Material:	<b>VCP</b>
Drain Area:	<b>NA</b>	Lining:	
Category:	<b>NA</b>		
Comment:

Location Details:		Direction of Survey:	<b>Downstream</b>
US MH:	<b>M-803-018</b>	DS MH:	<b>M-804-044</b>
		Total Length Surveyed (ft):	<b>63.5</b>

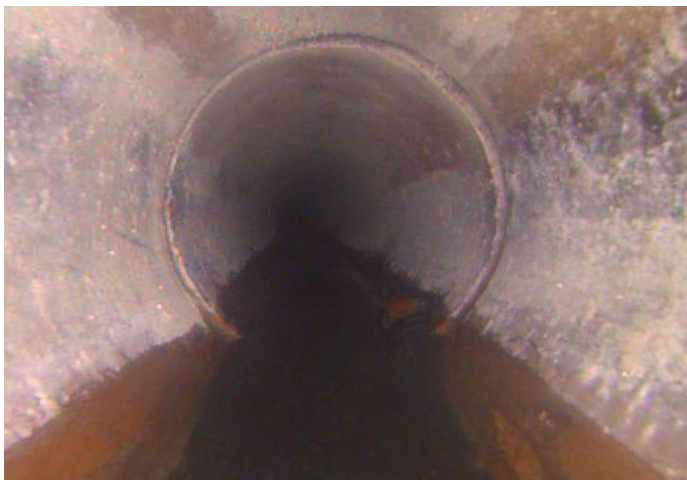
Code: **AMH**  
Description: **Manhole**

Distance (ft): **.0**  
Structural Grade: **0**  
O&M Grade: **0**  
Clock Start/From:  
Clock To:  
1st Value:  
2nd Value:  
Value Percent:  
Continuous Index:  
Within 8" of Joint: **NO**  
Remarks: **M-803-018**

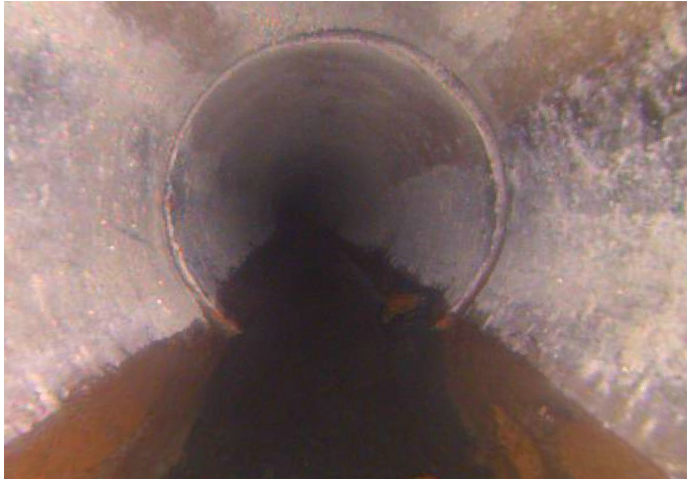
Code: **MWL**  
Description: **Water Level**

Distance (ft): **.0**  
Structural Grade: **0**  
O&M Grade: **0**  
Clock Start/From:  
Clock To:  
1st Value:  
2nd Value:  
Value Percent: **10.000**  
Continuous Index:  
Within 8" of Joint: **NO**  
Remarks:

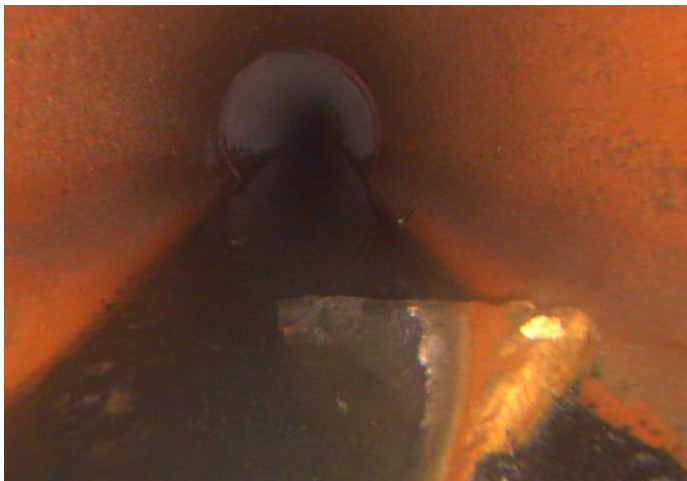
Code: **OBM**  
Description: **Obstacle Pipe Material**

Distance (ft): **15.0**  
Structural Grade: **0**  
O&M Grade: **2**  
Clock Start/From: **5**  
Clock To:  
1st Value:  
2nd Value:  
Value Percent: **5.000**  
Continuous Index:  
Within 8" of Joint: **NO**  
Remarks:

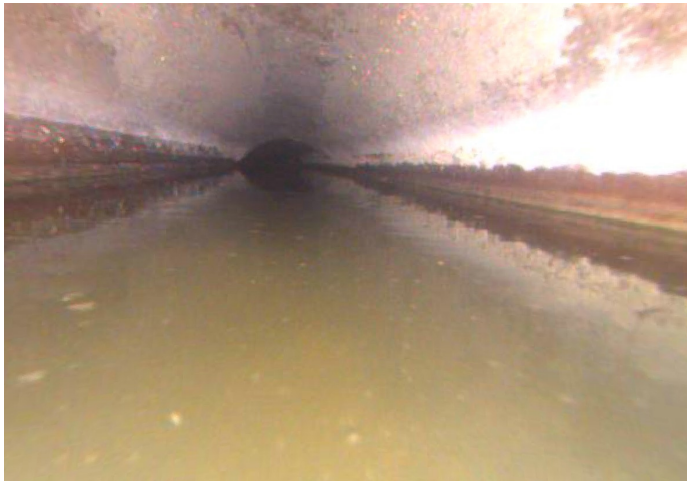
Code:	<b>MWL</b>
Description:	<b>Water Level</b>
Distance (ft):	<b>60.1</b>
Structural Grade:	<b>0</b>
O&M Grade:	<b>0</b>
Clock Start/From:	
Clock To:	
1st Value:	
2nd Value:	
Value Percent:	<b>65.000</b>
Continuous Index:	
Within 8" of Joint:	<b>NO</b>
Remarks:
