Profile/Photo Observation Report

Date:	10/01/2018	Weather:		Coding:	PACP 6.0
Pipe Length (ft):	233.0	Owner:	NA	Pre Clean:	Not Known
P.O.#:		Surveyor:	Michael Carlino	PSR:	P-804-044-018
Customer:		Clean Date:	01/01/1900	Shape:	C

Street:	HIGH ST	Flow Control:	Not Controlled
City:	Hobart, IN	Year Renewed:	
Location:	Light Highway	Tape/Media #:	
Purpose:	Routine Assessment	Dia/Height:	12"
Use:	Sanitary	Material:	VCP
Drain Area:	NA	Lining:	
Category:	NA		
Comment:

Location Details:		Direction of Survey:	Upstream
US MH:	M-803-018	DS MH:	M-804-044
		Total Length Surveyed (ft):	17.0

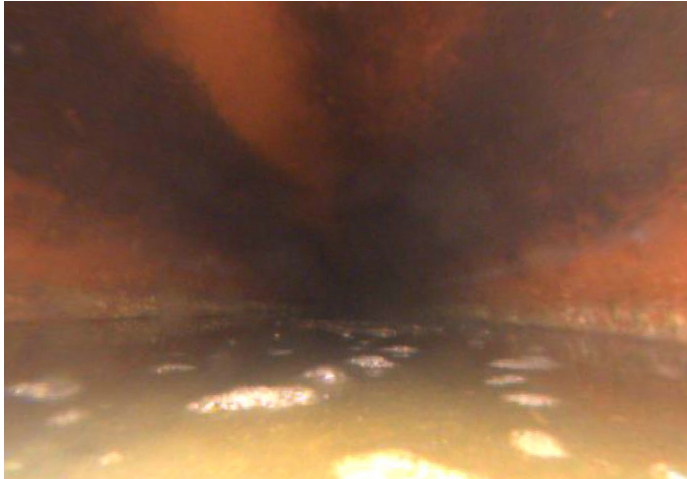
Code:	AMH
Description:	Manhole
Distance (ft):	.0
Structural Grade:	0
O&M Grade:	0
Clock Start/From:	
Clock To:	
1st Value:	
2nd Value:	
Value Percent:	
Continuous Index:	
Within 8" of Joint:	NO
Remarks:	M-804-044

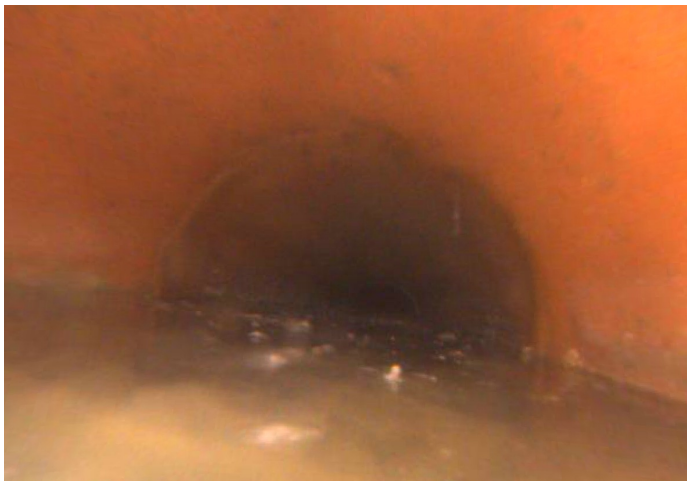
Code:	MWL
Description:	Water Level
Distance (ft):	.0
Structural Grade:	0
O&M Grade:	0
Clock Start/From:	
Clock To:	
1st Value:	
2nd Value:	
Value Percent:	25.000
Continuous Index:	
Within 8" of Joint:	NO
Remarks:
