Profile/Photo Observation Report

Date:	10/01/2018	Weather:		Coding:	PACP 6.0
Pipe Length (ft):	233.0	Owner:	NA	Pre Clean:	Not Known
P.O.#:		Surveyor:	Michael Carlino	PSR:	P-804-044-018
Customer:		Clean Date:	01/01/1900	Shape:	C

Street:	41st. Ave.	Flow Control:	Not Controlled
City:	Hobart, IN	Year Renewed:	
Location:	Light Highway	Tape/Media #:	
Purpose:	Routine Assessment	Dia/Height:	12"
Use:	Sanitary	Material:	VCP
Drain Area:	NA	Lining:	
Category:	NA		
Comment:

Location Details:		Direction of Survey:	Upstream
US MH:	M-803-018	DS MH:	M-804-044
		Total Length Surveyed (ft):	17.0

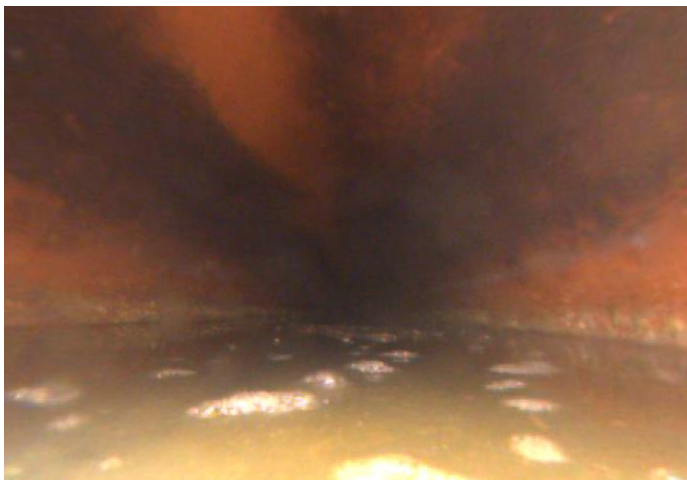
Code: **AMH**
Description: **Manhole**

Distance (ft): **.0**
Structural Grade: **0**
O&M Grade: **0**
Clock Start/From:
Clock To:
1st Value:
2nd Value:
Value Percent:
Continuous Index:
Within 8" of Joint: **NO**
Remarks: **M-804-044**

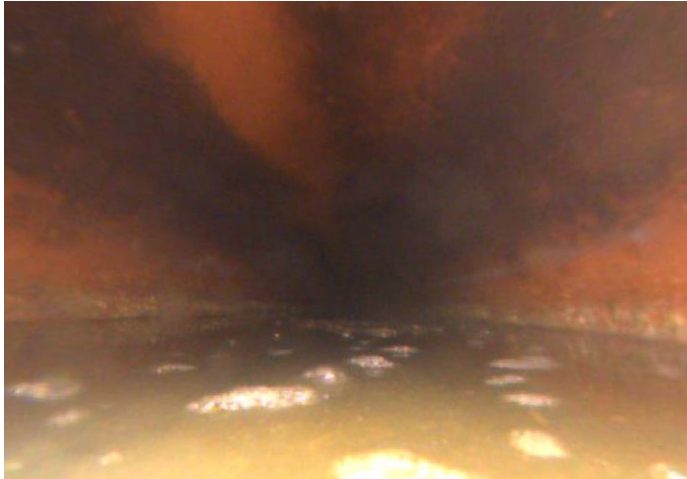
Code:	MWL
Description:	Water Level
Distance (ft):	.0
Structural Grade:	0
O&M Grade:	0
Clock Start/From:	
Clock To:	
1st Value:	
2nd Value:	
Value Percent:	25.000
Continuous Index:	
Within 8" of Joint:	NO
Remarks:

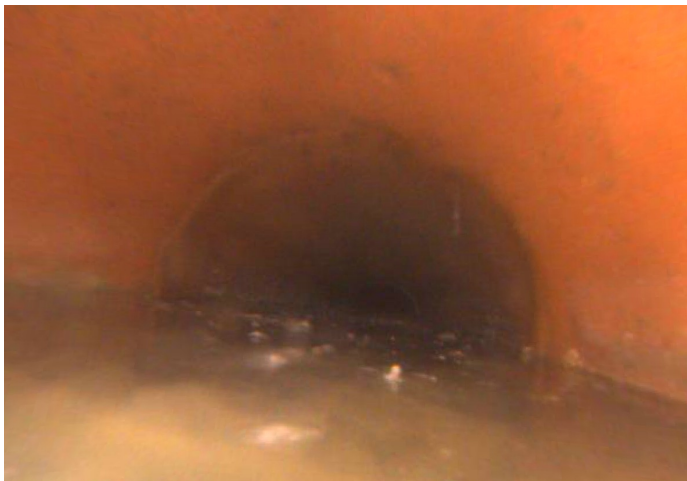
Code:	MWL
Description:	Water Level
Distance (ft):	7.7
Structural Grade:	0
O&M Grade:	0
Clock Start/From:	
Clock To:	
1st Value:	
2nd Value:	
Value Percent:	45.000
Continuous Index:	
Within 8" of Joint:	NO
Remarks:
