Profile/Photo Observation Report

Date:	03/28/2018	Weather:		Coding:	PACP 6.0
Pipe Length (ft):	294.1	Owner:	NA	Pre Clean:	Not Known
P.O.#:		Surveyor:	Selasie Honu	PSR:	P-803-018-019
Customer:		Clean Date:	01/01/1900	Shape:	C

Street:	ALLEY BETWEEN N LIBERTY ST & N J	Flow Control:	Not Controlled
City:	Hobart, IN	Year Renewed:	
Location:	Other	Tape/Media #:	
Purpose:	Not Known	Dia/Height:	10"
Use:	Sanitary	Material:	VCP
Drain Area:	NA	Lining:	
Category:	NA		
Comment:	NULL-ROOTBALL BLOCKING ENTRENCE		
Location Details:		Direction of Survey:	Upstream
US MH:	M-803-019	DS MH:	M-803-018
		Total Length Surveyed (ft):	206.0

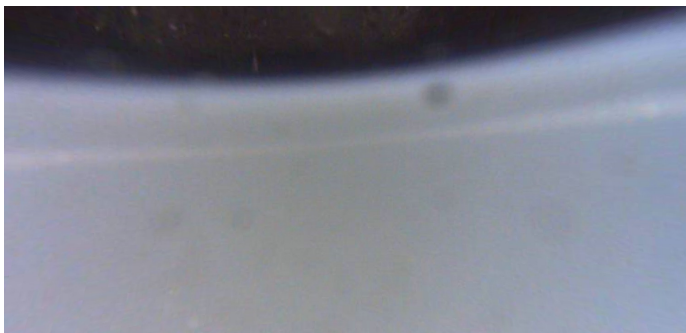
Code: **MCU**
Description: **Camera Underwater**

Distance (ft): **.0**
Structural Grade: **0**
O&M Grade: **4**
Clock Start/From:
Clock To:
1st Value:
2nd Value:
Value Percent:
Continuous Index: **S02**
Within 8" of Joint: **NO**
Remarks:

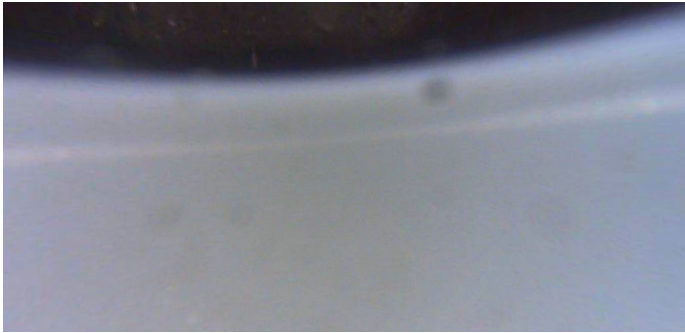
Code:	AMH
Description:	Manhole

Distance (ft):	.0
Structural Grade:	0
O&M Grade:	0
Clock Start/From:	
Clock To:	
1st Value:	
2nd Value:	
Value Percent:	
Continuous Index:	
Within 8" of Joint:	NO
Remarks:	M-803-018

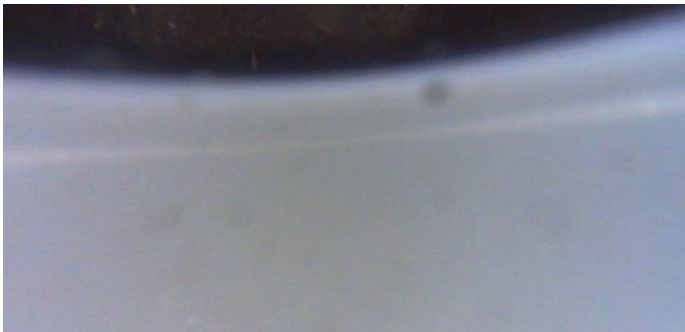
Code:	MWL
Description:	Water Level

Distance (ft):	.0
Structural Grade:	0
O&M Grade:	0
Clock Start/From:	
Clock To:	
1st Value:	
2nd Value:	
Value Percent:	5.000
Continuous Index:	
Within 8" of Joint:	NO
Remarks:

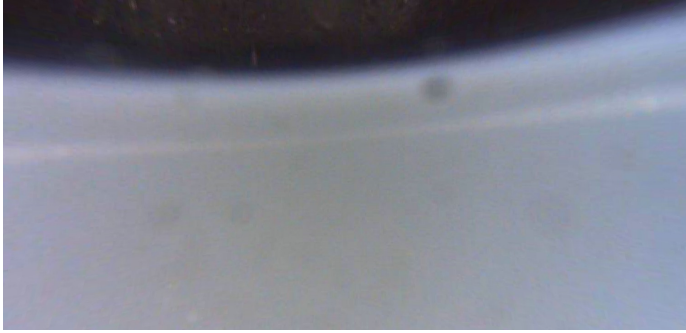
Code: **MWLS**
Description: **Water Level Sag**

Distance (ft): **.0**
Structural Grade: **2**
O&M Grade: **3**
Clock Start/From:
Clock To:
1st Value:
2nd Value:
Value Percent: **10.000**
Continuous Index: **S01**
Within 8" of Joint: **NO**
Remarks:

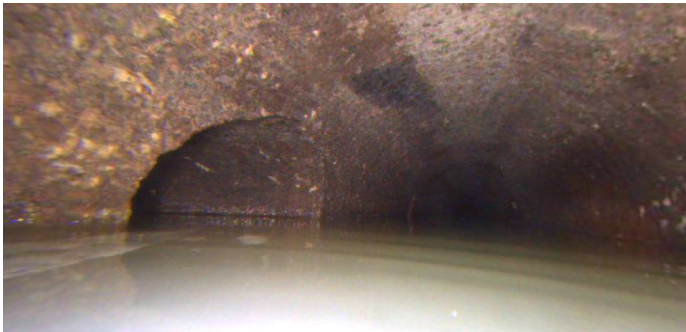
Code: **TFA**
Description: **Tap Factory Active**

Distance (ft): **4.9**
Structural Grade: **0**
O&M Grade: **0**
Clock Start/From: **9**
Clock To:
1st Value: **4.000**
2nd Value:
Value Percent:
Continuous Index:
Within 8" of Joint:
Remarks:
