## Profile/Photo Observation Report

Date:	<b>03/28/2018</b>	Weather:		Coding:	<b>PACP 6.0</b>
Pipe Length (ft):	<b>294.1</b>	Owner:	<b>NA</b>	Pre Clean:	<b>Not Known</b>
P.O.#:		Surveyor:	<b>Selasie Honu</b>	PSR:	<b>P-803-018-019</b>
Customer:		Clean Date:	<b>01/01/1900</b>	Shape:	<b>C</b>

Street:	<b>ALLEY</b>	Flow Control:	<b>Not Controlled</b>
City:	<b>Hobart, IN</b>	Year Renewed:	
Location:	<b>Other</b>	Tape/Media #:	
Purpose:	<b>Not Known</b>	Dia/Height:	<b>10"</b>
Use:	<b>Sanitary</b>	Material:	<b>VCP</b>
Drain Area:	<b>NA</b>	Lining:	
Category:	<b>NA</b>		
Comment:	<b>NULL-ROOTBALL BLOCKING ENTRENCE</b>		
Location Details:		Direction of Survey:	<b>Upstream</b>
US MH:	<b>M-803-019</b>	DS MH:	<b>M-803-018</b>
		Total Length Surveyed (ft):	<b>206.0</b>

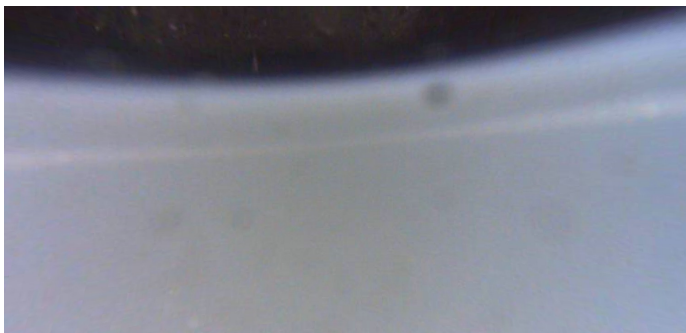
Code: **MCU**  
Description: **Camera Underwater**

Distance (ft): **.0**  
Structural Grade: **0**  
O&M Grade: **4**  
Clock Start/From:  
Clock To:  
1st Value:  
2nd Value:  
Value Percent:  
Continuous Index: **S02**  
Within 8" of Joint: **NO**  
Remarks:

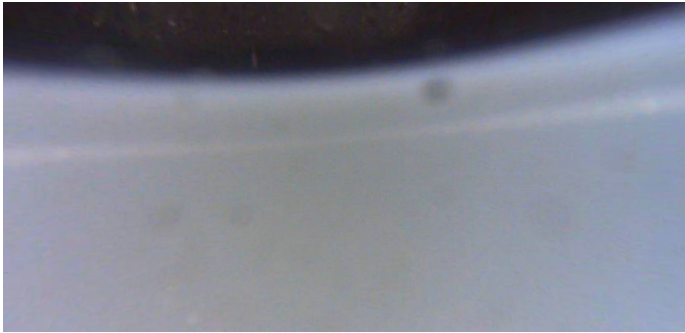
Code:	<b>AMH</b>
Description:	<b>Manhole</b>

Distance (ft):	<b>.0</b>
Structural Grade:	<b>0</b>
O&M Grade:	<b>0</b>
Clock Start/From:	
Clock To:	
1st Value:	
2nd Value:	
Value Percent:	
Continuous Index:	
Within 8" of Joint:	<b>NO</b>
Remarks:	<b>M-803-018</b>

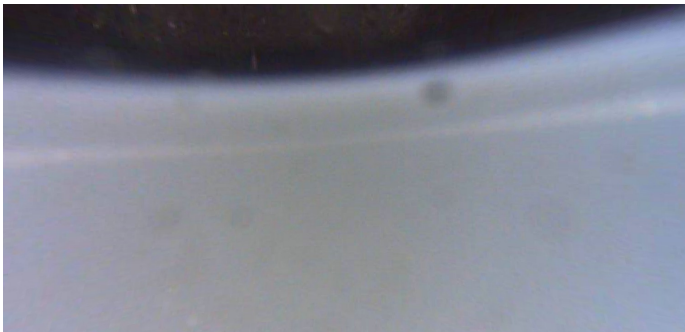
Code:	<b>MWL</b>
Description:	<b>Water Level</b>

Distance (ft):	<b>.0</b>
Structural Grade:	<b>0</b>
O&M Grade:	<b>0</b>
Clock Start/From:	
Clock To:	
1st Value:	
2nd Value:	
Value Percent:	<b>5.000</b>
Continuous Index:	
Within 8" of Joint:	<b>NO</b>
Remarks:

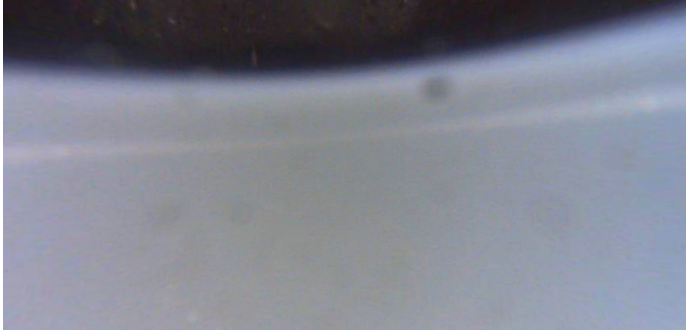
Code: **MWLS**  
Description: **Water Level Sag**

Distance (ft): **.0**  
Structural Grade: **2**  
O&M Grade: **3**  
Clock Start/From:  
Clock To:  
1st Value:  
2nd Value:  
Value Percent: **10.000**  
Continuous Index: **S01**  
Within 8" of Joint: **NO**  
Remarks:

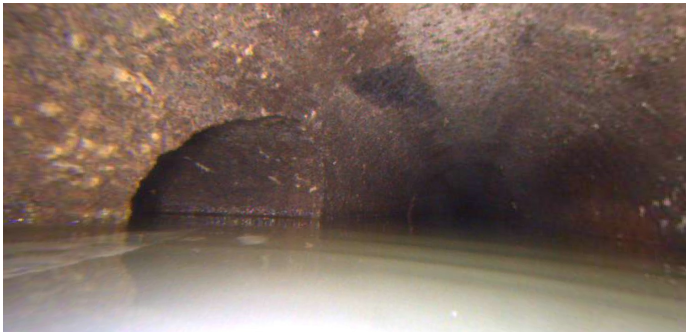
Code: **TFA**  
Description: **Tap Factory Active**

Distance (ft): **4.9**  
Structural Grade: **0**  
O&M Grade: **0**  
Clock Start/From: **9**  
Clock To:  
1st Value: **4.000**  
2nd Value:  
Value Percent:  
Continuous Index:  
Within 8" of Joint:  
Remarks:
