## Profile/Photo Observation Report

| Street: | <b>41st. Ave.</b> | Flow Control: | <b>Not Controlled</b> |
| City: | <b>Hobart, IN</b> | Year Renewed: | |

| US MH: | <b>M-803-019</b> | DS MH: | <b>M-803-018</b> |

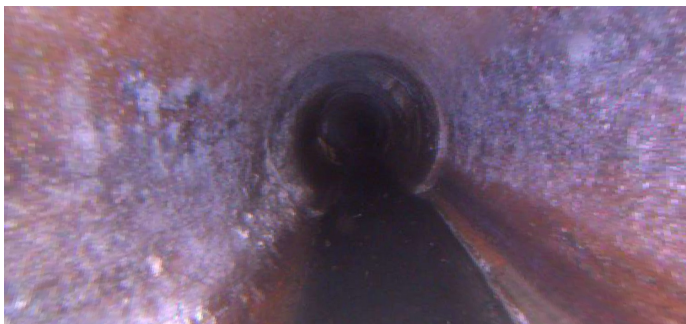
Code: **AMH**  
Description: **Manhole**

Distance (ft): **.0**  
Structural Grade: **0**  
O&M Grade: **0**  
Clock Start/From:  
Clock To:  
1st Value:  
2nd Value:  
Value Percent:  
Continuous Index:  
Within 8" of Joint: **NO**  
Remarks: **M-803-018**

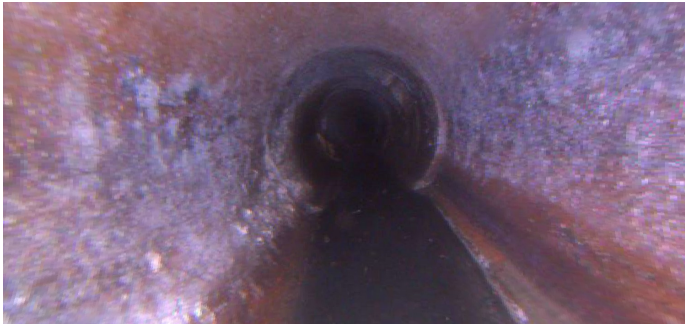
| Code: | <b>MWL</b> |
| Description: | <b>Water Level</b> |

| Value Percent: | <b>5.000</b> |

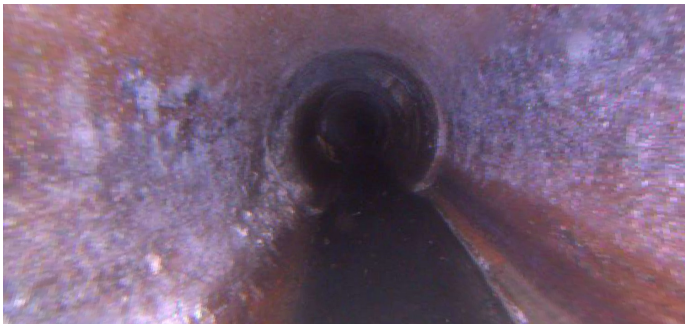
| Code: | <b>DAGS</b> |
| Description: | <b>Deposits Attached Grease</b> |

| O&M Grade: | <b>2</b> |
| Clock Start/From: | <b>7</b> |
| Clock To: | <b>5</b> |
| Value Percent: | <b>5.000</b> |

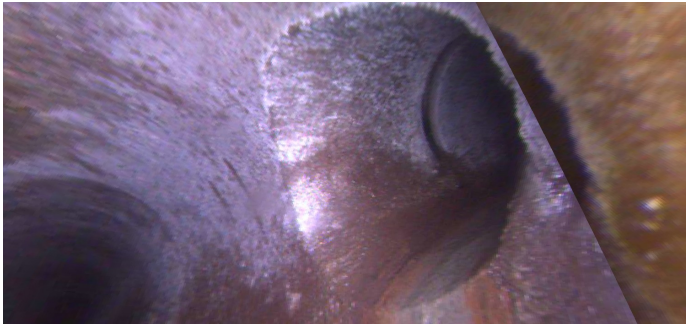
Code: **TF**  
Description: **Tap Factory**

Distance (ft): **3.3**  
Structural Grade: **0**  
O&M Grade: **0**  
Clock Start/From: **2**  
Clock To:  
1st Value: **4.000**  
2nd Value:  
Value Percent:  
Continuous Index:  
Within 8" of Joint:  
Remarks:

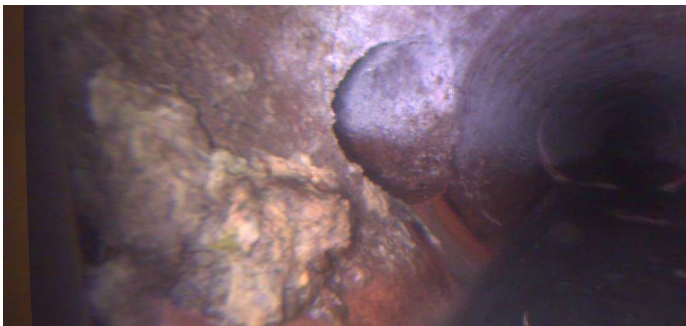
Code: **DAE**  
Description: **Deposits Attached Encrustation**

Distance (ft): **5.0**  
Structural Grade: **0**  
O&M Grade: **2**  
Clock Start/From: **7**  
Clock To: **9**  
1st Value:  
2nd Value:  
Value Percent: **5.000**  
Continuous Index:  
Within 8" of Joint: **YES**  
Remarks:

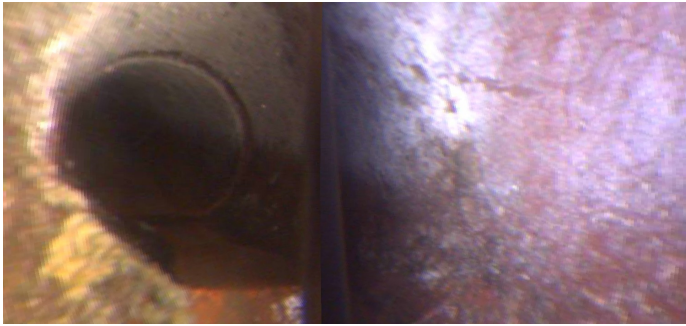
Code: **TF**  
Description: **Tap Factory**

Distance (ft): **5.8**  
Structural Grade: **0**  
O&M Grade: **0**  
Clock Start/From: **9**  
Clock To:  
1st Value: **4.000**  
2nd Value:  
Value Percent:  
Continuous Index:  
Within 8" of Joint:  
Remarks:

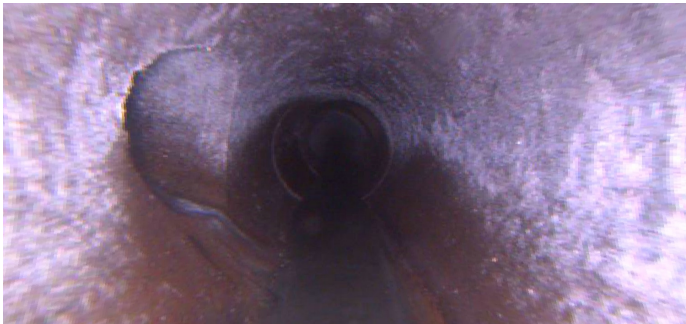
Code: **TF**  
Description: **Tap Factory**

Distance (ft): **44.2**  
Structural Grade: **0**  
O&M Grade: **0**  
Clock Start/From: **9**  
Clock To:  
1st Value: **4.000**  
2nd Value:  
Value Percent:  
Continuous Index:  
Within 8" of Joint:  
Remarks:

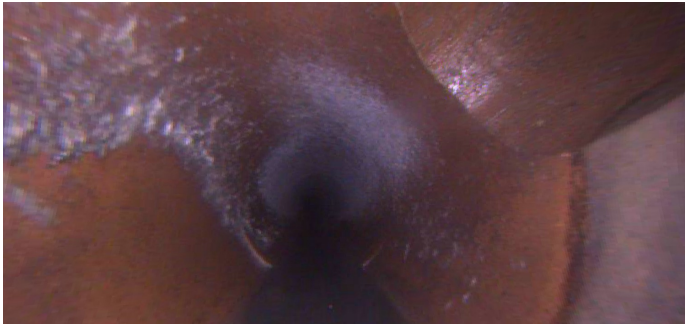
Code: **TF**  
Description: **Tap Factory**

Distance (ft): **46.7**  
Structural Grade: **0**  
O&M Grade: **0**  
Clock Start/From: **2**  
Clock To:  
1st Value: **4.000**  
2nd Value:  
Value Percent:  
Continuous Index:  
Within 8" of Joint:  
Remarks:

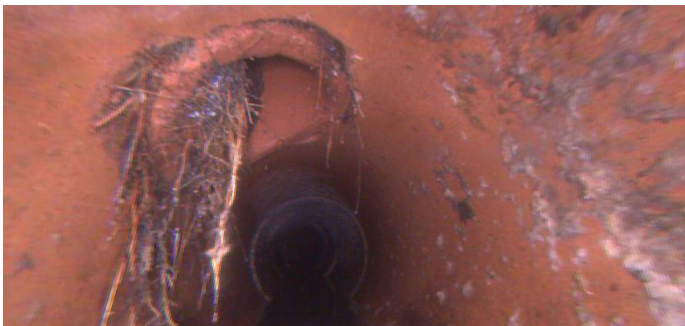
Code: **TBD**  
Description: **Tap Break-in Defective**

Distance (ft): **109.0**  
Structural Grade: **0**  
O&M Grade: **3**  
Clock Start/From: **10**  
Clock To:  
1st Value: **4.000**  
2nd Value:  
Value Percent:  
Continuous Index:  
Within 8" of Joint:  
Remarks: **RF COMING FROM TAP**

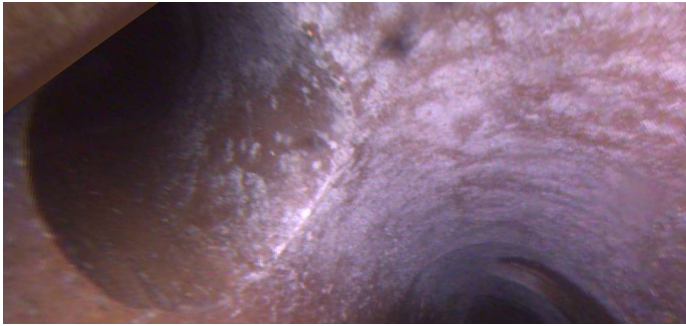
Code: **TF**  
Description: **Tap Factory**

Distance (ft): **112.0**  
Structural Grade: **0**  
O&M Grade: **0**  
Clock Start/From: **10**  
Clock To:  
1st Value: **4.000**  
2nd Value:  
Value Percent:  
Continuous Index:  
Within 8" of Joint:  
Remarks:

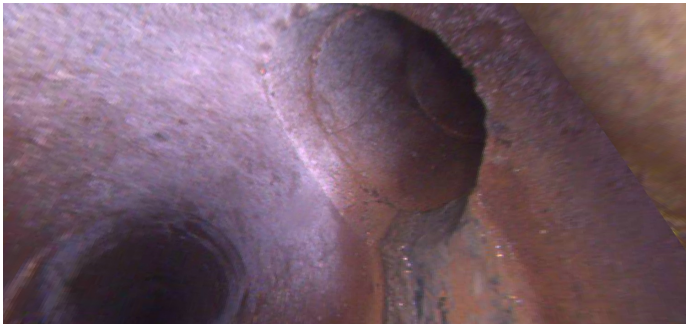
Code: **TF**  
Description: **Tap Factory**

Distance (ft): **113.9**  
Structural Grade: **0**  
O&M Grade: **0**  
Clock Start/From: **2**  
Clock To:  
1st Value: **4.000**  
2nd Value:  
Value Percent:  
Continuous Index:  
Within 8" of Joint:  
Remarks:

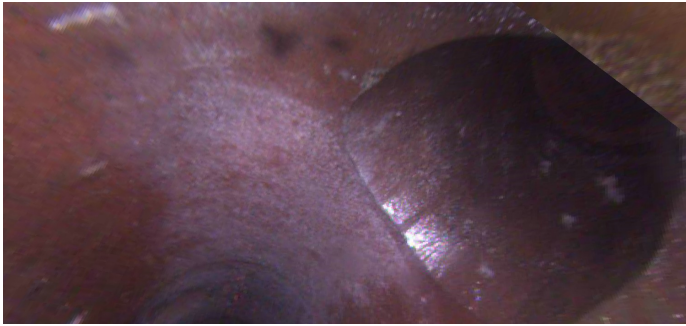
Code: **TF**  
Description: **Tap Factory**

Distance (ft): **179.3**  
Structural Grade: **0**  
O&M Grade: **0**  
Clock Start/From: **2**  
Clock To:  
1st Value: **4.000**  
2nd Value:  
Value Percent:  
Continuous Index:  
Within 8" of Joint:  
Remarks:

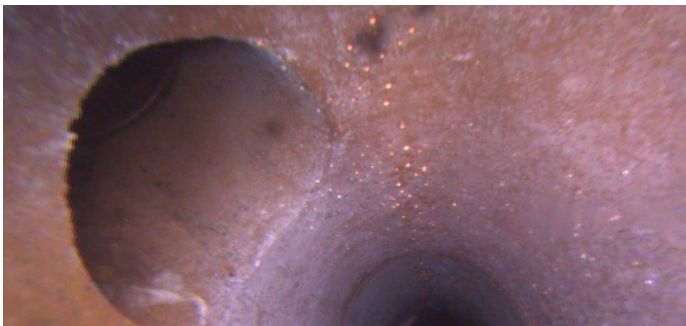
Code: **TF**  
Description: **Tap Factory**

Distance (ft): **181.3**  
Structural Grade: **0**  
O&M Grade: **0**  
Clock Start/From: **10**  
Clock To:  
1st Value: **4.000**  
2nd Value:  
Value Percent:  
Continuous Index:  
Within 8" of Joint:  
Remarks:

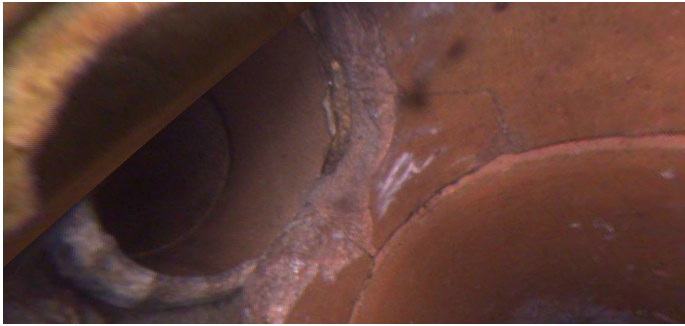
Code: **TBI**  
Description: **Tap Break-in Intruding**

Distance (ft): **185.4**  
Structural Grade: **0**  
O&M Grade: **2**  
Clock Start/From: **10**  
Clock To:  
1st Value: **4.000**  
2nd Value: **0.500**  
Value Percent:  
Continuous Index:  
Within 8" of Joint:  
Remarks:

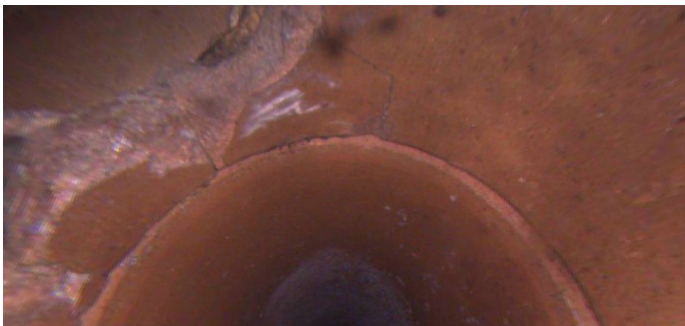
Code: **CM**  
Description: **Crack Multiple**

Distance (ft): **185.4**  
Structural Grade: **3**  
O&M Grade: **0**  
Clock Start/From: **10**  
Clock To: **12**  
1st Value:  
2nd Value:  
Value Percent:  
Continuous Index:  
Within 8" of Joint: **YES**  
Remarks:

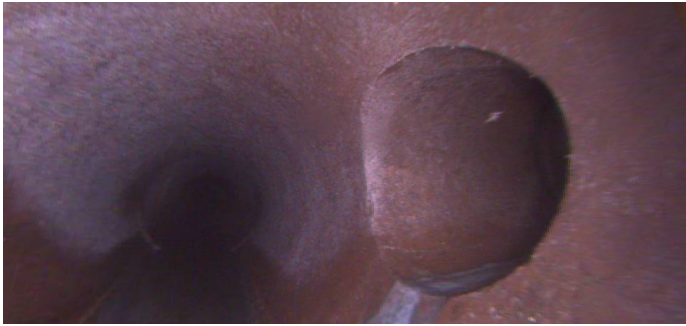
Code: **TF**  
Description: **Tap Factory**

Distance (ft): **246.8**  
Structural Grade: **0**  
O&M Grade: **0**  
Clock Start/From: **3**  
Clock To:  
1st Value: **4.000**  
2nd Value:  
Value Percent:  
Continuous Index:  
Within 8" of Joint:  
Remarks:

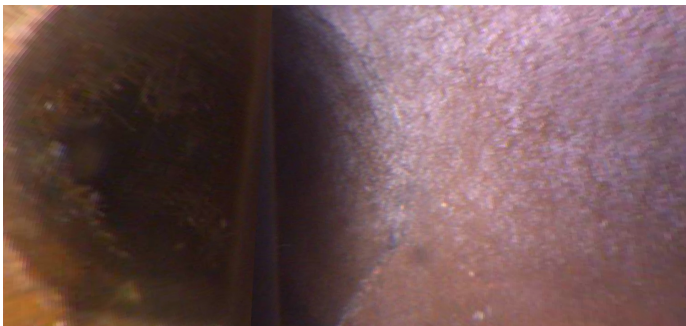
Code: **TF**  
Description: **Tap Factory**

Distance (ft): **250.4**  
Structural Grade: **0**  
O&M Grade: **0**  
Clock Start/From: **9**  
Clock To:  
1st Value: **4.000**  
2nd Value:  
Value Percent:  
Continuous Index:  
Within 8" of Joint:  
Remarks:

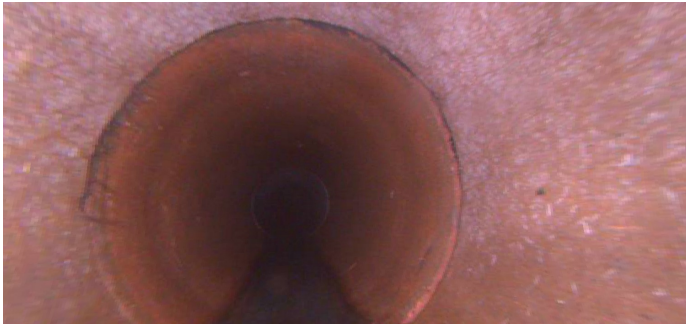
Code: **RFJ**  
Description: **Roots Fine Joint**

Distance (ft): **251.9**  
Structural Grade: **0**  
O&M Grade: **1**  
Clock Start/From: **9**  
Clock To: **2**  
1st Value:  
2nd Value:  
Value Percent:  
Continuous Index:  
Within 8" of Joint: **YES**  
Remarks:

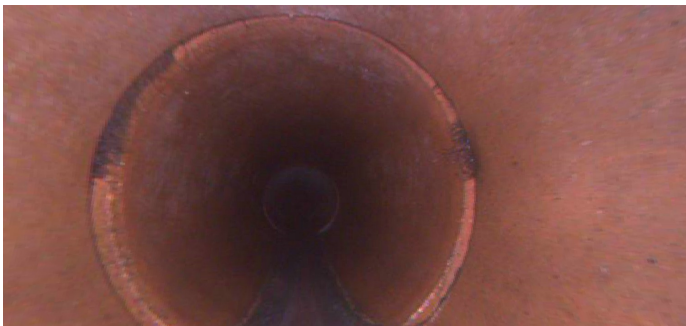
Code: **RFJ**  
Description: **Roots Fine Joint**

Distance (ft): **257.9**  
Structural Grade: **0**  
O&M Grade: **1**  
Clock Start/From: **9**  
Clock To: **3**  
1st Value:  
2nd Value:  
Value Percent:  
Continuous Index:  
Within 8" of Joint: **YES**  
Remarks:

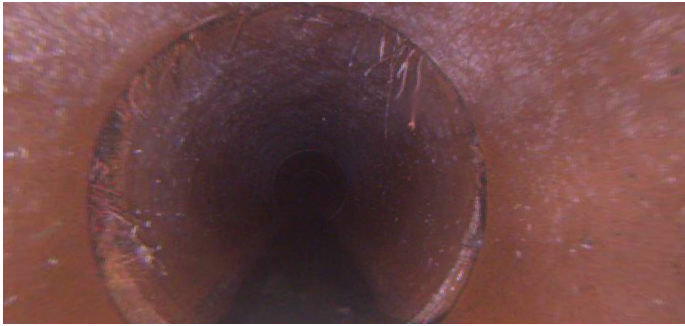
Code: **RFJ**  
Description: **Roots Fine Joint**

Distance (ft): **264.0**  
Structural Grade: **0**  
O&M Grade: **1**  
Clock Start/From: **8**  
Clock To: **4**  
1st Value:  
2nd Value:  
Value Percent:  
Continuous Index: **S02**  
Within 8" of Joint: **YES**  
Remarks: **WANDER**

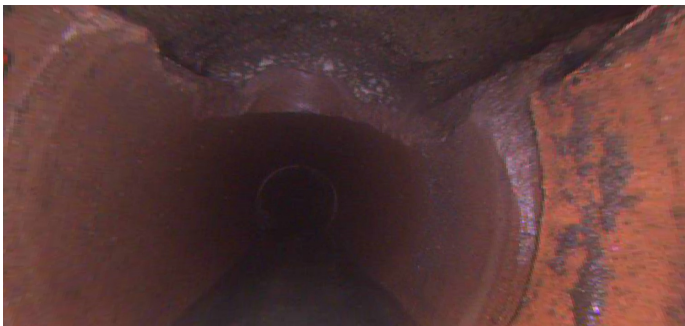
Code: **AMH**  
Description: **Manhole**

Distance (ft): **291.5**  
Structural Grade: **0**  
O&M Grade: **0**  
Clock Start/From:  
Clock To:  
1st Value:  
2nd Value:  
Value Percent:  
Continuous Index:  
Within 8" of Joint: **NO**  
Remarks: **M-803-019**

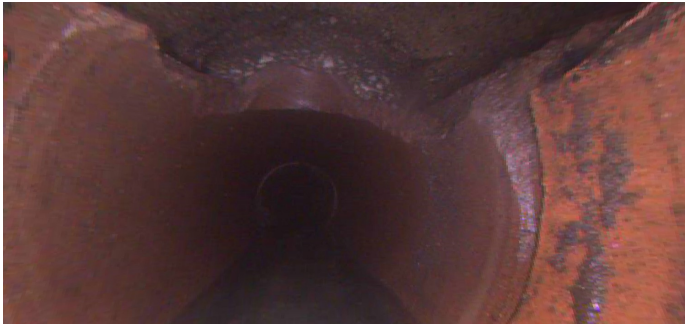
Code: **RFJ**  
Description: **Roots Fine Joint**

Distance (ft): **291.5**  
Structural Grade: **0**  
O&M Grade: **1**  
Clock Start/From: **8**  
Clock To: **4**  
1st Value:  
2nd Value:  
Value Percent:  
Continuous Index: **F02**  
Within 8" of Joint: **YES**  
Remarks: **WANDER**

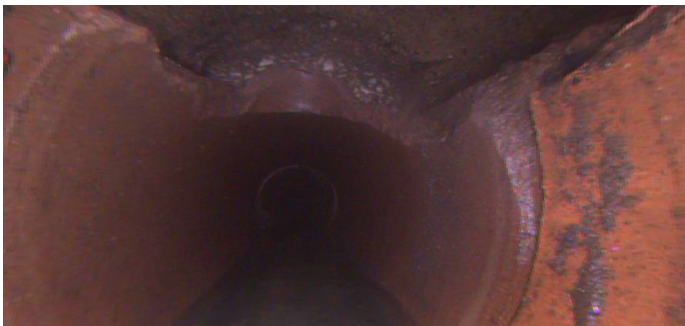
Code: **DAGS**  
Description: **Deposits Attached Grease**

Distance (ft): **291.5**  
Structural Grade: **0**  
O&M Grade: **2**  
Clock Start/From: **7**  
Clock To: **5**  
1st Value:  
2nd Value:  
Value Percent: **5.000**  
Continuous Index: **F01**  
Within 8" of Joint: **YES**  
Remarks: **WANDER**
