Profile/Photo Observation Report

Street:	E 40TH AVE	Flow Control:	Not Controlled
City:	Hobart, IN	Year Renewed:	
Location:	Other	Tape/Media #:	
Purpose:	Not Known	Dia/Height:	10"
Use:	Sanitary	Material:	VCP
Drain Area:	NA	Lining:	
Category:	NA		
Comment:

Location Details:		Direction of Survey:	Downstream
US MH:	M-803-019	DS MH:	M-803-020
		Total Length Surveyed (ft):	2.8

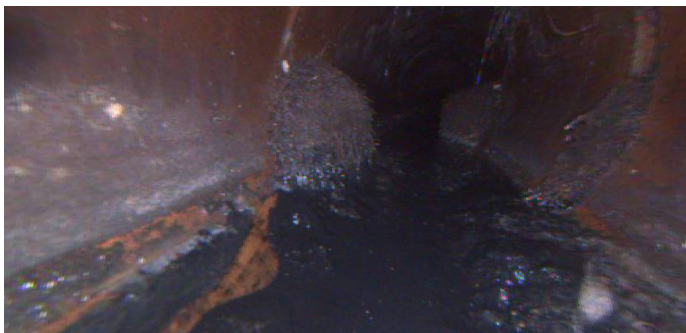
Code: **AMH**
Description: **Manhole**

Distance (ft): **.0**
Structural Grade: **0**
O&M Grade: **0**
Clock Start/From:
Clock To:
1st Value:
2nd Value:
Value Percent:
Continuous Index:
Within 8" of Joint: **NO**
Remarks: **M-803-019**

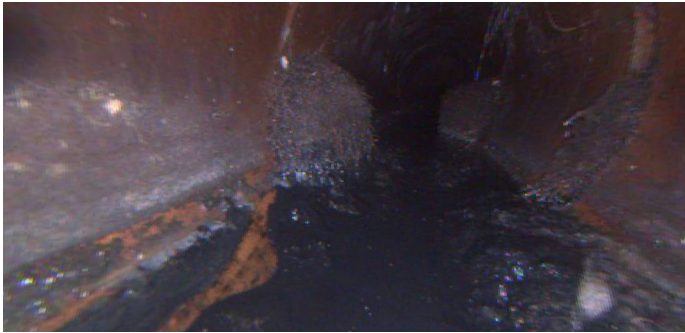
Code:	MWL
Description:	Water Level

Distance (ft):	.0
Structural Grade:	0
O&M Grade:	0
Clock Start/From:	
Clock To:	
1st Value:	
2nd Value:	
Value Percent:	5.000
Continuous Index:	
Within 8" of Joint:	NO
Remarks:

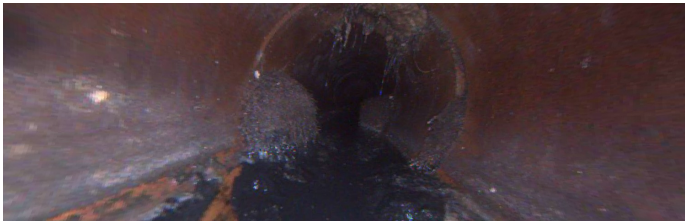
Code:	RMJ
Description:	Roots Medium Joint

Distance (ft):	.0
Structural Grade:	0
O&M Grade:	3
Clock Start/From:	7
Clock To:	5
1st Value:	
2nd Value:	
Value Percent:	15.000
Continuous Index:	
Within 8" of Joint:	YES
Remarks:

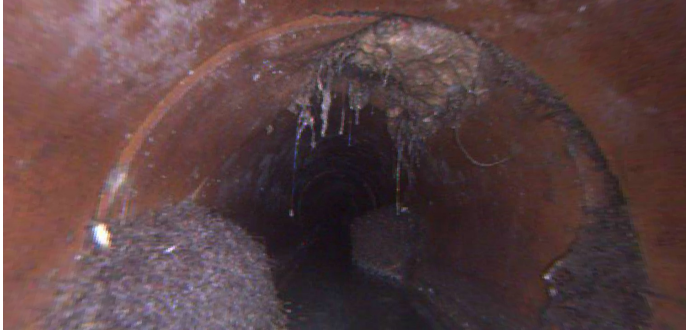
Code: **FM**
Description: **Fracture Multiple**

Distance (ft): **2.1**
Structural Grade: **4**
O&M Grade: **0**
Clock Start/From: **7**
Clock To: **1**
1st Value:
2nd Value:
Value Percent:
Continuous Index:
Within 8" of Joint: **YES**
Remarks:

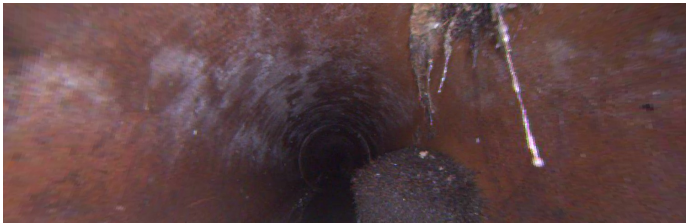
Code: **MSA**
Description: **Abandoned Survey**

Distance (ft): **2.8**
Structural Grade: **0**
O&M Grade: **0**
Clock Start/From:
Clock To:
1st Value:
2nd Value:
Value Percent:
Continuous Index:
Within 8" of Joint: **NO**
Remarks: **root infiltration**
