## Profile/Photo Observation Report

Date:	<b>03/28/2018</b>	Weather:		Coding:	<b>PACP 6.0</b>
Pipe Length (ft):	<b>306.0</b>	Owner:	<b>NA</b>	Pre Clean:	<b>Not Known</b>
P.O.#:		Surveyor:	<b>Selasie Honu</b>	PSR:	<b>P-803-019-020</b>
Customer:		Clean Date:	<b>01/01/1900</b>	Shape:	<b>C</b>

Location Details:		Direction of Survey:	<b>Downstream</b>
US MH:	<b>M-803-019</b>	DS MH:	<b>M-803-020</b>
		Total Length Surveyed (ft):	<b>2.8</b>

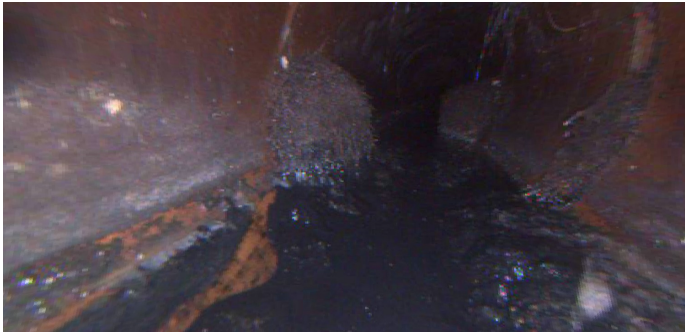
Code:	<b>MWL</b>
Description:	<b>Water Level</b>

Distance (ft):	<b>.0</b>
Structural Grade:	<b>0</b>
O&M Grade:	<b>0</b>
Clock Start/From:	
Clock To:	
1st Value:	
2nd Value:	
Value Percent:	<b>5.000</b>
Continuous Index:	
Within 8" of Joint:	<b>NO</b>
Remarks:

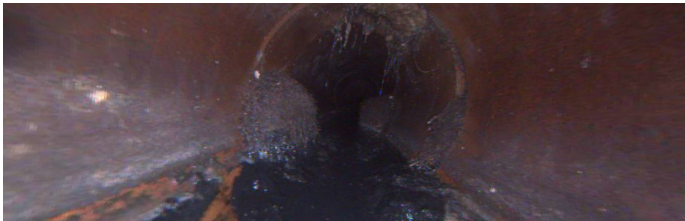
Code:	<b>RMJ</b>
Description:	<b>Roots Medium Joint</b>

Distance (ft):	<b>.0</b>
Structural Grade:	<b>0</b>
O&M Grade:	<b>3</b>
Clock Start/From:	<b>7</b>
Clock To:	<b>5</b>
1st Value:	
2nd Value:	
Value Percent:	<b>15.000</b>
Continuous Index:	
Within 8" of Joint:	<b>YES</b>
Remarks:

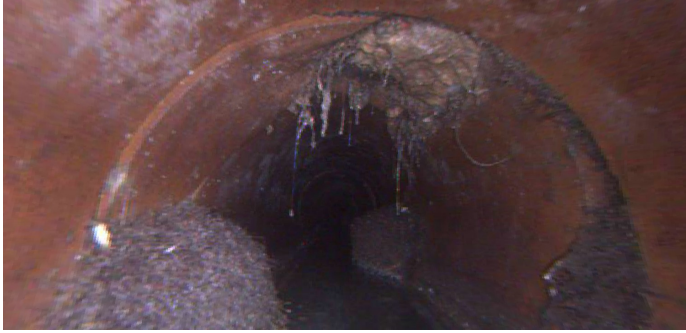
Code: **FM**  
Description: **Fracture Multiple**

Distance (ft): **2.1**  
Structural Grade: **4**  
O&M Grade: **0**  
Clock Start/From: **7**  
Clock To: **1**  
1st Value:  
2nd Value:  
Value Percent:  
Continuous Index:  
Within 8" of Joint: **YES**  
Remarks:

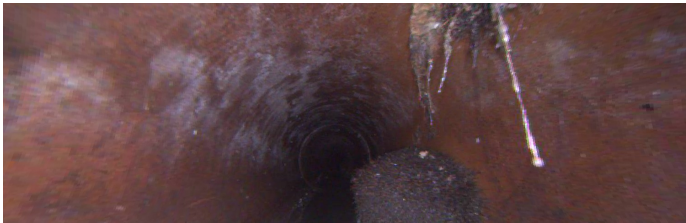
Code: **MSA**  
Description: **Abandoned Survey**

Distance (ft): **2.8**  
Structural Grade: **0**  
O&M Grade: **0**  
Clock Start/From:  
Clock To:  
1st Value:  
2nd Value:  
Value Percent:  
Continuous Index:  
Within 8" of Joint: **NO**  
Remarks: **root infiltration**
