Profile/Photo Observation Report

Date:	10/01/2018	Weather:		Coding:	PACP 6.0
Pipe Length (ft):	306.0	Owner:	NA	Pre Clean:	Not Known
P.O.#:		Surveyor:	Justin Gonzales	PSR:	P-803-019-020
Customer:		Clean Date:	01/01/1900	Shape:	C

Street:	40th. Ave.	Flow Control:	Not Controlled
City:	Hobart, IN	Year Renewed:	
Location:	Light Highway	Tape/Media #:	
Purpose:	Routine Assessment	Dia/Height:	12"
Use:	Sanitary	Material:	VCP
Drain Area:	NA	Lining:	
Category:	NA		
Comment:

Location Details:		Direction of Survey:	Upstream
US MH:	M-803-019	DS MH:	M-803-020
		Total Length Surveyed (ft):	291.3

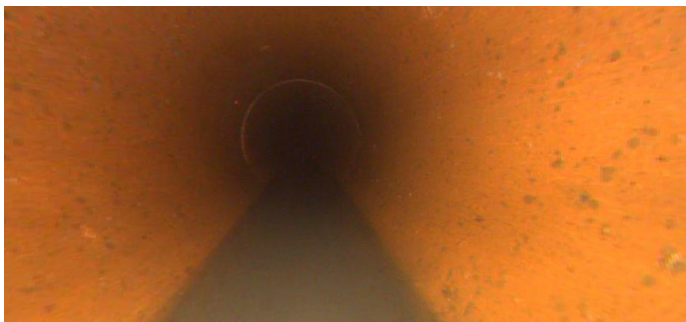
Code: **AMH**
Description: **Manhole**

Distance (ft): **.0**
Structural Grade: **0**
O&M Grade: **0**
Clock Start/From:
Clock To:
1st Value:
2nd Value:
Value Percent:
Continuous Index:
Within 8" of Joint: **NO**
Remarks: **M-803-020**

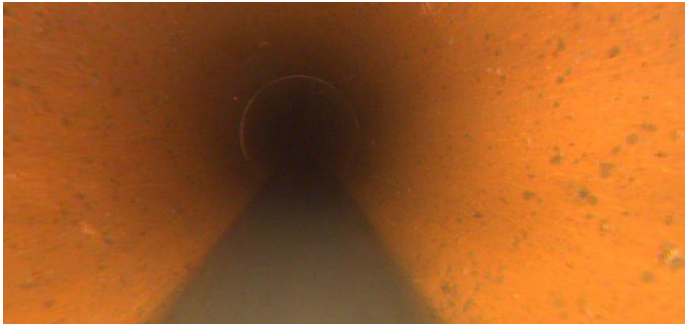
Code:	MWL
Description:	Water Level

Distance (ft):	.0
Structural Grade:	0
O&M Grade:	0
Clock Start/From:	
Clock To:	
1st Value:	
2nd Value:	
Value Percent:	5.000
Continuous Index:	
Within 8" of Joint:	NO
Remarks:

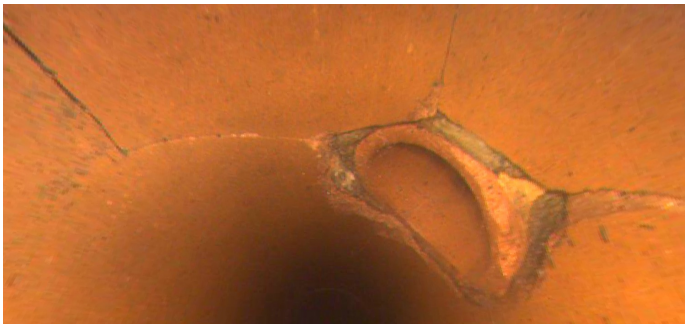
Code:	FM
Description:	Fracture Multiple

Distance (ft):	73.8
Structural Grade:	4
O&M Grade:	0
Clock Start/From:	10
Clock To:	2
1st Value:	
2nd Value:	
Value Percent:	
Continuous Index:	
Within 8" of Joint:	YES
Remarks:

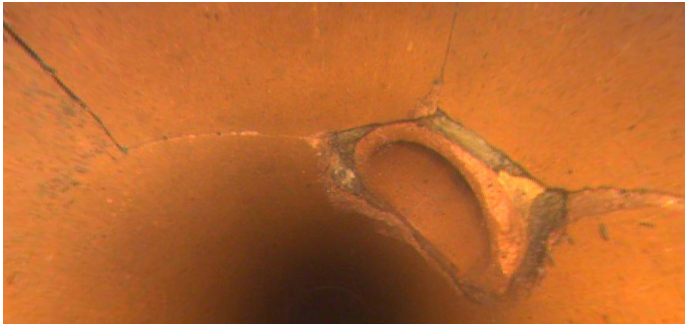
Code: **TBI**
Description: **Tap Break-in Intruding**

Distance (ft): **73.8**
Structural Grade: **0**
O&M Grade: **2**
Clock Start/From: **2**
Clock To:
1st Value: **4.000**
2nd Value: **0.500**
Value Percent:
Continuous Index:
Within 8" of Joint:
Remarks:

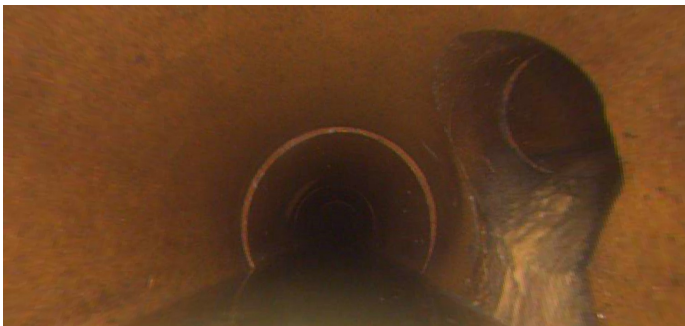
Code: **TF**
Description: **Tap Factory**

Distance (ft): **86.1**
Structural Grade: **0**
O&M Grade: **0**
Clock Start/From: **3**
Clock To:
1st Value: **4.000**
2nd Value:
Value Percent:
Continuous Index:
Within 8" of Joint:
Remarks:

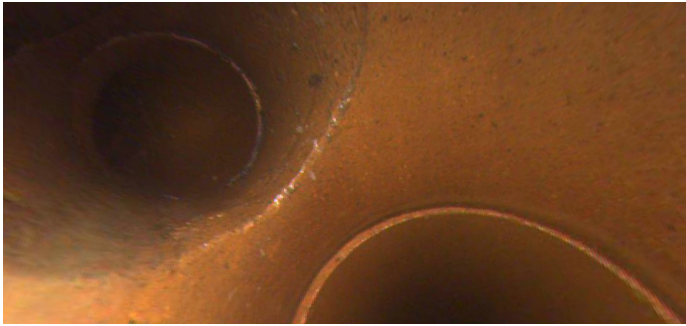
Code: **TF**
Description: **Tap Factory**

Distance (ft): **88.6**
Structural Grade: **0**
O&M Grade: **0**
Clock Start/From: **10**
Clock To:
1st Value: **4.000**
2nd Value:
Value Percent:
Continuous Index:
Within 8" of Joint:
Remarks:

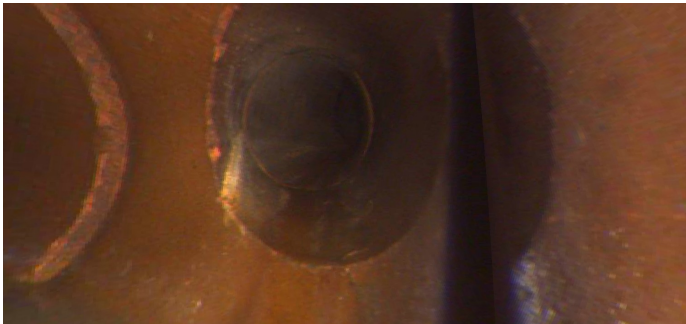
Code: **TF**
Description: **Tap Factory**

Distance (ft): **141.2**
Structural Grade: **0**
O&M Grade: **0**
Clock Start/From: **3**
Clock To:
1st Value: **4.000**
2nd Value:
Value Percent:
Continuous Index:
Within 8" of Joint:
Remarks:

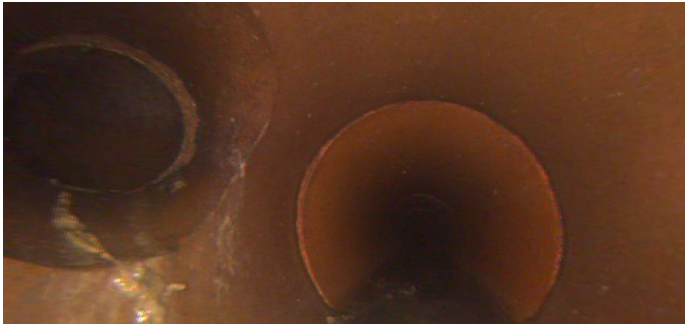
Code: **TF**
Description: **Tap Factory**

Distance (ft): **144.0**
Structural Grade: **0**
O&M Grade: **0**
Clock Start/From: **9**
Clock To:
1st Value: **4.000**
2nd Value:
Value Percent:
Continuous Index:
Within 8" of Joint:
Remarks:

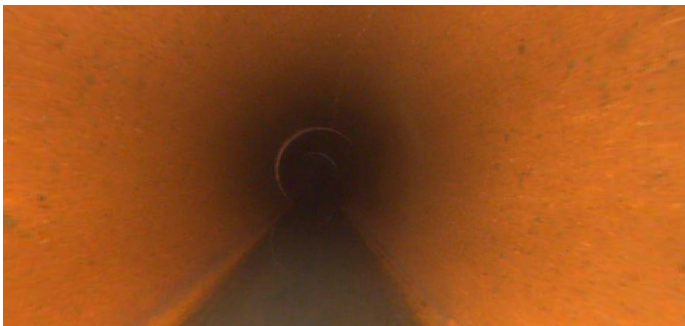
Code: **CL**
Description: **Crack Longitudinal**

Distance (ft): **185.7**
Structural Grade: **2**
O&M Grade: **0**
Clock Start/From: **1**
Clock To:
1st Value:
2nd Value:
Value Percent:
Continuous Index:
Within 8" of Joint: **YES**
Remarks:

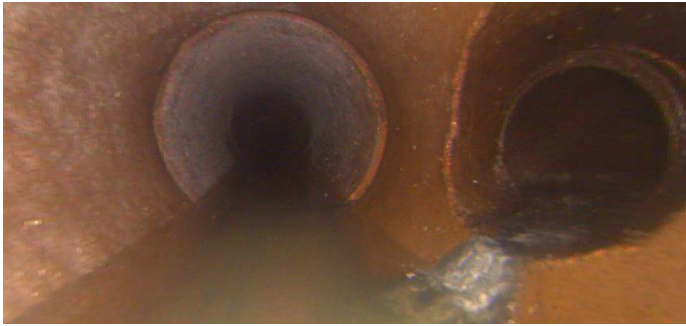
Code: **TF**
Description: **Tap Factory**

Distance (ft): **199.5**
Structural Grade: **0**
O&M Grade: **0**
Clock Start/From: **3**
Clock To:
1st Value: **4.000**
2nd Value:
Value Percent:
Continuous Index:
Within 8" of Joint:
Remarks:

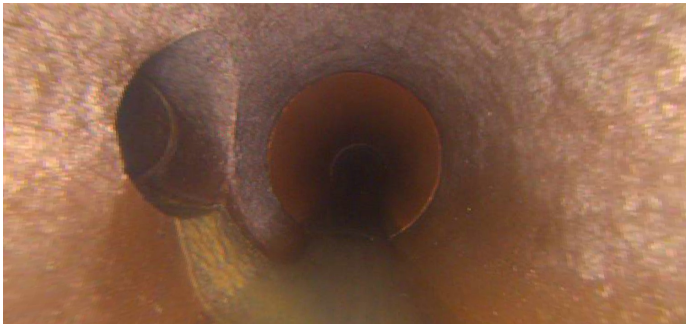
Code: **TF**
Description: **Tap Factory**

Distance (ft): **202.0**
Structural Grade: **0**
O&M Grade: **0**
Clock Start/From: **9**
Clock To:
1st Value: **4.000**
2nd Value:
Value Percent:
Continuous Index:
Within 8" of Joint:
Remarks:

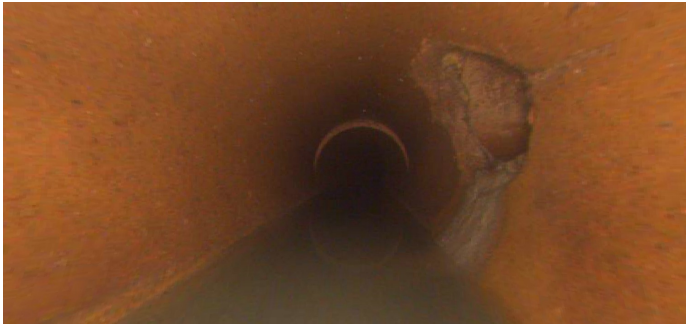
Code: **TB**
Description: **Tap Break-in**

Distance (ft): **262.1**
Structural Grade: **0**
O&M Grade: **0**
Clock Start/From: **3**
Clock To:
1st Value: **4.000**
2nd Value:
Value Percent:
Continuous Index:
Within 8" of Joint:
Remarks:

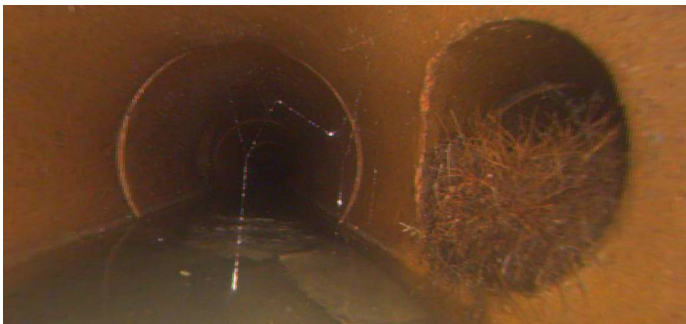
Code: **TFC**
Description: **Tap Factory Capped**

Distance (ft): **266.6**
Structural Grade: **0**
O&M Grade: **0**
Clock Start/From: **3**
Clock To:
1st Value: **4.000**
2nd Value:
Value Percent:
Continuous Index:
Within 8" of Joint:
Remarks:

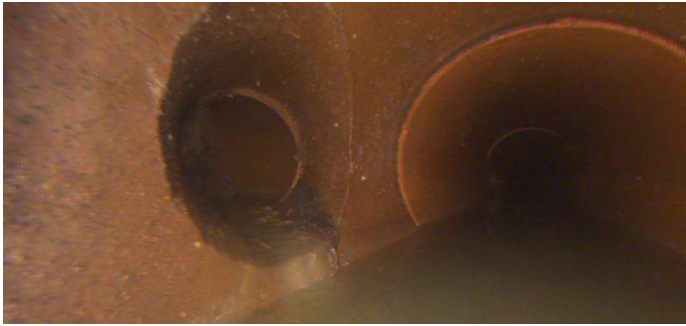
Code: **TF**
Description: **Tap Factory**

Distance (ft): **268.6**
Structural Grade: **0**
O&M Grade: **0**
Clock Start/From: **9**
Clock To:
1st Value: **4.000**
2nd Value:
Value Percent:
Continuous Index:
Within 8" of Joint:
Remarks:

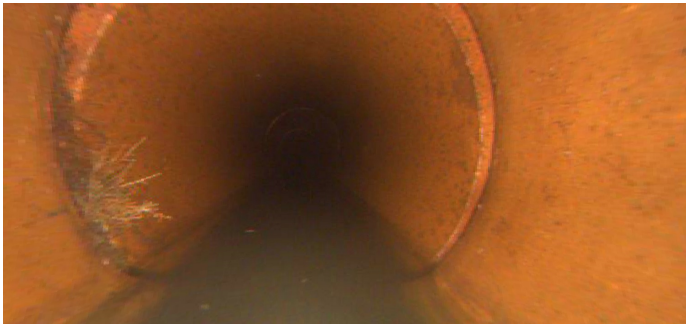
Code: **RFJ**
Description: **Roots Fine Joint**

Distance (ft): **272.0**
Structural Grade: **0**
O&M Grade: **1**
Clock Start/From: **7**
Clock To: **8**
1st Value:
2nd Value:
Value Percent:
Continuous Index:
Within 8" of Joint: **YES**
Remarks:

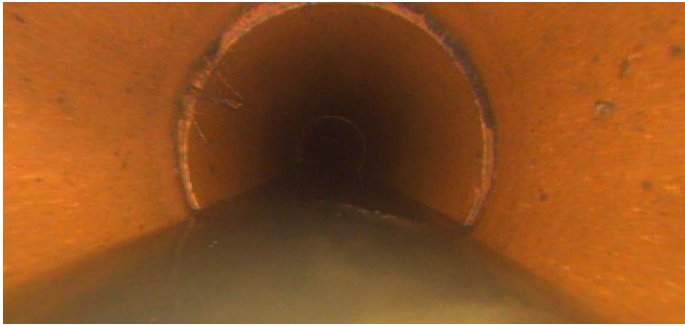
Code: **RFJ**
Description: **Roots Fine Joint**

Distance (ft): **277.7**
Structural Grade: **0**
O&M Grade: **1**
Clock Start/From: **7**
Clock To: **5**
1st Value:
2nd Value:
Value Percent:
Continuous Index: **S01**
Within 8" of Joint: **YES**
Remarks: **WANDER**

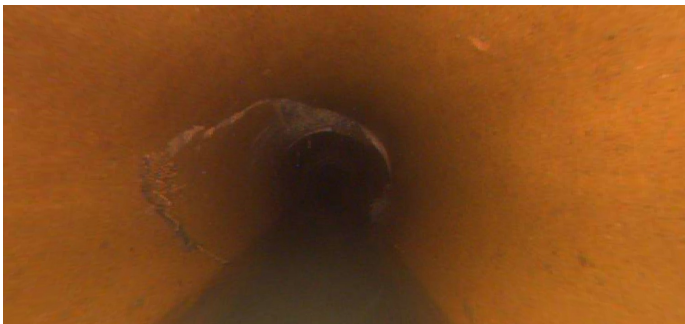
Code: **FC**
Description: **Fracture Circumferential**

Distance (ft): **285.1**
Structural Grade: **2**
O&M Grade: **0**
Clock Start/From: **7**
Clock To: **6**
1st Value:
2nd Value:
Value Percent:
Continuous Index:
Within 8" of Joint: **YES**
Remarks: **ROOTS COMING FROM FRACTURES**

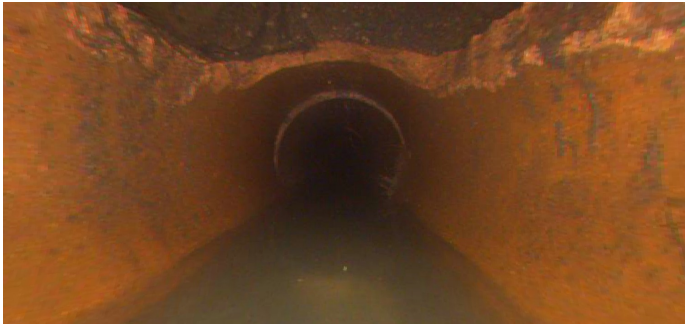
Code: **AMH**
Description: **Manhole**

Distance (ft): **291.3**
Structural Grade: **0**
O&M Grade: **0**
Clock Start/From:
Clock To:
1st Value:
2nd Value:
Value Percent:
Continuous Index:
Within 8" of Joint: **NO**
Remarks: **M-803-019**

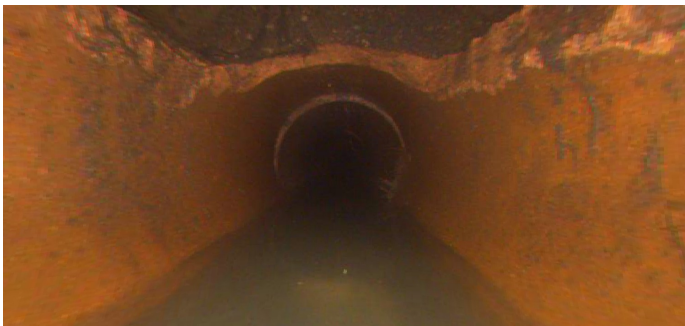
Code: **RFJ**
Description: **Roots Fine Joint**

Distance (ft): **291.3**
Structural Grade: **0**
O&M Grade: **1**
Clock Start/From: **7**
Clock To: **5**
1st Value:
2nd Value:
Value Percent:
Continuous Index: **F01**
Within 8" of Joint: **YES**
Remarks: **WANDER**
