Profile/Photo Observation Report

Date:	03/28/2018	Weather:		Coding:	PACP 6.0
Pipe Length (ft):	163.7	Owner:	NA	Pre Clean:	Not Known
P.O.#:		Surveyor:	Selasie Honu	PSR:	P-803-020-021
Customer:		Clean Date:	01/01/1900	Shape:	C

Street:	E 40TH AVE & N JOLIET ST	Flow Control:	Not Controlled
City:	Hobart, IN	Year Renewed:	
Location:	Other	Tape/Media #:	
Purpose:	Not Known	Dia/Height:	10"
Use:	Sanitary	Material:	VCP
Drain Area:	NA	Lining:	
Category:	NA		
Comment:

Location Details:		Direction of Survey:	Upstream
US MH:	M-803-021	DS MH:	M-803-020
		Total Length Surveyed (ft):	166.0

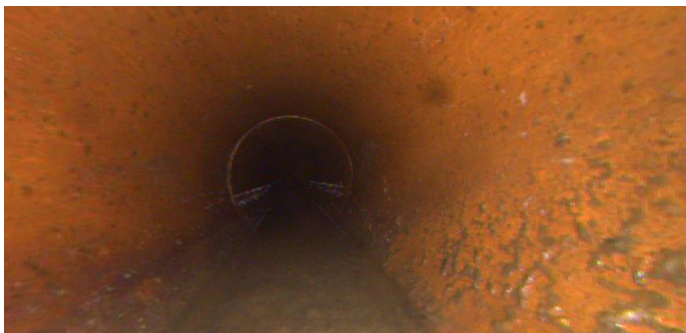
Code: **AMH**
Description: **Manhole**

Distance (ft): **.0**
Structural Grade: **0**
O&M Grade: **0**
Clock Start/From:
Clock To:
1st Value:
2nd Value:
Value Percent:
Continuous Index:
Within 8" of Joint: **NO**
Remarks: **M-803-020**

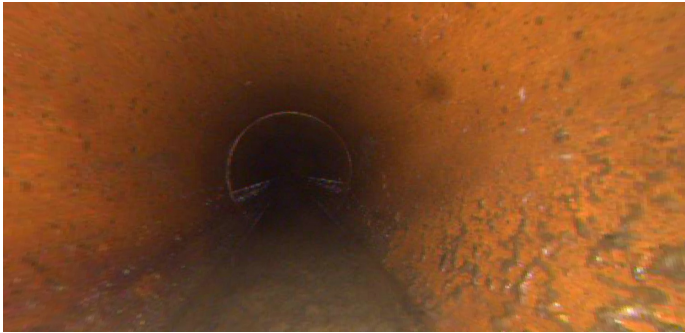
Code:	MWL
Description:	Water Level

Distance (ft):	.0
Structural Grade:	0
O&M Grade:	0
Clock Start/From:	
Clock To:	
1st Value:	
2nd Value:	
Value Percent:	5.000
Continuous Index:	
Within 8" of Joint:	NO
Remarks:

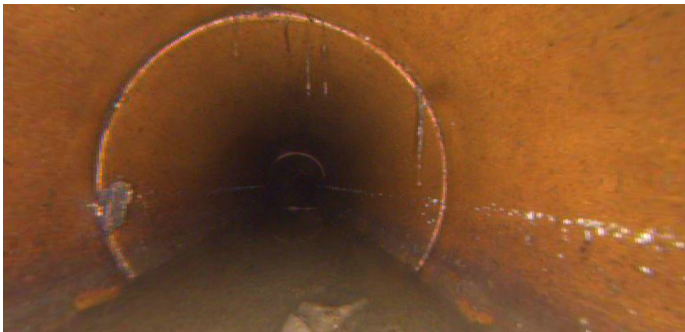
Code:	RFJ
Description:	Roots Fine Joint

Distance (ft):	34.4
Structural Grade:	0
O&M Grade:	1
Clock Start/From:	8
Clock To:	2
1st Value:	
2nd Value:	
Value Percent:	
Continuous Index:	
Within 8" of Joint:	YES
Remarks:

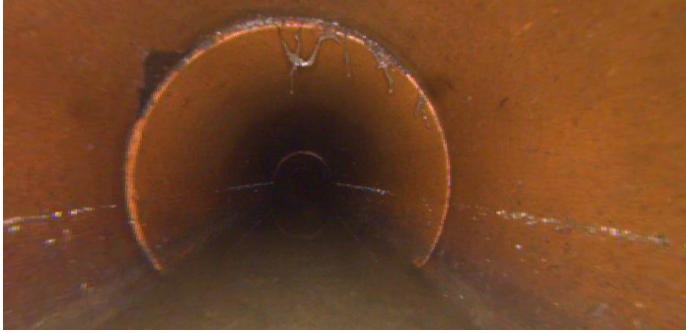
Code: **RFJ**
Description: **Roots Fine Joint**

Distance (ft): **42.0**
Structural Grade: **0**
O&M Grade: **1**
Clock Start/From: **11**
Clock To: **2**
1st Value:
2nd Value:
Value Percent:
Continuous Index:
Within 8" of Joint: **YES**
Remarks:

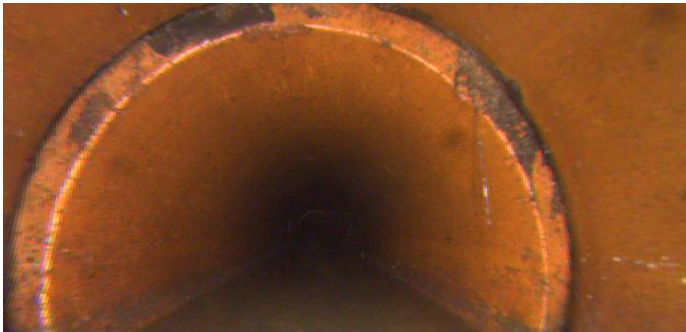
Code: **RFJ**
Description: **Roots Fine Joint**

Distance (ft): **46.3**
Structural Grade: **0**
O&M Grade: **1**
Clock Start/From: **1**
Clock To: **2**
1st Value:
2nd Value:
Value Percent:
Continuous Index:
Within 8" of Joint: **YES**
Remarks:

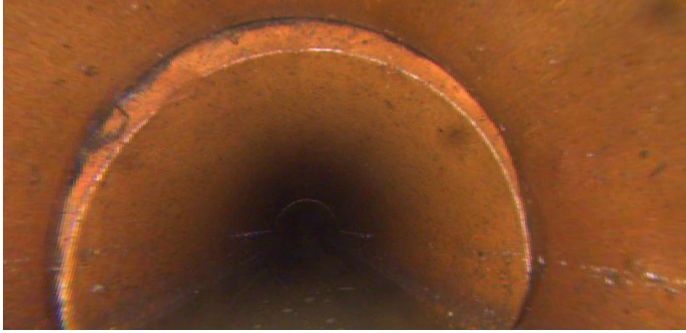
Code: **RFJ**
Description: **Roots Fine Joint**

Distance (ft): **54.2**
Structural Grade: **0**
O&M Grade: **1**
Clock Start/From: **10**
Clock To:
1st Value:
2nd Value:
Value Percent:
Continuous Index:
Within 8" of Joint: **YES**
Remarks:

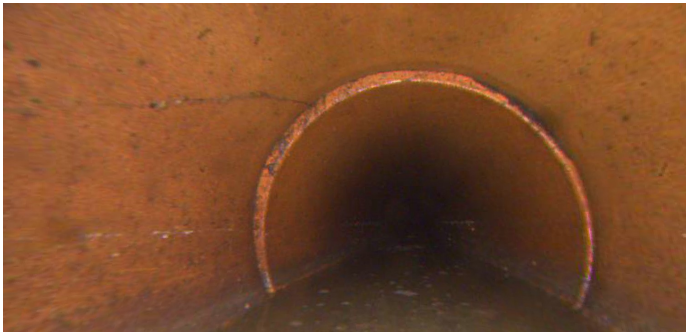
Code: **FS**
Description: **Fracture Spiral**

Distance (ft): **58.0**
Structural Grade: **3**
O&M Grade: **0**
Clock Start/From: **10**
Clock To: **11**
1st Value:
2nd Value:
Value Percent:
Continuous Index:
Within 8" of Joint: **YES**
Remarks:

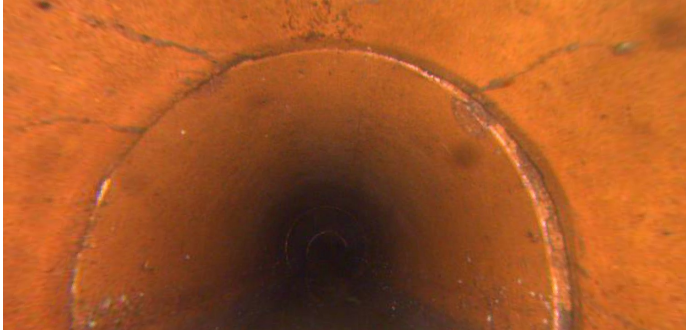
Code: **CM**
Description: **Crack Multiple**

Distance (ft): **69.2**
Structural Grade: **3**
O&M Grade: **0**
Clock Start/From: **11**
Clock To: **1**
1st Value:
2nd Value:
Value Percent:
Continuous Index:
Within 8" of Joint: **YES**
Remarks:

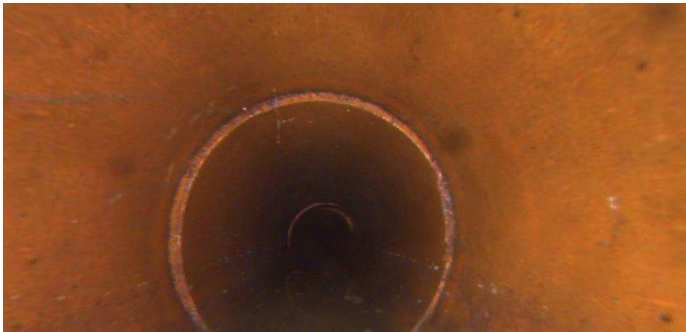
Code: **RFJ**
Description: **Roots Fine Joint**

Distance (ft): **71.8**
Structural Grade: **0**
O&M Grade: **1**
Clock Start/From: **12**
Clock To: **3**
1st Value:
2nd Value:
Value Percent:
Continuous Index:
Within 8" of Joint: **YES**
Remarks:

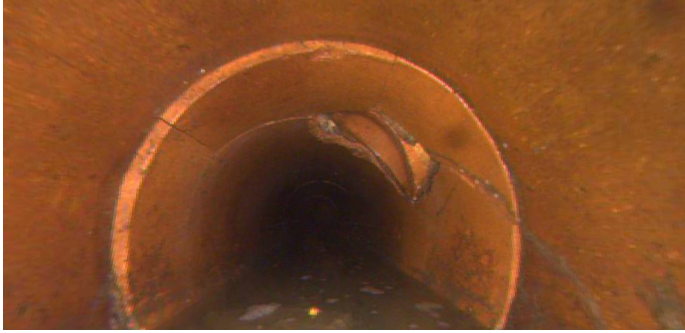
Code: **FM**
Description: **Fracture Multiple**

Distance (ft): **75.0**
Structural Grade: **4**
O&M Grade: **0**
Clock Start/From: **10**
Clock To: **4**
1st Value:
2nd Value:
Value Percent:
Continuous Index:
Within 8" of Joint: **YES**
Remarks:

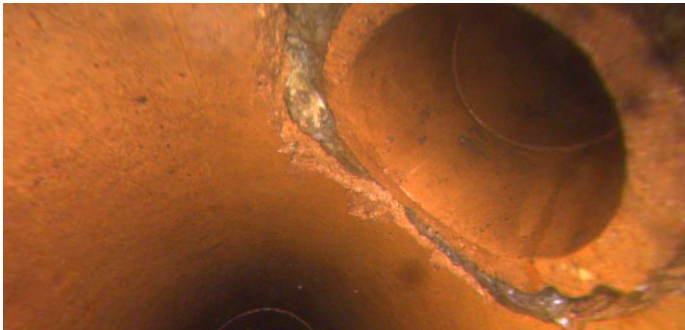
Code: **TBI**
Description: **Tap Break-in Intruding**

Distance (ft): **76.1**
Structural Grade: **0**
O&M Grade: **2**
Clock Start/From: **1**
Clock To:
1st Value: **4.000**
2nd Value: **1.000**
Value Percent:
Continuous Index:
Within 8" of Joint:
Remarks:

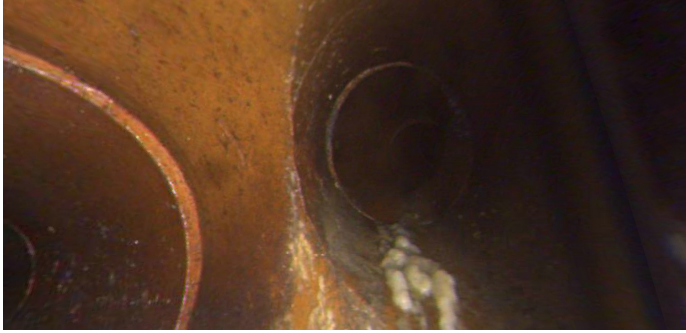
Code: **TF**
Description: **Tap Factory**

Distance (ft): **88.9**
Structural Grade: **0**
O&M Grade: **0**
Clock Start/From: **3**
Clock To:
1st Value: **4.000**
2nd Value:
Value Percent:
Continuous Index:
Within 8" of Joint:
Remarks:

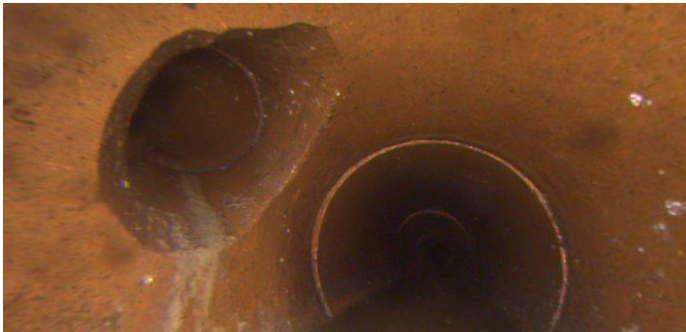
Code: **TF**
Description: **Tap Factory**

Distance (ft): **90.4**
Structural Grade: **0**
O&M Grade: **0**
Clock Start/From: **10**
Clock To:
1st Value: **4.000**
2nd Value:
Value Percent:
Continuous Index:
Within 8" of Joint:
Remarks:

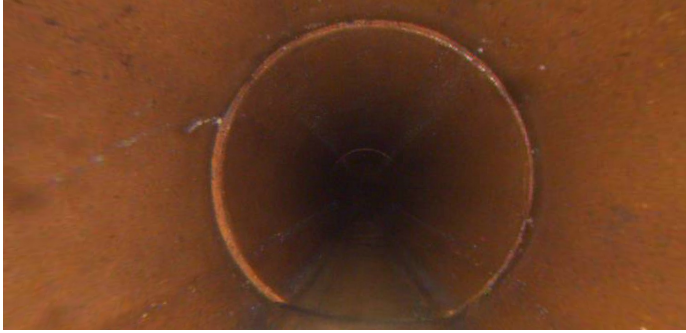
Code: **CL**
Description: **Crack Longitudinal**

Distance (ft): **129.6**
Structural Grade: **2**
O&M Grade: **0**
Clock Start/From: **9**
Clock To:
1st Value:
2nd Value:
Value Percent:
Continuous Index:
Within 8" of Joint: **YES**
Remarks:

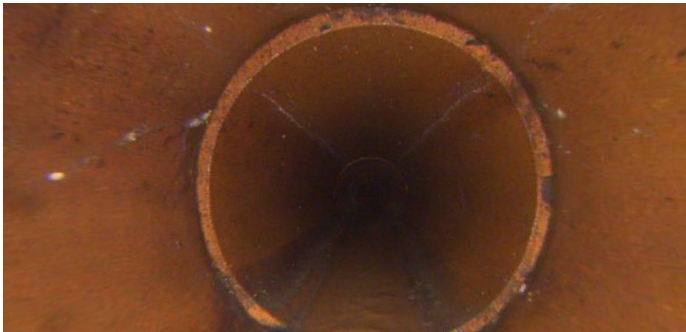
Code: **CS**
Description: **Crack Spiral**

Distance (ft): **135.7**
Structural Grade: **2**
O&M Grade: **0**
Clock Start/From: **9**
Clock To: **10**
1st Value:
2nd Value:
Value Percent:
Continuous Index:
Within 8" of Joint: **YES**
Remarks:

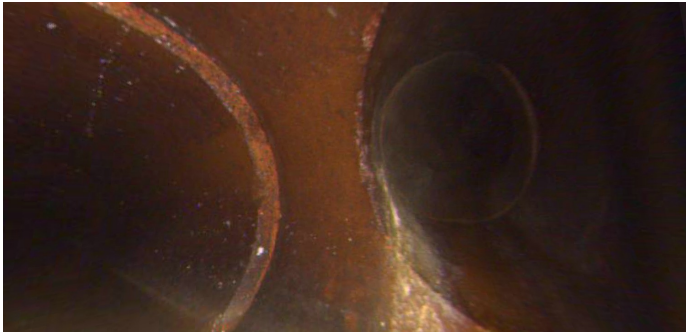
Code: **TF**
Description: **Tap Factory**

Distance (ft): **144.7**
Structural Grade: **0**
O&M Grade: **0**
Clock Start/From: **3**
Clock To:
1st Value: **4.000**
2nd Value:
Value Percent:
Continuous Index:
Within 8" of Joint:
Remarks:

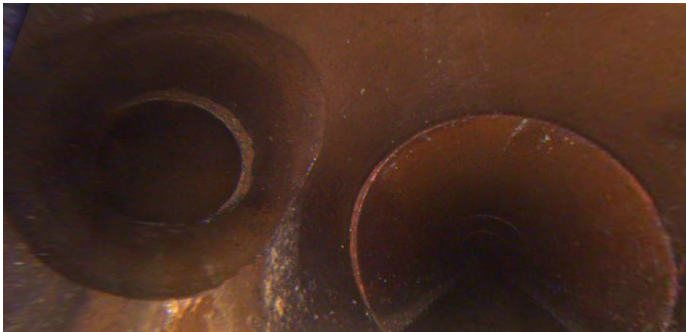
Code: **TF**
Description: **Tap Factory**

Distance (ft): **147.4**
Structural Grade: **0**
O&M Grade: **0**
Clock Start/From: **9**
Clock To:
1st Value: **4.000**
2nd Value:
Value Percent:
Continuous Index:
Within 8" of Joint:
Remarks:

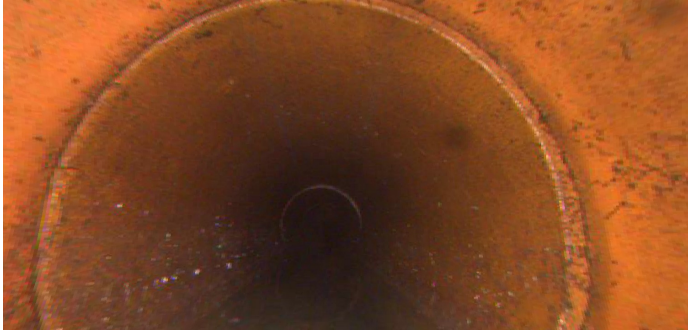
Code:	MSA
Description:	Abandoned Survey
Distance (ft):	166.0
Structural Grade:	0
O&M Grade:	0
Clock Start/From:	
Clock To:	
1st Value:	
2nd Value:	
Value Percent:	
Continuous Index:	
Within 8" of Joint:	NO
Remarks:	unknown
