Profile/Photo Observation Report

Street:	E 40TH AV	Flow Control:	Not Controlled
City:	Hobart, IN	Year Renewed:	
Location:	Other	Tape/Media #:	
Purpose:	Not Known	Dia/Height:	10"
Use:	Sanitary	Material:	VCP
Drain Area:	NA	Lining:	
Category:	NA		
Comment:

Location Details:		Direction of Survey:	Upstream
US MH:	M-803-021	DS MH:	M-803-020
		Total Length Surveyed (ft):	166.0

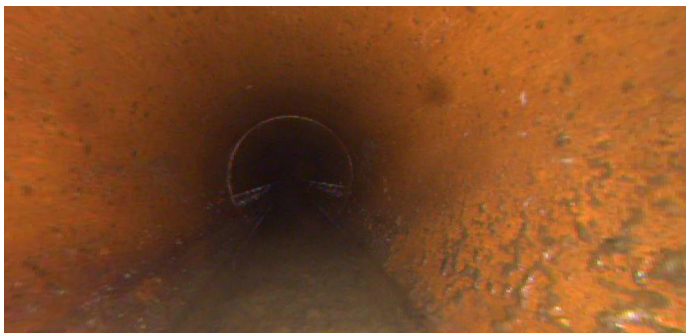
Code: **AMH**
Description: **Manhole**

Distance (ft): **.0**
Structural Grade: **0**
O&M Grade: **0**
Clock Start/From:
Clock To:
1st Value:
2nd Value:
Value Percent:
Continuous Index:
Within 8" of Joint: **NO**
Remarks: **M-803-020**

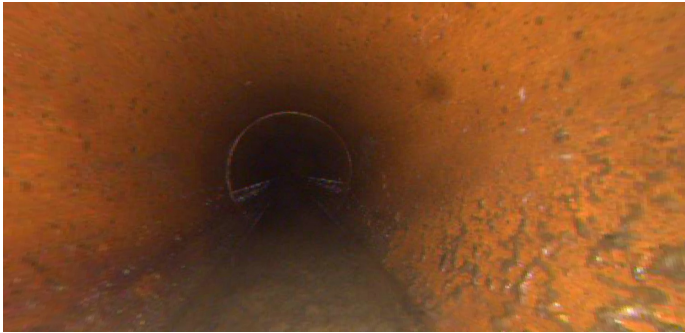
Code:	MWL
Description:	Water Level

Distance (ft):	.0
Structural Grade:	0
O&M Grade:	0
Clock Start/From:	
Clock To:	
1st Value:	
2nd Value:	
Value Percent:	5.000
Continuous Index:	
Within 8" of Joint:	NO
Remarks:

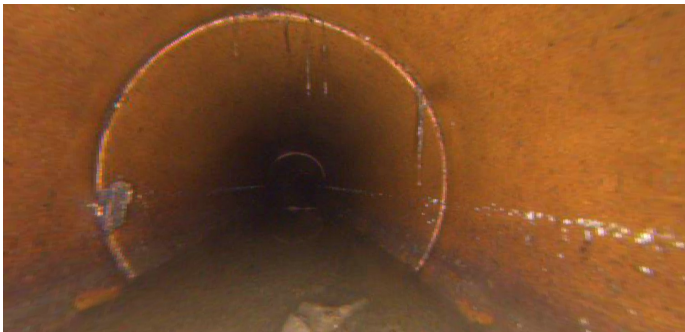
Code:	RFJ
Description:	Roots Fine Joint

Distance (ft):	34.4
Structural Grade:	0
O&M Grade:	1
Clock Start/From:	8
Clock To:	2
1st Value:	
2nd Value:	
Value Percent:	
Continuous Index:	
Within 8" of Joint:	YES
Remarks:

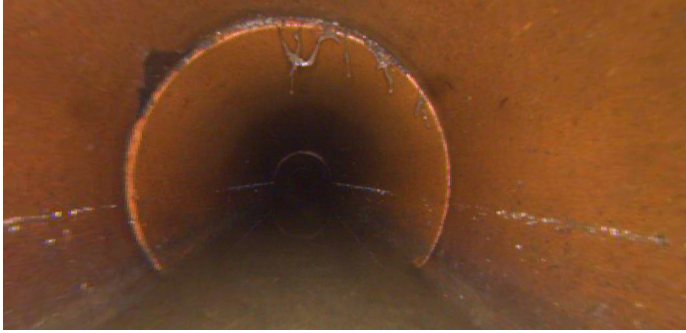
Code: **RFJ**
Description: **Roots Fine Joint**

Distance (ft): **42.0**
Structural Grade: **0**
O&M Grade: **1**
Clock Start/From: **11**
Clock To: **2**
1st Value:
2nd Value:
Value Percent:
Continuous Index:
Within 8" of Joint: **YES**
Remarks:

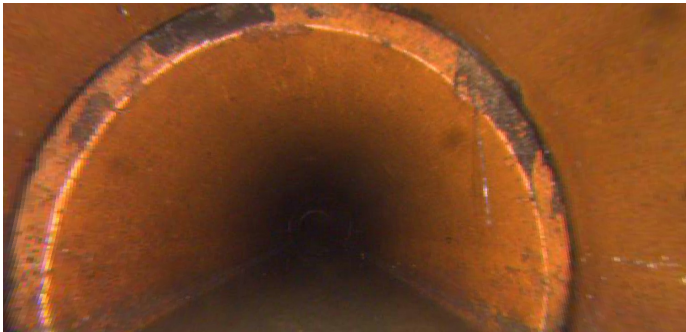
Code: **RFJ**
Description: **Roots Fine Joint**

Distance (ft): **46.3**
Structural Grade: **0**
O&M Grade: **1**
Clock Start/From: **1**
Clock To: **2**
1st Value:
2nd Value:
Value Percent:
Continuous Index:
Within 8" of Joint: **YES**
Remarks:

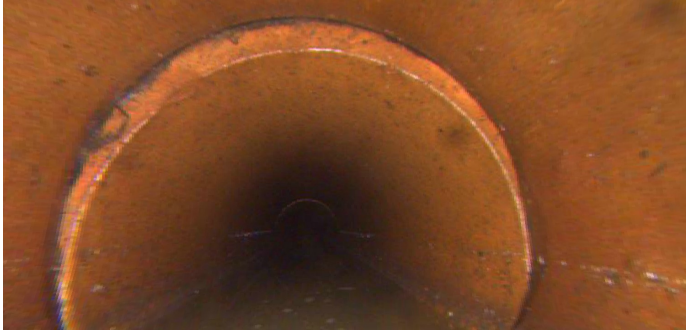
Code: **RFJ**
Description: **Roots Fine Joint**

Distance (ft): **54.2**
Structural Grade: **0**
O&M Grade: **1**
Clock Start/From: **10**
Clock To:
1st Value:
2nd Value:
Value Percent:
Continuous Index:
Within 8" of Joint: **YES**
Remarks:

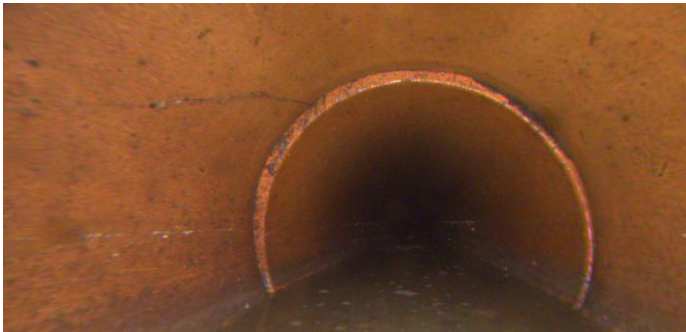
Code: **FS**
Description: **Fracture Spiral**

Distance (ft): **58.0**
Structural Grade: **3**
O&M Grade: **0**
Clock Start/From: **10**
Clock To: **11**
1st Value:
2nd Value:
Value Percent:
Continuous Index:
Within 8" of Joint: **YES**
Remarks:

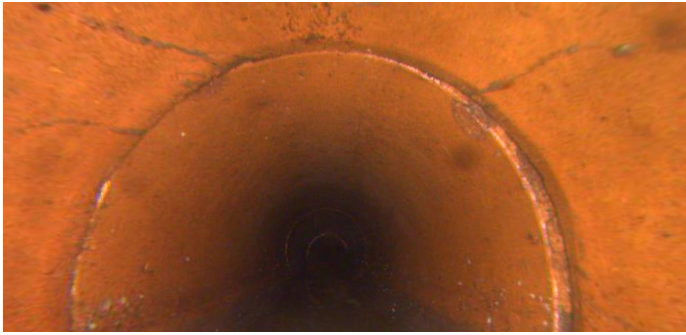
Code: **CM**
Description: **Crack Multiple**

Distance (ft): **69.2**
Structural Grade: **3**
O&M Grade: **0**
Clock Start/From: **11**
Clock To: **1**
1st Value:
2nd Value:
Value Percent:
Continuous Index:
Within 8" of Joint: **YES**
Remarks:

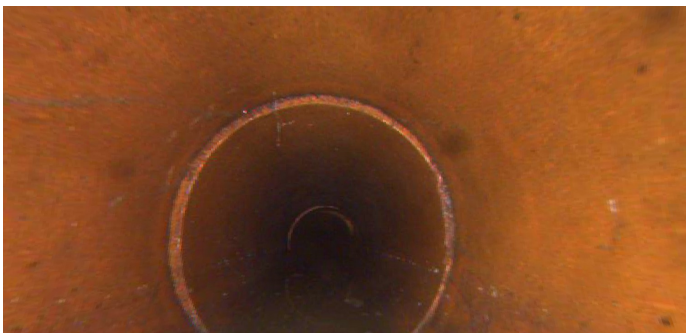
Code: **RFJ**
Description: **Roots Fine Joint**

Distance (ft): **71.8**
Structural Grade: **0**
O&M Grade: **1**
Clock Start/From: **12**
Clock To: **3**
1st Value:
2nd Value:
Value Percent:
Continuous Index:
Within 8" of Joint: **YES**
Remarks:

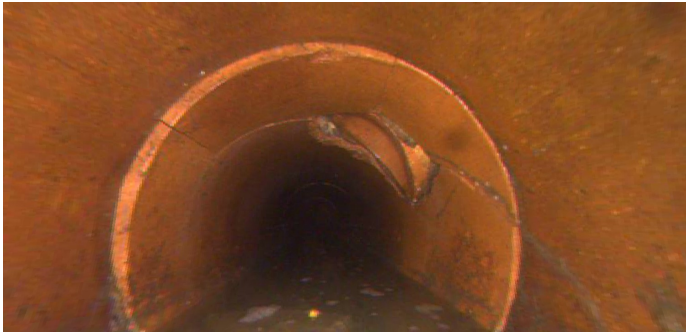
Code: **FM**
Description: **Fracture Multiple**

Distance (ft): **75.0**
Structural Grade: **4**
O&M Grade: **0**
Clock Start/From: **10**
Clock To: **4**
1st Value:
2nd Value:
Value Percent:
Continuous Index:
Within 8" of Joint: **YES**
Remarks:

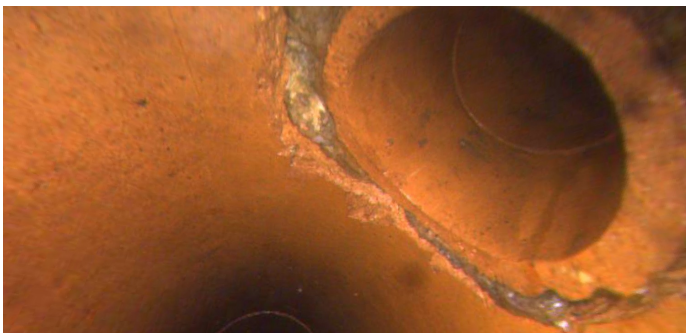
Code: **TBI**
Description: **Tap Break-in Intruding**

Distance (ft): **76.1**
Structural Grade: **0**
O&M Grade: **2**
Clock Start/From: **1**
Clock To:
1st Value: **4.000**
2nd Value: **1.000**
Value Percent:
Continuous Index:
Within 8" of Joint:
Remarks:

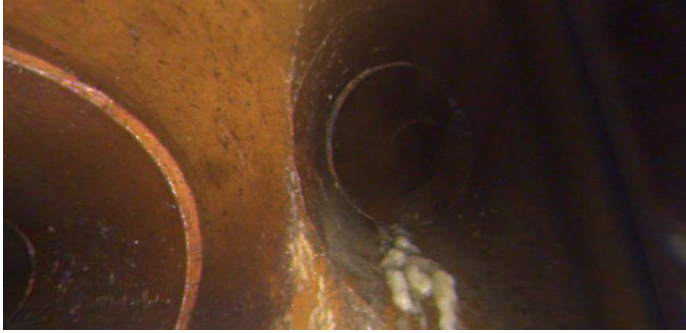
Code: **TF**
Description: **Tap Factory**

Distance (ft): **88.9**
Structural Grade: **0**
O&M Grade: **0**
Clock Start/From: **3**
Clock To:
1st Value: **4.000**
2nd Value:
Value Percent:
Continuous Index:
Within 8" of Joint:
Remarks:

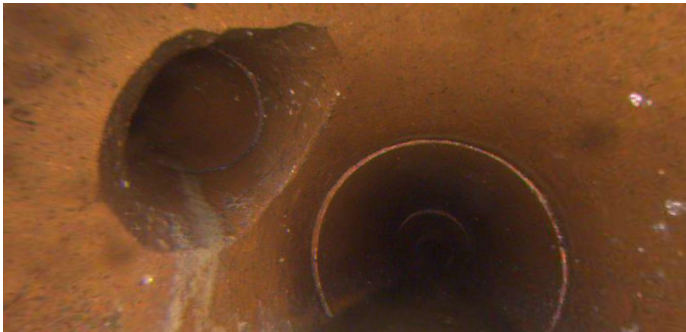
Code: **TF**
Description: **Tap Factory**

Distance (ft): **90.4**
Structural Grade: **0**
O&M Grade: **0**
Clock Start/From: **10**
Clock To:
1st Value: **4.000**
2nd Value:
Value Percent:
Continuous Index:
Within 8" of Joint:
Remarks:

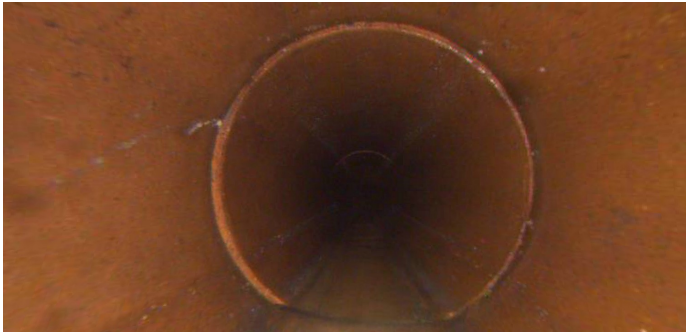
Code: **CL**
Description: **Crack Longitudinal**

Distance (ft): **129.6**
Structural Grade: **2**
O&M Grade: **0**
Clock Start/From: **9**
Clock To:
1st Value:
2nd Value:
Value Percent:
Continuous Index:
Within 8" of Joint: **YES**
Remarks:

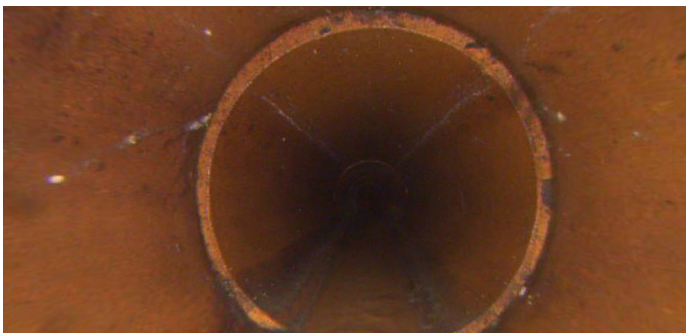
Code: **CS**
Description: **Crack Spiral**

Distance (ft): **135.7**
Structural Grade: **2**
O&M Grade: **0**
Clock Start/From: **9**
Clock To: **10**
1st Value:
2nd Value:
Value Percent:
Continuous Index:
Within 8" of Joint: **YES**
Remarks:

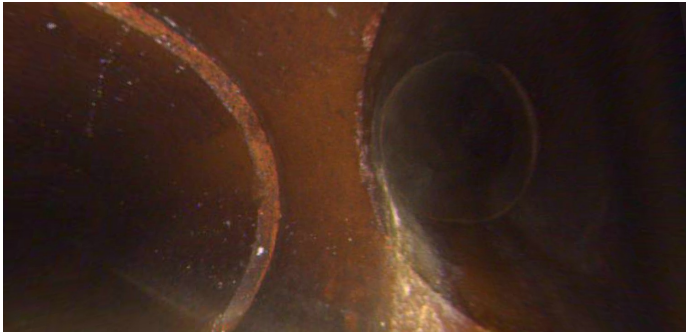
Code: **TF**
Description: **Tap Factory**

Distance (ft): **144.7**
Structural Grade: **0**
O&M Grade: **0**
Clock Start/From: **3**
Clock To:
1st Value: **4.000**
2nd Value:
Value Percent:
Continuous Index:
Within 8" of Joint:
Remarks:

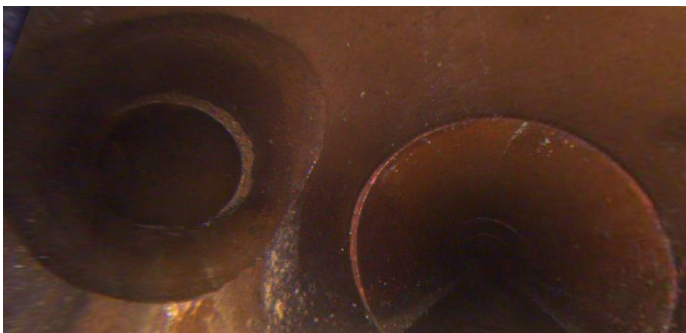
Code: **TF**
Description: **Tap Factory**

Distance (ft): **147.4**
Structural Grade: **0**
O&M Grade: **0**
Clock Start/From: **9**
Clock To:
1st Value: **4.000**
2nd Value:
Value Percent:
Continuous Index:
Within 8" of Joint:
Remarks:

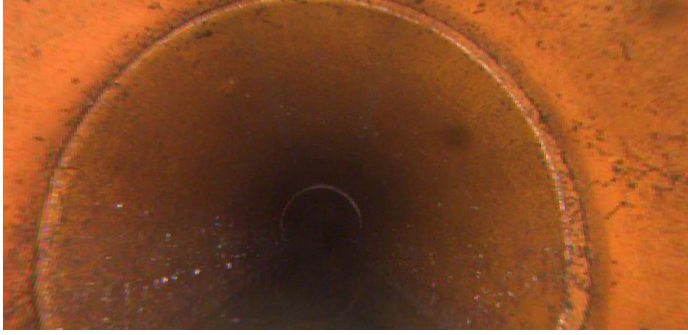
Code:	MSA
Description:	Abandoned Survey
Distance (ft):	166.0
Structural Grade:	0
O&M Grade:	0
Clock Start/From:	
Clock To:	
1st Value:	
2nd Value:	
Value Percent:	
Continuous Index:	
Within 8" of Joint:	NO
Remarks:	unknown
