Profile/Photo Observation Report

| Street: | 40th. Ave. | Flow Control: | Not Controlled |
| City: | Hobart, IN | Year Renewed: | |

| US MH: | M-803-021 | DS MH: | M-803-020 |

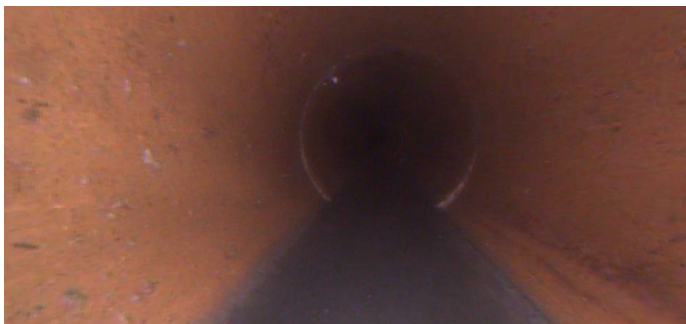
Code: **AMH**
Description: **Manhole**

Distance (ft): **.0**
Structural Grade: **0**
O&M Grade: **0**
Clock Start/From:
Clock To:
1st Value:
2nd Value:
Value Percent:
Continuous Index:
Within 8" of Joint: **NO**
Remarks: **M-803-020**

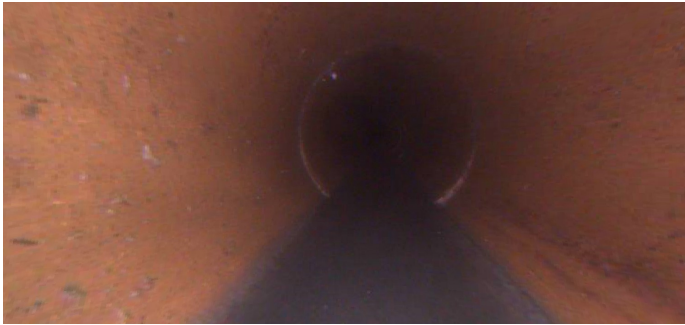
| Code: | MWL |
| Description: | Water Level |

| Value Percent: | 5.000 |

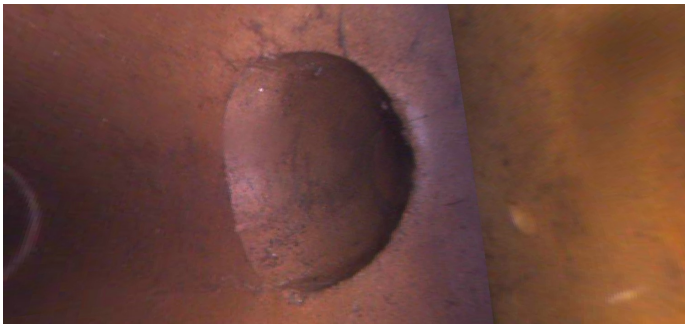
| Code: | TF |
| Description: | Tap Factory |

| Distance (ft): | 6.9 |

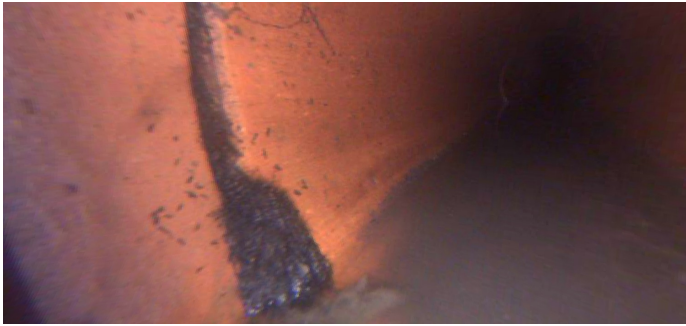
| | Position | Code | Observation | Video (sec) | Grade |
|--|---|---|---|---|---|
| | 37.7 | RFJ | Roots Fine Joint | 121 | M 1 |

Code: **RFJ**
Description: **Roots Fine Joint**

Distance (ft): **37.7**
Structural Grade: **0**
O&M Grade: **1**
Clock Start/From: **7**
Clock To: **9**
1st Value:
2nd Value:
Value Percent:
Continuous Index:
Within 8" of Joint: **YES**
Remarks:

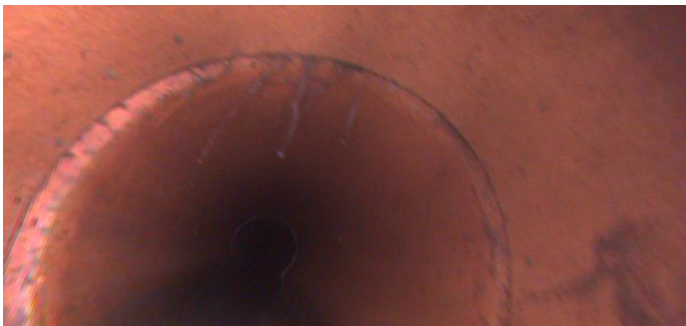
| | Position | Code | Observation | Video (sec) | Grade |
|--|---|---|---|---|---|
| | 41.4 | RFJ | Roots Fine Joint | 140 | M 1 |

Code: **RFJ**
Description: **Roots Fine Joint**

Distance (ft): **41.4**
Structural Grade: **0**
O&M Grade: **1**
Clock Start/From: **10**
Clock To: **12**
1st Value:
2nd Value:
Value Percent:
Continuous Index:
Within 8" of Joint: **YES**
Remarks:

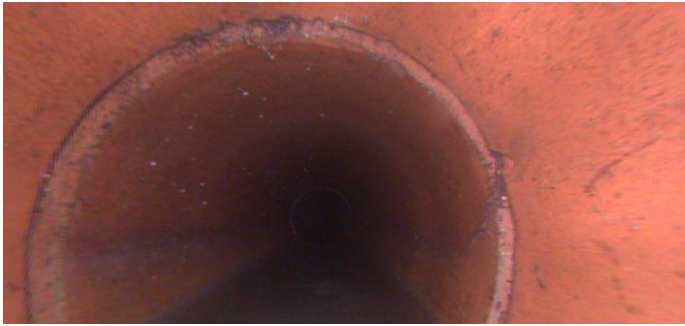
| | Position | Code | Observation | Video (sec) | Grade |
|--|---|---|---|---|---|
| | 45.2 | RFJ | Roots Fine Joint | 160 | M 1 |

Code: **RFJ**
Description: **Roots Fine Joint**

Distance (ft): **45.2**
Structural Grade: **0**
O&M Grade: **1**
Clock Start/From: **11**
Clock To: **3**
1st Value:
2nd Value:
Value Percent:
Continuous Index:
Within 8" of Joint: **YES**
Remarks:

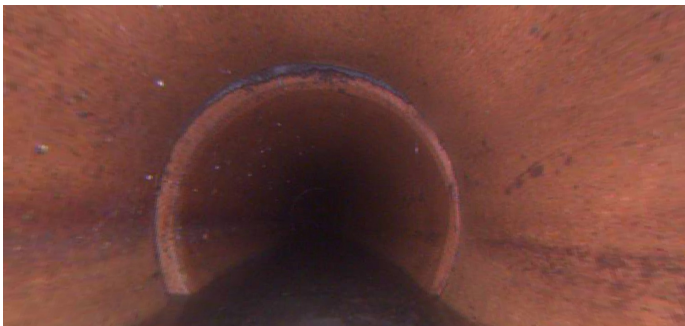
| | Position | Code | Observation | Video (sec) | Grade |
|--|---|---|---|---|---|
| | 49.0 | RFJ | Roots Fine Joint | 179 | M 1 |

Code: **RFJ**
Description: **Roots Fine Joint**

Distance (ft): **49.0**
Structural Grade: **0**
O&M Grade: **1**
Clock Start/From: **11**
Clock To: **1**
1st Value:
2nd Value:
Value Percent:
Continuous Index:
Within 8" of Joint: **YES**
Remarks:

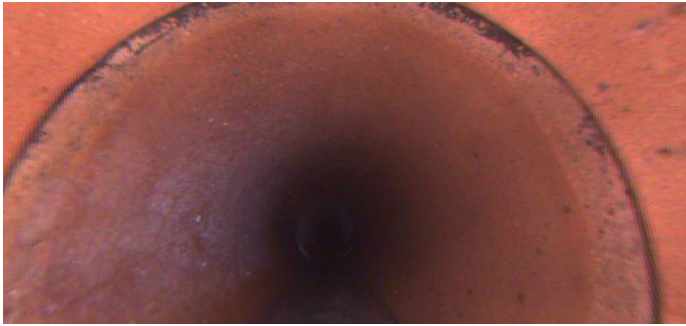
| | Position | Code | Observation | Video (sec) | Grade |
|--|---|---|---|---|---|
| | 65.6 | DAGS(S01) | Deposits Attached Grease | 224 | M 2 |

Code: **DAGS**
Description: **Deposits Attached Grease**

Distance (ft): **65.6**
Structural Grade: **0**
O&M Grade: **2**
Clock Start/From: **7**
Clock To: **5**
1st Value:
2nd Value:
Value Percent: **5.000**
Continuous Index: **S01**
Within 8" of Joint: **YES**
Remarks: **WANDER**

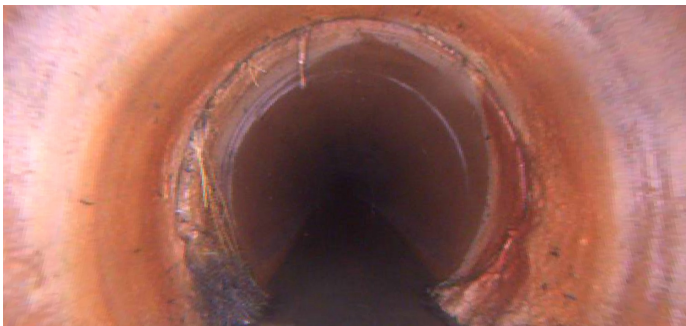
| | Position | Code | Observation | Video (sec) | Grade |
|--|---|---|---|---|---|
| | 146.5 | RFJ | Roots Fine Joint | 397 | M 1 |

Code: **RFJ**
Description: **Roots Fine Joint**

Distance (ft): **146.5**
Structural Grade: **0**
O&M Grade: **1**
Clock Start/From: **7**
Clock To: **5**
1st Value:
2nd Value:
Value Percent:
Continuous Index:
Within 8" of Joint: **YES**
Remarks:

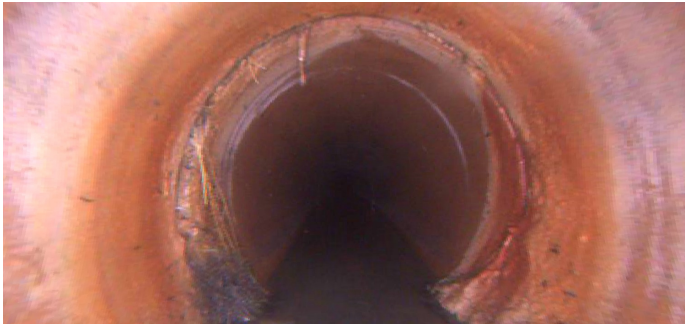
| | Position | Code | Observation | Video (sec) | Grade |
|--|---|---|---|---|---|
| | 146.5 | IS | Infil Stain | 408 | NA |

Code: **IS**
Description: **Infil Stain**

Distance (ft): **146.5**
Structural Grade: **0**
O&M Grade: **0**
Clock Start/From: **7**
Clock To: **5**
1st Value:
2nd Value:
Value Percent:
Continuous Index:
Within 8" of Joint: **YES**
Remarks:

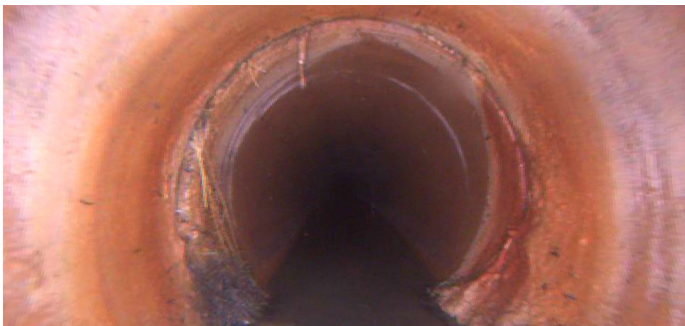
| | Position | Code | Observation | Video (sec) | Grade |
|--|---|---|---|---|---|
| | 146.5 | DAE | Deposits Attached Encrustation | 419 | M 2 |

Code: **DAE**
Description: **Deposits Attached Encrustation**

Distance (ft): **146.5**
Structural Grade: **0**
O&M Grade: **2**
Clock Start/From: **3**
Clock To: **5**
1st Value:
2nd Value:
Value Percent: **5.000**
Continuous Index:
Within 8" of Joint: **YES**
Remarks:

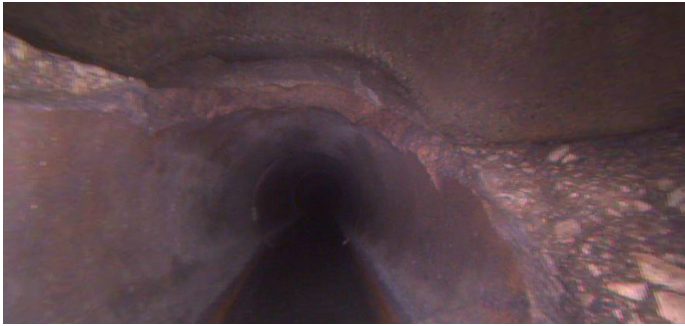
Code: **AMH**
Description: **Manhole**

Distance (ft): **156.1**
Structural Grade: **0**
O&M Grade: **0**
Clock Start/From:
Clock To:
1st Value:
2nd Value:
Value Percent:
Continuous Index:
Within 8" of Joint: **NO**
Remarks: **M-803-021**

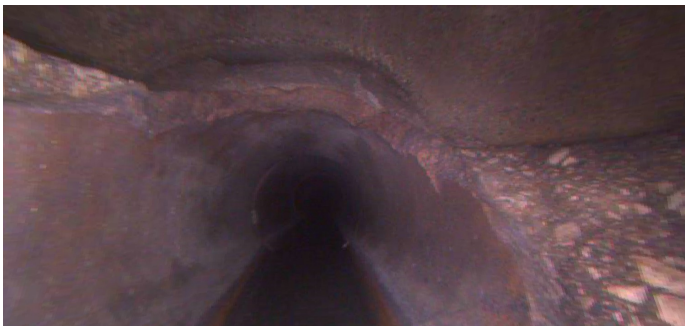
| | Position | Code | Observation | Video (sec) | Grade |
|--|---|---|---|---|---|
| | 156.1 | DAGS(F01) | Deposits Attached Grease | 461 | M 2 |

Code: **DAGS**
Description: **Deposits Attached Grease**

Distance (ft): **156.1**
Structural Grade: **0**
O&M Grade: **2**
Clock Start/From: **7**
Clock To: **5**
1st Value:
2nd Value:
Value Percent: **5.000**
Continuous Index: **F01**
Within 8" of Joint: **YES**
Remarks: **WANDER**
