## Profile/Photo Observation Report

Street:	<b>E 40TH AVE &amp; N JOLIET ST</b>	Flow Control:	<b>Not Controlled</b>
City:	<b>Hobart, IN</b>	Year Renewed:	
Location:	<b>Other</b>	Tape/Media #:	
Purpose:	<b>Not Known</b>	Dia/Height:	<b>10"</b>
Use:	<b>Sanitary</b>	Material:	<b>VCP</b>
Drain Area:	<b>NA</b>	Lining:	
Category:	<b>NA</b>		
Comment:

Location Details:		Direction of Survey:	<b>Upstream</b>
US MH:	<b>M-803-021</b>	DS MH:	<b>M-803-023</b>
		Total Length Surveyed (ft):	<b>155.6</b>

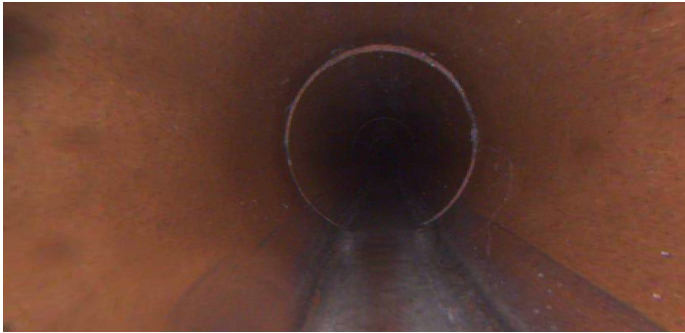
Code:	<b>MWL</b>
Description:	<b>Water Level</b>

Distance (ft):	<b>.0</b>
Structural Grade:	<b>0</b>
O&M Grade:	<b>0</b>
Clock Start/From:	
Clock To:	
1st Value:	
2nd Value:	
Value Percent:	<b>5.000</b>
Continuous Index:	
Within 8" of Joint:	<b>NO</b>
Remarks:

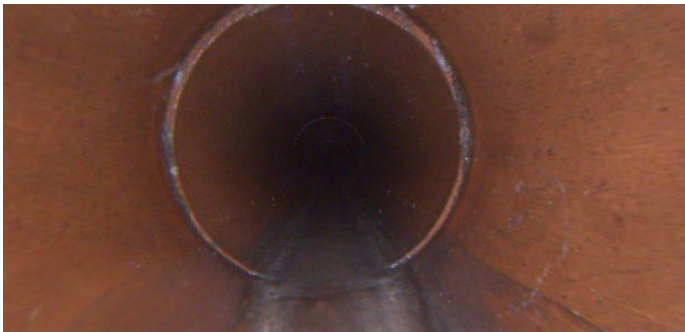
Code:	<b>FS</b>
Description:	<b>Fracture Spiral</b>

Distance (ft):	<b>.9</b>
Structural Grade:	<b>3</b>
O&M Grade:	<b>0</b>
Clock Start/From:	<b>3</b>
Clock To:	<b>5</b>
1st Value:	
2nd Value:	
Value Percent:	
Continuous Index:	
Within 8" of Joint:	<b>YES</b>
Remarks:

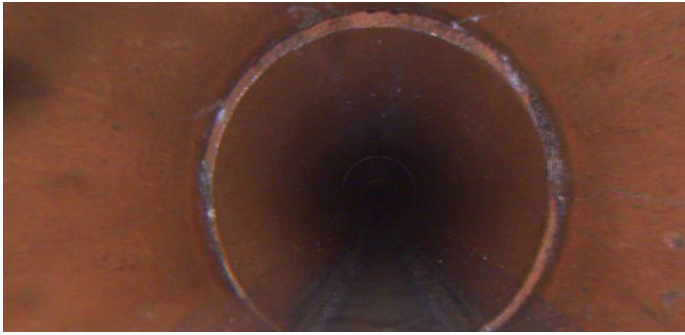
Code: **RFJ**  
Description: **Roots Fine Joint**

Distance (ft): **1.5**  
Structural Grade: **0**  
O&M Grade: **1**  
Clock Start/From: **9**  
Clock To: **3**  
1st Value:  
2nd Value:  
Value Percent:  
Continuous Index:  
Within 8" of Joint: **YES**  
Remarks:

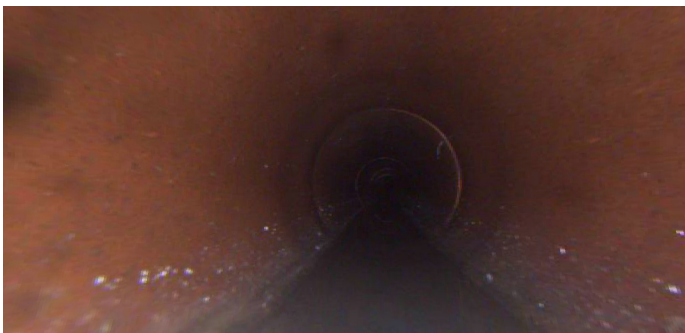
Code: **RFJ**  
Description: **Roots Fine Joint**

Distance (ft): **15.2**  
Structural Grade: **0**  
O&M Grade: **1**  
Clock Start/From: **2**  
Clock To:  
1st Value:  
2nd Value:  
Value Percent:  
Continuous Index:  
Within 8" of Joint: **YES**  
Remarks:

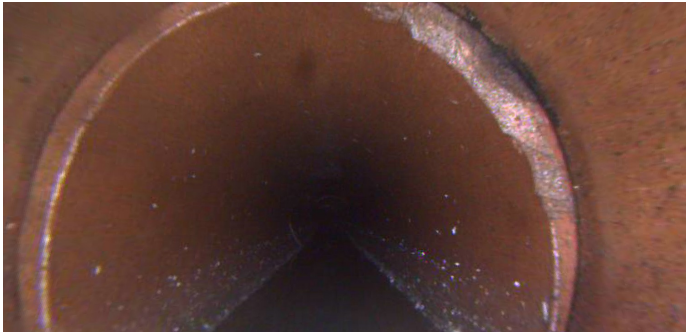
Code: **SSS**  
Description: **Surface Spalling**

Distance (ft): **58.1**  
Structural Grade: **2**  
O&M Grade: **0**  
Clock Start/From: **12**  
Clock To: **3**  
1st Value:  
2nd Value:  
Value Percent:  
Continuous Index:  
Within 8" of Joint: **YES**  
Remarks:

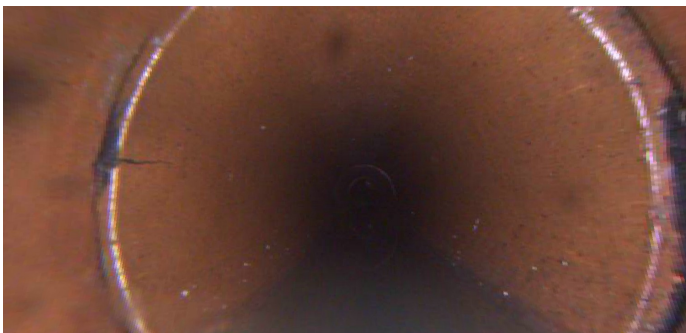
Code: **RFJ**  
Description: **Roots Fine Joint**

Distance (ft): **104.0**  
Structural Grade: **0**  
O&M Grade: **1**  
Clock Start/From: **9**  
Clock To:  
1st Value:  
2nd Value:  
Value Percent:  
Continuous Index:  
Within 8" of Joint: **YES**  
Remarks:

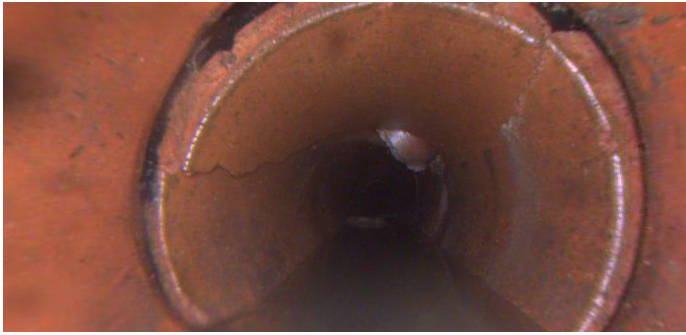
Code: **FM**  
Description: **Fracture Multiple**

Distance (ft): **112.0**  
Structural Grade: **4**  
O&M Grade: **0**  
Clock Start/From: **9**  
Clock To: **3**  
1st Value:  
2nd Value:  
Value Percent:  
Continuous Index:  
Within 8" of Joint: **YES**  
Remarks:

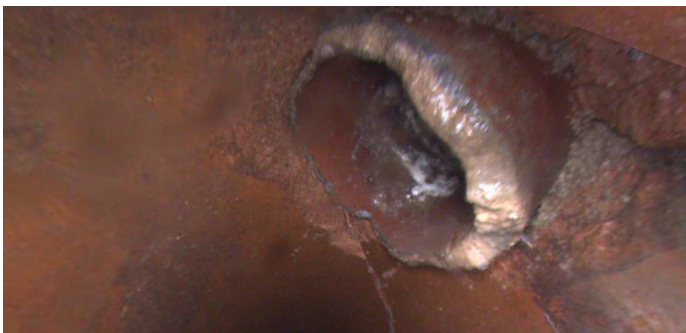
Code: **TBI**  
Description: **Tap Break-in Intruding**

Distance (ft): **113.6**  
Structural Grade: **0**  
O&M Grade: **2**  
Clock Start/From: **1**  
Clock To:  
1st Value: **4.000**  
2nd Value: **2.000**  
Value Percent:  
Continuous Index:  
Within 8" of Joint:  
Remarks:

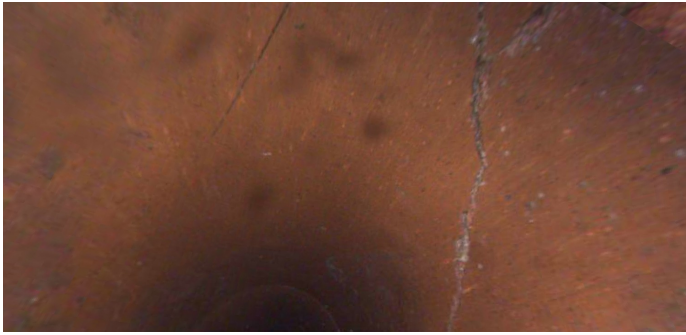
Code: **FM**  
Description: **Fracture Multiple**

Distance (ft): **114.4**  
Structural Grade: **4**  
O&M Grade: **0**  
Clock Start/From: **12**  
Clock To: **5**  
1st Value:  
2nd Value:  
Value Percent:  
Continuous Index:  
Within 8" of Joint:  
Remarks:

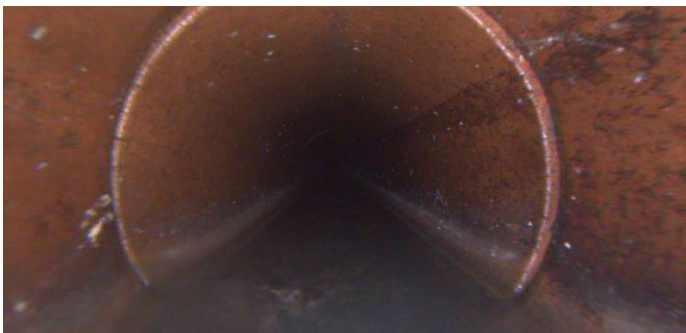
Code: **CM**  
Description: **Crack Multiple**

Distance (ft): **124.0**  
Structural Grade: **3**  
O&M Grade: **0**  
Clock Start/From: **8**  
Clock To: **4**  
1st Value:  
2nd Value:  
Value Percent:  
Continuous Index:  
Within 8" of Joint: **YES**  
Remarks:

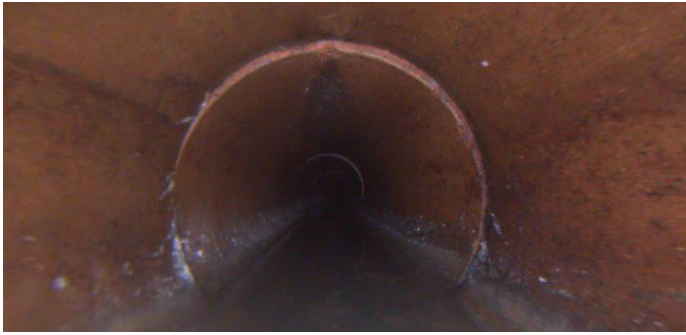
Code: **RFJ**  
Description: **Roots Fine Joint**

Distance (ft): **136.6**  
Structural Grade: **0**  
O&M Grade: **1**  
Clock Start/From: **8**  
Clock To: **4**  
1st Value:  
2nd Value:  
Value Percent:  
Continuous Index:  
Within 8" of Joint: **YES**  
Remarks:

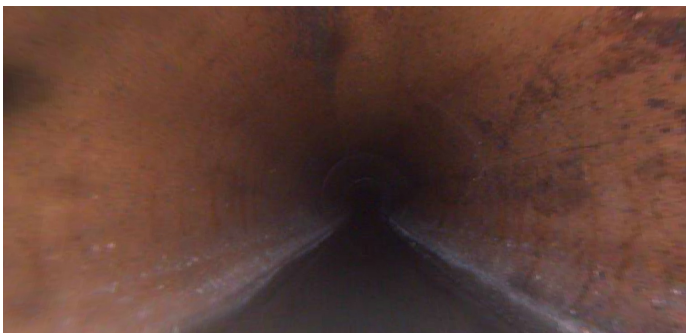
Code: **FL**  
Description: **Fracture Longitudinal**

Distance (ft): **146.3**  
Structural Grade: **3**  
O&M Grade: **0**  
Clock Start/From: **3**  
Clock To:  
1st Value:  
2nd Value:  
Value Percent:  
Continuous Index:  
Within 8" of Joint:  
Remarks:
