## Profile/Photo Observation Report

Street:	<b>E 40TH AV</b>	Flow Control:	<b>Not Controlled</b>
City:	<b>Hobart, IN</b>	Year Renewed:	
Location:	<b>Other</b>	Tape/Media #:	
Purpose:	<b>Not Known</b>	Dia/Height:	<b>10"</b>
Use:	<b>Sanitary</b>	Material:	<b>VCP</b>
Drain Area:	<b>NA</b>	Lining:	
Category:	<b>NA</b>		
Comment:

Location Details:		Direction of Survey:	<b>Upstream</b>
US MH:	<b>M-803-021</b>	DS MH:	<b>M-803-023</b>
		Total Length Surveyed (ft):	<b>155.6</b>

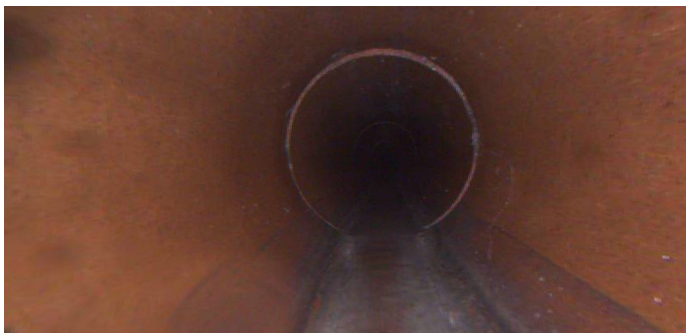
Code: **AMH**  
Description: **Manhole**

Distance (ft): **.0**  
Structural Grade: **0**  
O&M Grade: **0**  
Clock Start/From:  
Clock To:  
1st Value:  
2nd Value:  
Value Percent:  
Continuous Index:  
Within 8" of Joint: **NO**  
Remarks: **M-803-023**

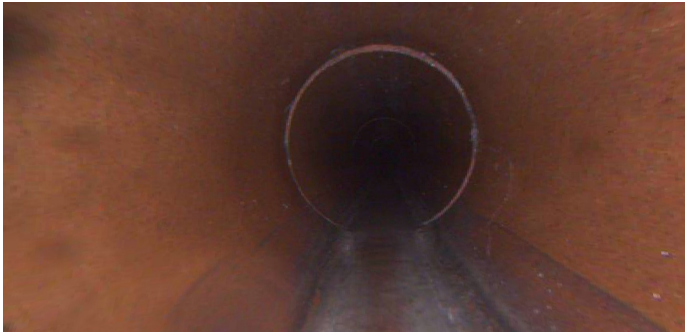
Code:	<b>MWL</b>
Description:	<b>Water Level</b>

Distance (ft):	<b>.0</b>
Structural Grade:	<b>0</b>
O&M Grade:	<b>0</b>
Clock Start/From:	
Clock To:	
1st Value:	
2nd Value:	
Value Percent:	<b>5.000</b>
Continuous Index:	
Within 8" of Joint:	<b>NO</b>
Remarks:

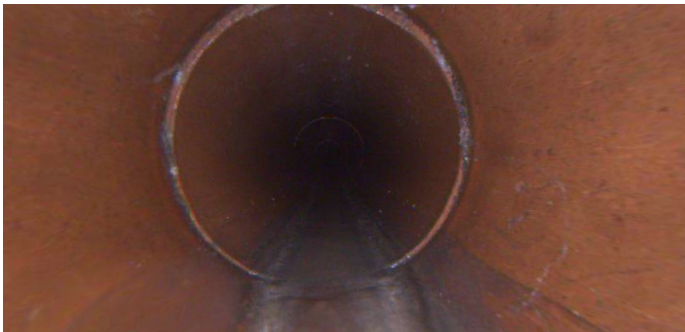
Code:	<b>FS</b>
Description:	<b>Fracture Spiral</b>

Distance (ft):	<b>.9</b>
Structural Grade:	<b>3</b>
O&M Grade:	<b>0</b>
Clock Start/From:	<b>3</b>
Clock To:	<b>5</b>
1st Value:	
2nd Value:	
Value Percent:	
Continuous Index:	
Within 8" of Joint:	<b>YES</b>
Remarks:

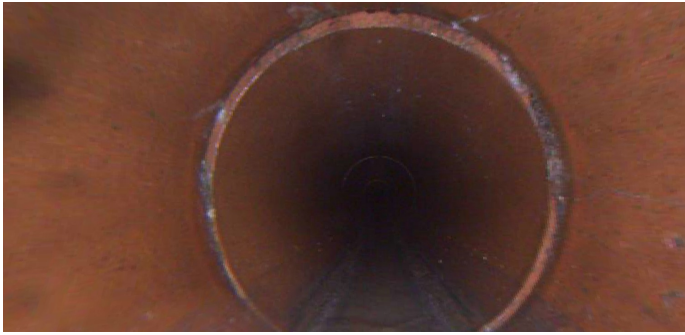
Code: **RFJ**  
Description: **Roots Fine Joint**

Distance (ft): **1.5**  
Structural Grade: **0**  
O&M Grade: **1**  
Clock Start/From: **9**  
Clock To: **3**  
1st Value:  
2nd Value:  
Value Percent:  
Continuous Index:  
Within 8" of Joint: **YES**  
Remarks:

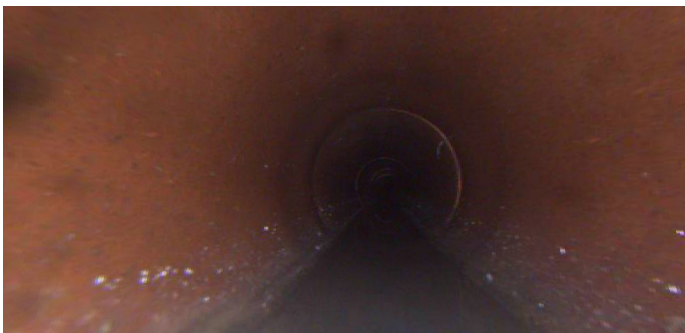
Code: **RFJ**  
Description: **Roots Fine Joint**

Distance (ft): **15.2**  
Structural Grade: **0**  
O&M Grade: **1**  
Clock Start/From: **2**  
Clock To:  
1st Value:  
2nd Value:  
Value Percent:  
Continuous Index:  
Within 8" of Joint: **YES**  
Remarks:

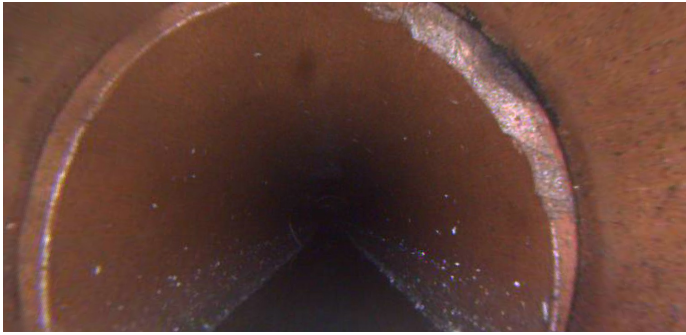
Code: **SSS**  
Description: **Surface Spalling**

Distance (ft): **58.1**  
Structural Grade: **2**  
O&M Grade: **0**  
Clock Start/From: **12**  
Clock To: **3**  
1st Value:  
2nd Value:  
Value Percent:  
Continuous Index:  
Within 8" of Joint: **YES**  
Remarks:

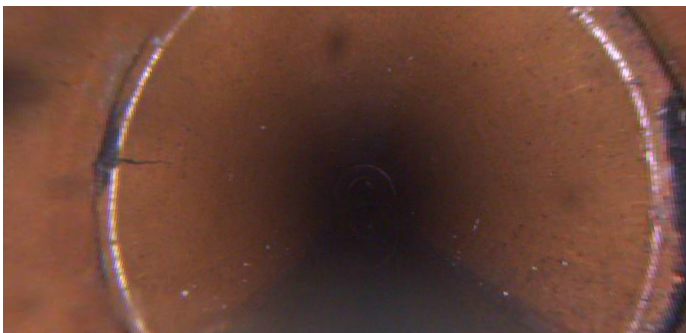
Code: **RFJ**  
Description: **Roots Fine Joint**

Distance (ft): **104.0**  
Structural Grade: **0**  
O&M Grade: **1**  
Clock Start/From: **9**  
Clock To:  
1st Value:  
2nd Value:  
Value Percent:  
Continuous Index:  
Within 8" of Joint: **YES**  
Remarks:

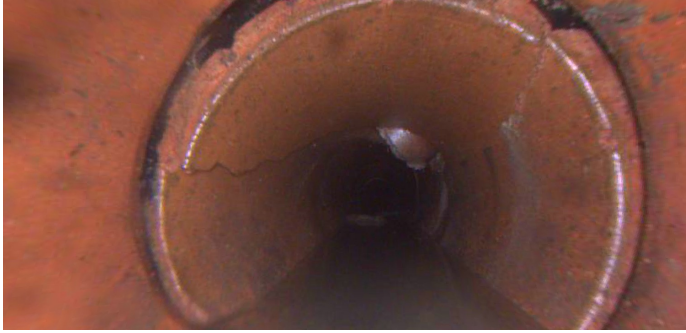
Code: **FM**  
Description: **Fracture Multiple**

Distance (ft): **112.0**  
Structural Grade: **4**  
O&M Grade: **0**  
Clock Start/From: **9**  
Clock To: **3**  
1st Value:  
2nd Value:  
Value Percent:  
Continuous Index:  
Within 8" of Joint: **YES**  
Remarks:

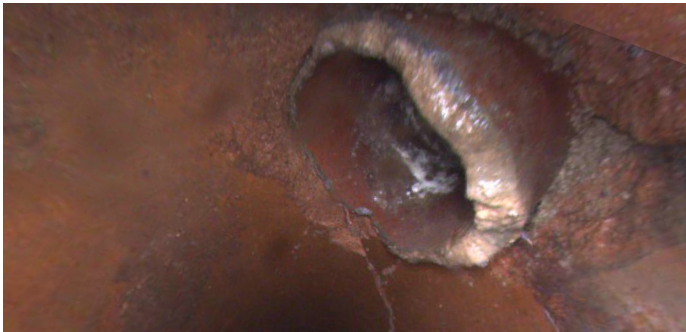
Code: **TBI**  
Description: **Tap Break-in Intruding**

Distance (ft): **113.6**  
Structural Grade: **0**  
O&M Grade: **2**  
Clock Start/From: **1**  
Clock To:  
1st Value: **4.000**  
2nd Value: **2.000**  
Value Percent:  
Continuous Index:  
Within 8" of Joint:  
Remarks:

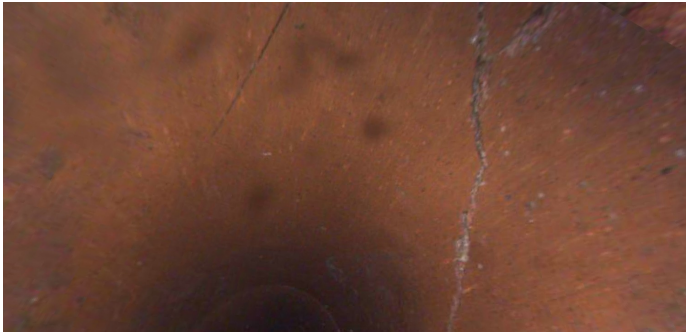
Code: **FM**  
Description: **Fracture Multiple**

Distance (ft): **114.4**  
Structural Grade: **4**  
O&M Grade: **0**  
Clock Start/From: **12**  
Clock To: **5**  
1st Value:  
2nd Value:  
Value Percent:  
Continuous Index:  
Within 8" of Joint:  
Remarks:

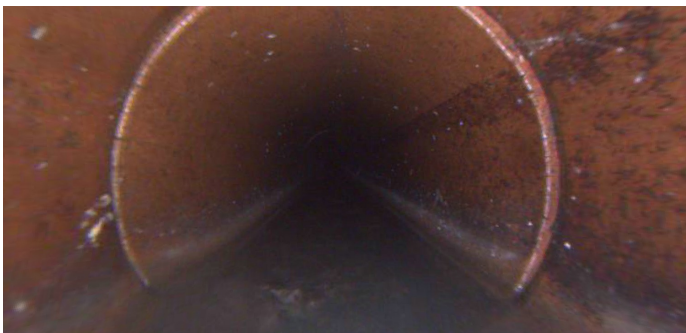
Code: **CM**  
Description: **Crack Multiple**

Distance (ft): **124.0**  
Structural Grade: **3**  
O&M Grade: **0**  
Clock Start/From: **8**  
Clock To: **4**  
1st Value:  
2nd Value:  
Value Percent:  
Continuous Index:  
Within 8" of Joint: **YES**  
Remarks:

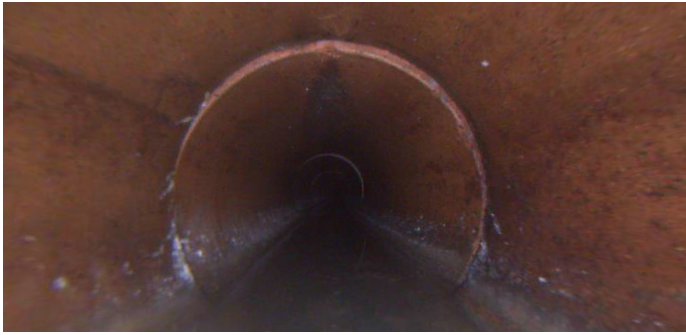
Code: **RFJ**  
Description: **Roots Fine Joint**

Distance (ft): **136.6**  
Structural Grade: **0**  
O&M Grade: **1**  
Clock Start/From: **8**  
Clock To: **4**  
1st Value:  
2nd Value:  
Value Percent:  
Continuous Index:  
Within 8" of Joint: **YES**  
Remarks:

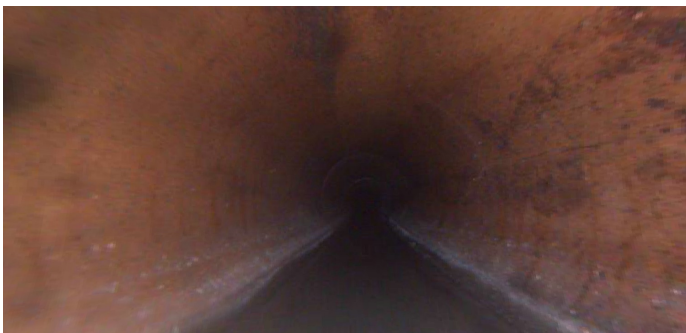
Code: **FL**  
Description: **Fracture Longitudinal**

Distance (ft): **146.3**  
Structural Grade: **3**  
O&M Grade: **0**  
Clock Start/From: **3**  
Clock To:  
1st Value:  
2nd Value:  
Value Percent:  
Continuous Index:  
Within 8" of Joint:  
Remarks:

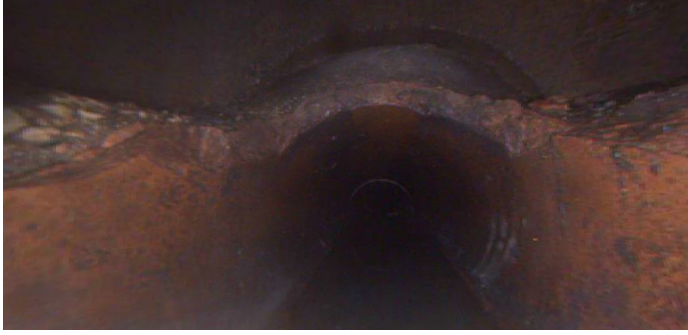
Code:	<b>AMH</b>
Description:	<b>Manhole</b>
Distance (ft):	<b>155.6</b>
Structural Grade:	<b>0</b>
O&M Grade:	<b>0</b>
Clock Start/From:	
Clock To:	
1st Value:	
2nd Value:	
Value Percent:	
Continuous Index:	
Within 8" of Joint:	<b>NO</b>
Remarks:	<b>M-803-021</b>
