## Profile/Photo Observation Report

Street:	<b>E 40TH AV</b>	Flow Control:	<b>Not Controlled</b>
City:	<b>Hobart, IN</b>	Year Renewed:	
Location:	<b>Other</b>	Tape/Media #:	
Purpose:	<b>Not Known</b>	Dia/Height:	<b>10"</b>
Use:	<b>Sanitary</b>	Material:	<b>VCP</b>
Drain Area:	<b>NA</b>	Lining:	
Category:	<b>NA</b>		
Comment:

Location Details:		Direction of Survey:	<b>Downstream</b>
US MH:	<b>M-803-023</b>	DS MH:	<b>M-803-026</b>
		Total Length Surveyed (ft):	<b>165.7</b>

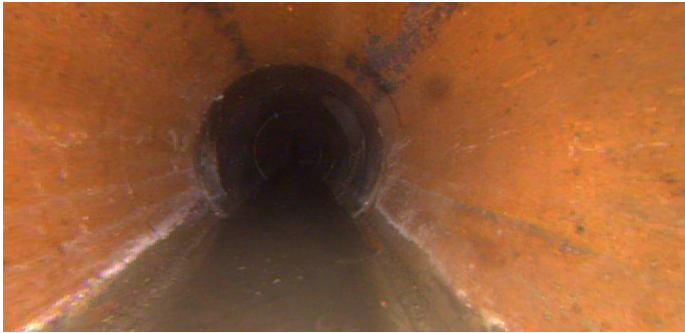
Code:	<b>MWL</b>
Description:	<b>Water Level</b>

Distance (ft):	<b>.0</b>
Structural Grade:	<b>0</b>
O&M Grade:	<b>0</b>
Clock Start/From:	
Clock To:	
1st Value:	
2nd Value:	
Value Percent:	<b>5.000</b>
Continuous Index:	
Within 8" of Joint:	<b>NO</b>
Remarks:

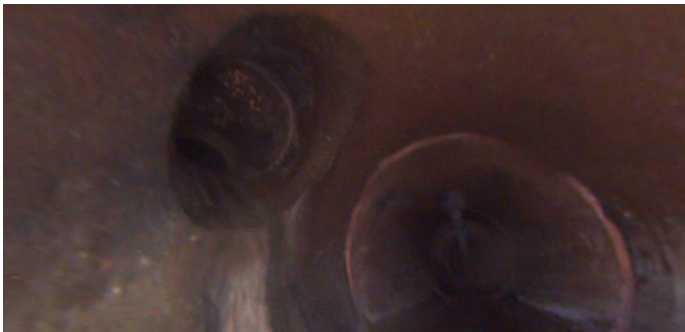
Code:	<b>TF</b>
Description:	<b>Tap Factory</b>

Distance (ft):	<b>4.1</b>
Structural Grade:	<b>0</b>
O&M Grade:	<b>0</b>
Clock Start/From:	<b>2</b>
Clock To:	
1st Value:	<b>4.000</b>
2nd Value:	
Value Percent:	
Continuous Index:	
Within 8" of Joint:	
Remarks:

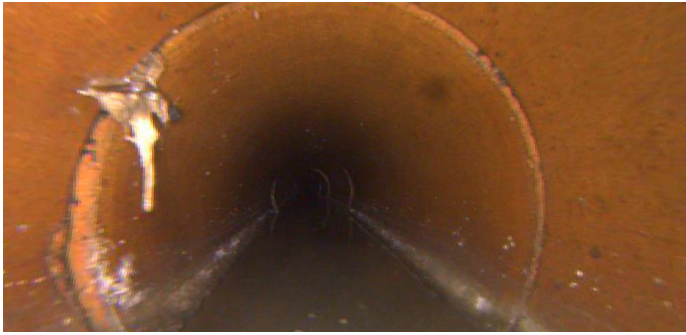
Code: **RFJ**  
Description: **Roots Fine Joint**

Distance (ft): **13.0**  
Structural Grade: **0**  
O&M Grade: **1**  
Clock Start/From: **10**  
Clock To:  
1st Value:  
2nd Value:  
Value Percent:  
Continuous Index:  
Within 8" of Joint: **YES**  
Remarks:

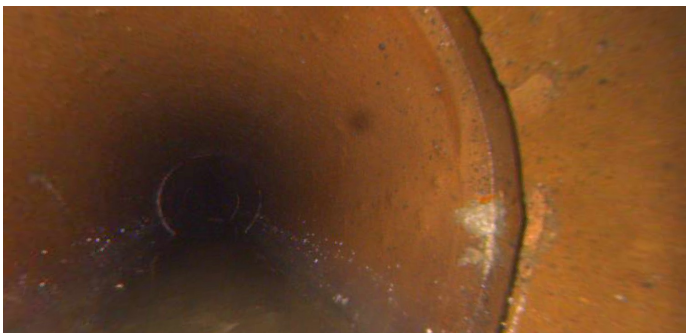
Code: **SSS**  
Description: **Surface Spalling**

Distance (ft): **126.3**  
Structural Grade: **2**  
O&M Grade: **0**  
Clock Start/From: **2**  
Clock To: **3**  
1st Value:  
2nd Value:  
Value Percent:  
Continuous Index:  
Within 8" of Joint: **YES**  
Remarks:

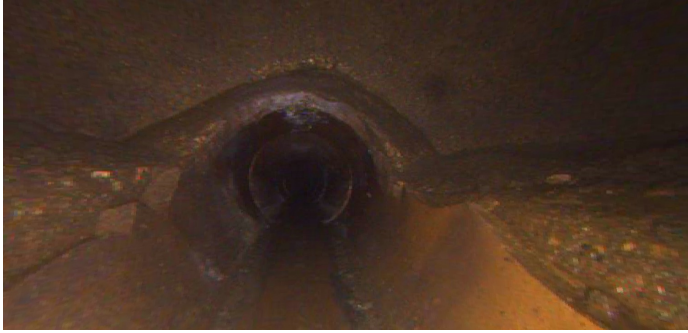
Code:	<b>AMH</b>
Description:	<b>Manhole</b>
Distance (ft):	<b>165.7</b>
Structural Grade:	<b>0</b>
O&M Grade:	<b>0</b>
Clock Start/From:	
Clock To:	
1st Value:	
2nd Value:	
Value Percent:	
Continuous Index:	
Within 8" of Joint:	<b>NO</b>
Remarks:	<b>M-803-026</b>
