## Profile/Photo Observation Report

Street:	<b>ALLEY BETWEEN N JOLIET ST &amp; N OH</b>	Flow Control:	<b>Not Controlled</b>
City:	<b>Hobart, IN</b>	Year Renewed:	
Location:	<b>Other</b>	Tape/Media #:	
Purpose:	<b>Not Known</b>	Dia/Height:	<b>10"</b>
Use:	<b>Sanitary</b>	Material:	<b>VCP</b>
Drain Area:	<b>NA</b>	Lining:	
Category:	<b>NA</b>		
Comment:

Location Details:		Direction of Survey:	<b>Upstream</b>
US MH:	<b>M-803-024</b>	DS MH:	<b>M-803-025</b>
		Total Length Surveyed (ft):	<b>3.7</b>

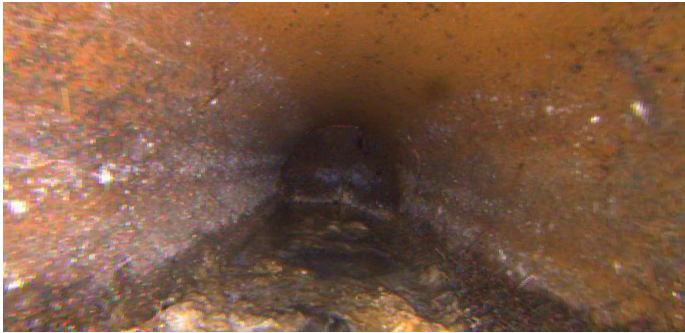
Code:	<b>MWL</b>
Description:	<b>Water Level</b>

Distance (ft):	<b>.0</b>
Structural Grade:	<b>0</b>
O&M Grade:	<b>0</b>
Clock Start/From:	
Clock To:	
1st Value:	
2nd Value:	
Value Percent:	<b>5.000</b>
Continuous Index:	
Within 8" of Joint:	<b>NO</b>
Remarks:

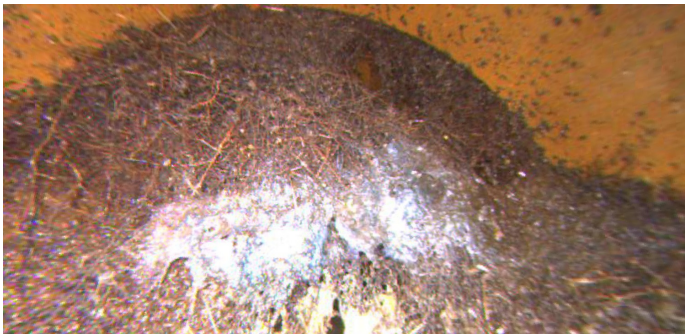
Code:	<b>RBJ</b>
Description:	<b>Roots Ball Joint</b>

Distance (ft):	<b>3.2</b>
Structural Grade:	<b>0</b>
O&M Grade:	<b>4</b>
Clock Start/From:	<b>12</b>
Clock To:	<b>12</b>
1st Value:	
2nd Value:	
Value Percent:	<b>95.000</b>
Continuous Index:	
Within 8" of Joint:	<b>YES</b>
Remarks:

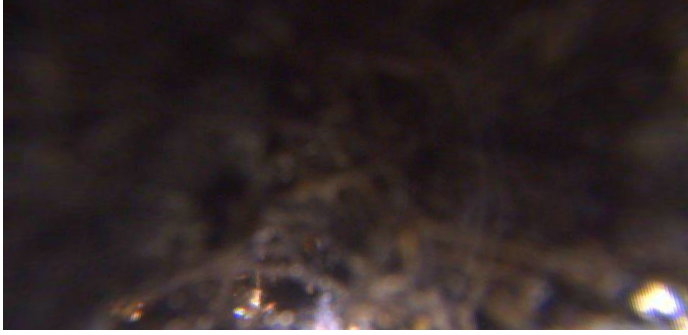
Code:	<b>MSA</b>
Description:	<b>Abandoned Survey</b>
Distance (ft):	<b>3.7</b>
Structural Grade:	<b>0</b>
O&M Grade:	<b>0</b>
Clock Start/From:	
Clock To:	
1st Value:	
2nd Value:	
Value Percent:	
Continuous Index:	
Within 8" of Joint:	<b>NO</b>
Remarks:	<b>root ball infiltration</b>
