Profile/Photo Observation Report

Date:	03/28/2018	Weather:		Coding:	PACP 6.0
Pipe Length (ft):	298.5	Owner:	NA	Pre Clean:	Not Known
P.O.#:		Surveyor:	Selasie Honu	PSR:	P-803-025-024
Customer:		Clean Date:	01/01/1900	Shape:	C

Location Details:		Direction of Survey:	Upstream
US MH:	M-803-024	DS MH:	M-803-025
		Total Length Surveyed (ft):	3.7

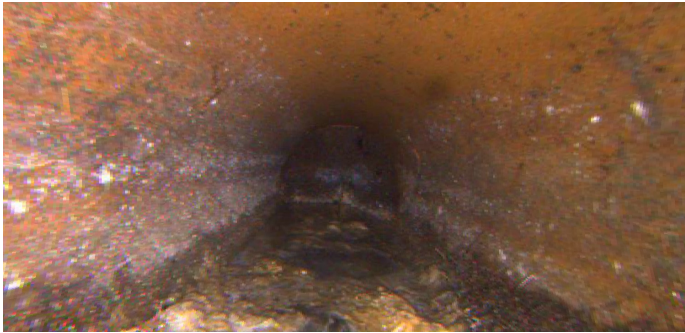
Code:	MWL
Description:	Water Level

Distance (ft):	.0
Structural Grade:	0
O&M Grade:	0
Clock Start/From:	
Clock To:	
1st Value:	
2nd Value:	
Value Percent:	5.000
Continuous Index:	
Within 8" of Joint:	NO
Remarks:

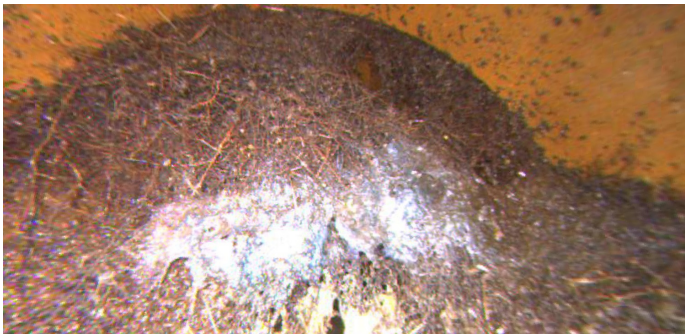
Code:	RBJ
Description:	Roots Ball Joint

Distance (ft):	3.2
Structural Grade:	0
O&M Grade:	4
Clock Start/From:	12
Clock To:	12
1st Value:	
2nd Value:	
Value Percent:	95.000
Continuous Index:	
Within 8" of Joint:	YES
Remarks:

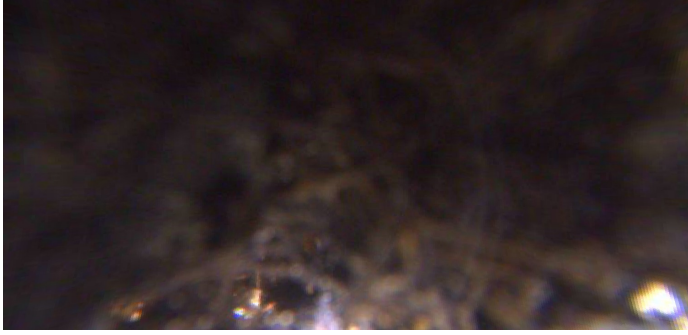
Code:	MSA
Description:	Abandoned Survey
Distance (ft):	3.7
Structural Grade:	0
O&M Grade:	0
Clock Start/From:	
Clock To:	
1st Value:	
2nd Value:	
Value Percent:	
Continuous Index:	
Within 8" of Joint:	NO
Remarks:	root ball infiltration
