Profile/Photo Observation Report

Street:	ALLEY BETWEEN N JOLIET ST & N OH	Flow Control:	Not Controlled
City:	Hobart, IN	Year Renewed:	
Location:	Light Highway	Tape/Media #:	
Purpose:	Routine Assessment	Dia/Height:	12"
Use:	Sanitary	Material:	VCP
Drain Area:	NA	Lining:	
Category:	NA		
Comment:

Location Details:		Direction of Survey:	Upstream
US MH:	M-803-024	DS MH:	M-803-025
		Total Length Surveyed (ft):	2.3

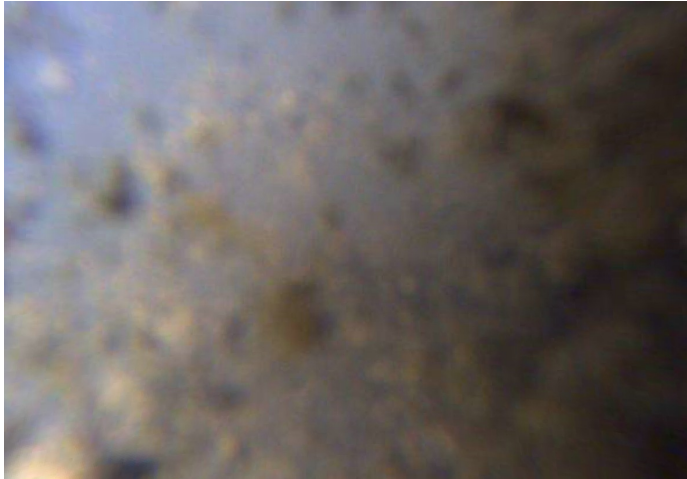
Code:	MWL
Description:	Water Level
Distance (ft):	.0
Structural Grade:	0
O&M Grade:	0
Clock Start/From:	
Clock To:	
1st Value:	
2nd Value:	
Value Percent:	60.000
Continuous Index:	
Within 8" of Joint:	NO
Remarks:

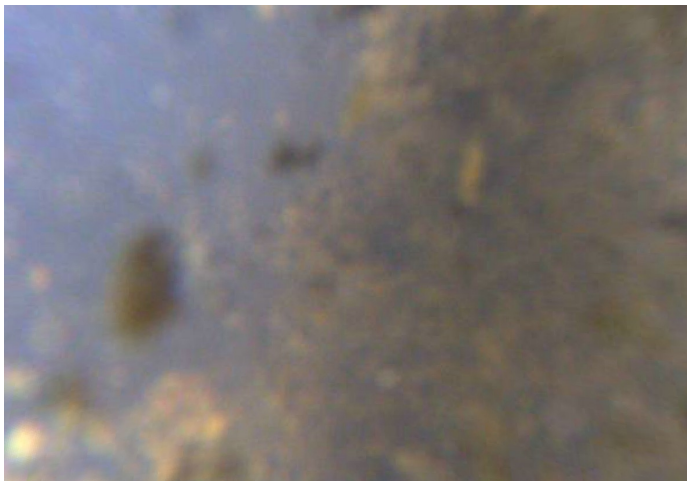
Code:	MCU
Description:	Camera Underwater
Distance (ft):	1.9
Structural Grade:	0
O&M Grade:	4
Clock Start/From:	
Clock To:	
1st Value:	
2nd Value:	
Value Percent:	
Continuous Index:	
Within 8" of Joint:	NO
Remarks:
