Profile/Photo Observation Report

Street:	Ohio St.	Flow Control:	Not Controlled
City:	Hobart, IN	Year Renewed:	
Location:	Light Highway	Tape/Media #:	
Purpose:	Routine Assessment	Dia/Height:	12"
Use:	Sanitary	Material:	VCP
Drain Area:	NA	Lining:	
Category:	NA		
Comment:

Location Details:		Direction of Survey:	Upstream
US MH:	M-803-024	DS MH:	M-803-025
		Total Length Surveyed (ft):	2.3

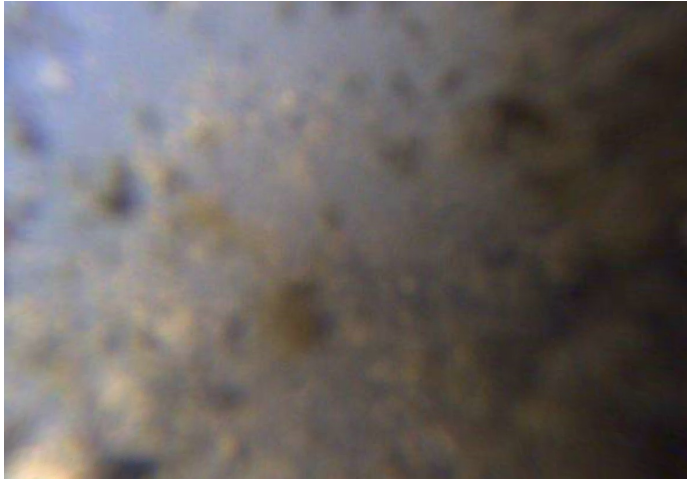
Code:	MWL
Description:	Water Level
Distance (ft):	.0
Structural Grade:	0
O&M Grade:	0
Clock Start/From:	
Clock To:	
1st Value:	
2nd Value:	
Value Percent:	60.000
Continuous Index:	
Within 8" of Joint:	NO
Remarks:

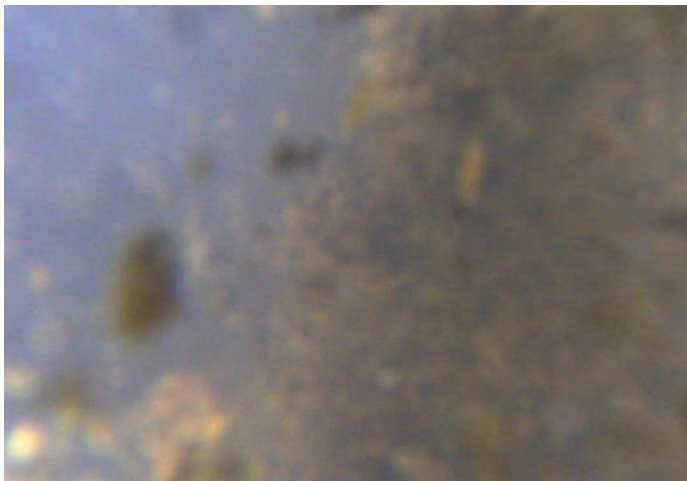
Code:	MCU
Description:	Camera Underwater
Distance (ft):	1.9
Structural Grade:	0
O&M Grade:	4
Clock Start/From:	
Clock To:	
1st Value:	
2nd Value:	
Value Percent:	
Continuous Index:	
Within 8" of Joint:	NO
Remarks:
