## Profile/Photo Observation Report

| Street: | <b>E RAND ST</b> | Flow Control: | <b>Not Controlled</b> |
| City: | <b>Hobart, IN</b> | Year Renewed: | |

| US MH: | <b>M-803-028</b> | DS MH: | <b>M-803-027</b> |

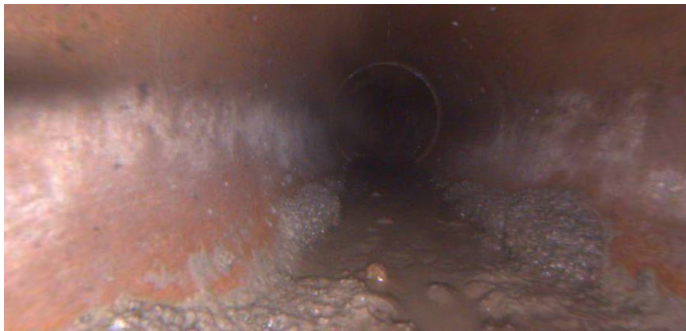
Code: **AMH**  
Description: **Manhole**

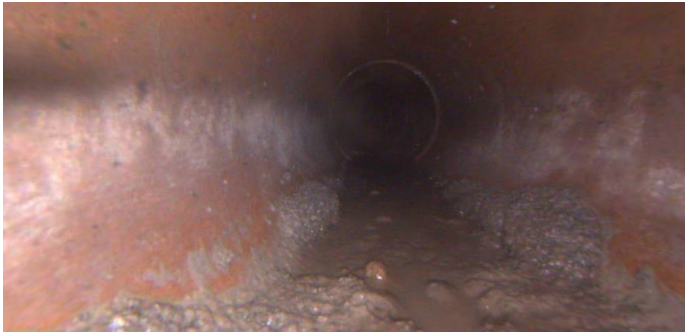
| Code: | <b>MWL</b> |
| Description: | <b>Water Level</b> |

| Value Percent: | <b>5.000</b> |

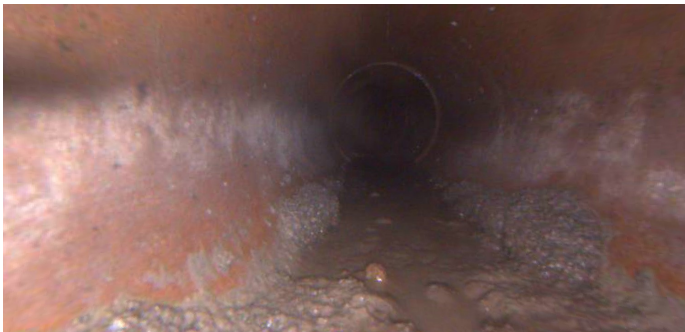
| Code: | <b>DSF</b> |
| Description: | <b>Deposits Settled Fine</b> |

| O&M Grade: | <b>2</b> |
| Clock Start/From: | <b>5</b> |
| Clock To: | <b>7</b> |
| Value Percent: | <b>5.000</b> |

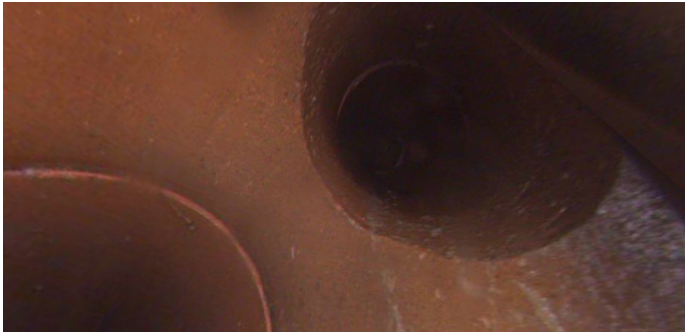
Code: **TF**  
Description: **Tap Factory**

Distance (ft): **4.7**  
Structural Grade: **0**  
O&M Grade: **0**  
Clock Start/From: **10**  
Clock To:  
1st Value: **4.000**  
2nd Value:  
Value Percent:  
Continuous Index:  
Within 8" of Joint:  
Remarks:

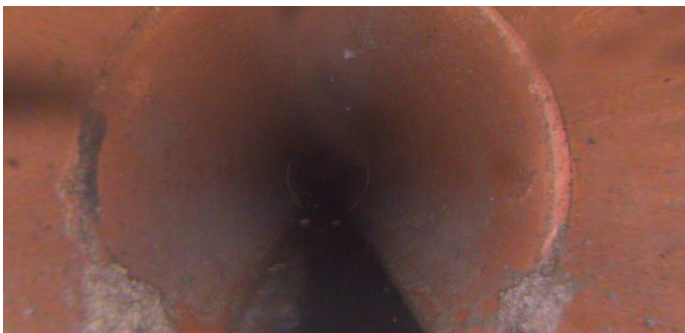
Code: **DAZ**  
Description: **Deposits Attached Other**

Distance (ft): **13.9**  
Structural Grade: **0**  
O&M Grade: **2**  
Clock Start/From: **8**  
Clock To: **4**  
1st Value:  
2nd Value:  
Value Percent: **5.000**  
Continuous Index: **S01**  
Within 8" of Joint: **YES**  
Remarks:

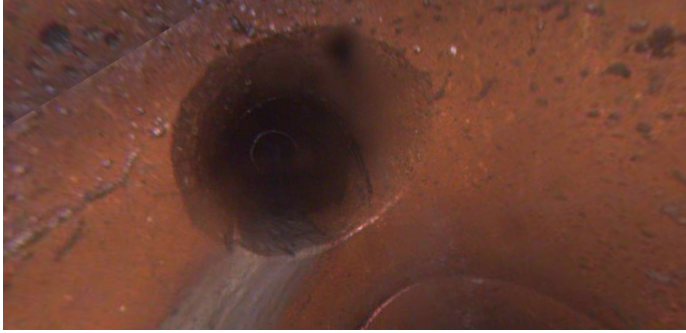
Code: **TF**  
Description: **Tap Factory**

Distance (ft): **88.5**  
Structural Grade: **0**  
O&M Grade: **0**  
Clock Start/From: **1**  
Clock To:  
1st Value: **4.000**  
2nd Value:  
Value Percent:  
Continuous Index:  
Within 8" of Joint:  
Remarks:

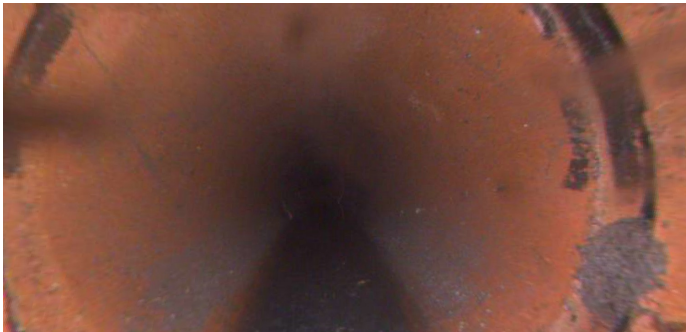
Code: **CL**  
Description: **Crack Longitudinal**

Distance (ft): **91.8**  
Structural Grade: **2**  
O&M Grade: **0**  
Clock Start/From: **10**  
Clock To:  
1st Value:  
2nd Value:  
Value Percent:  
Continuous Index:  
Within 8" of Joint: **YES**  
Remarks:

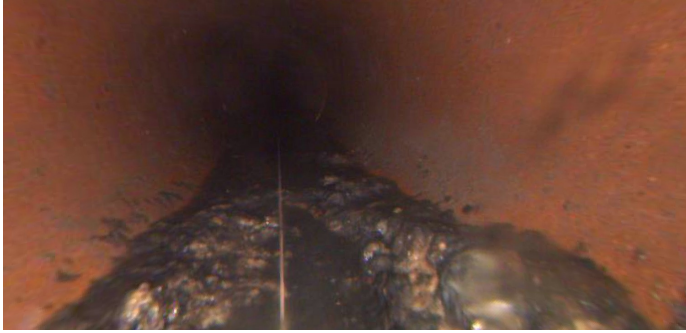
Code: **DSZ**  
Description: **Deposits Settled Other**

Distance (ft): **109.8**  
Structural Grade: **0**  
O&M Grade: **2**  
Clock Start/From: **5**  
Clock To: **7**  
1st Value:  
2nd Value:  
Value Percent: **10.000**  
Continuous Index:  
Within 8" of Joint: **NO**  
Remarks: **misc**

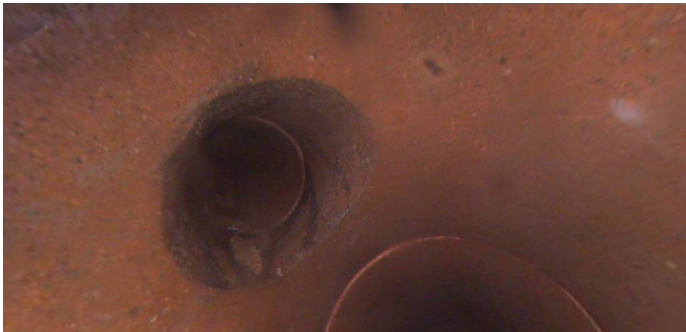
Code: **TF**  
Description: **Tap Factory**

Distance (ft): **131.6**  
Structural Grade: **0**  
O&M Grade: **0**  
Clock Start/From: **2**  
Clock To:  
1st Value: **4.000**  
2nd Value:  
Value Percent:  
Continuous Index:  
Within 8" of Joint:  
Remarks:

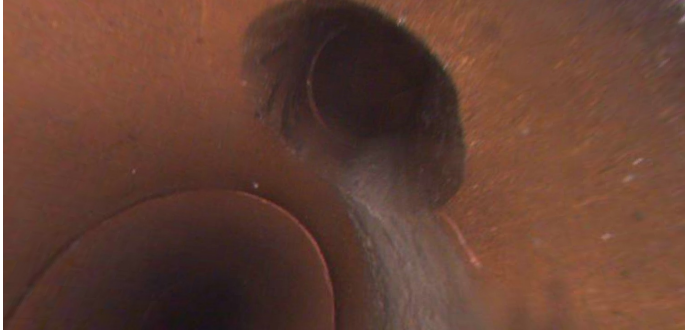
Code: **TF**  
Description: **Tap Factory**

Distance (ft): **145.3**  
Structural Grade: **0**  
O&M Grade: **0**  
Clock Start/From: **10**  
Clock To:  
1st Value: **4.000**  
2nd Value:  
Value Percent:  
Continuous Index:  
Within 8" of Joint:  
Remarks:

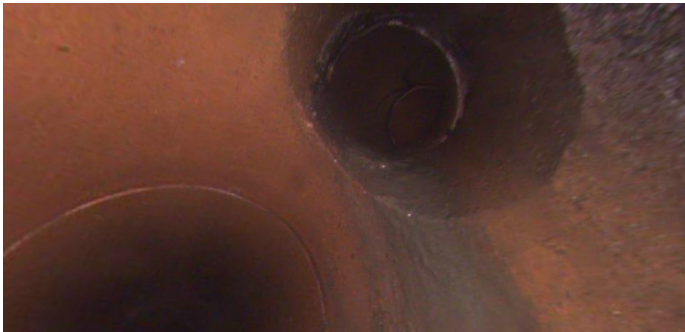
Code: **TF**  
Description: **Tap Factory**

Distance (ft): **185.5**  
Structural Grade: **0**  
O&M Grade: **0**  
Clock Start/From: **10**  
Clock To:  
1st Value: **4.000**  
2nd Value:  
Value Percent:  
Continuous Index:  
Within 8" of Joint:  
Remarks:

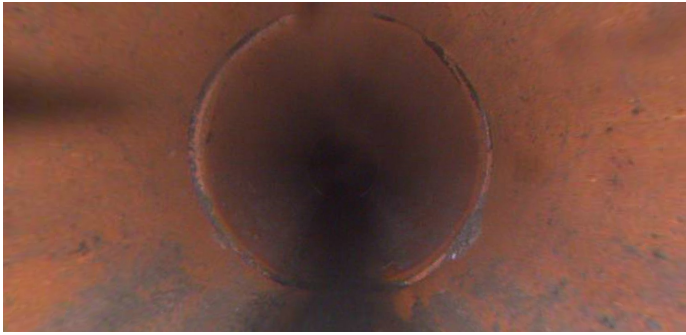
Code: **DAZ**  
Description: **Deposits Attached Other**

Distance (ft): **211.9**  
Structural Grade: **0**  
O&M Grade: **2**  
Clock Start/From: **8**  
Clock To: **4**  
1st Value:  
2nd Value:  
Value Percent: **5.000**  
Continuous Index: **F01**  
Within 8" of Joint: **YES**  
Remarks:

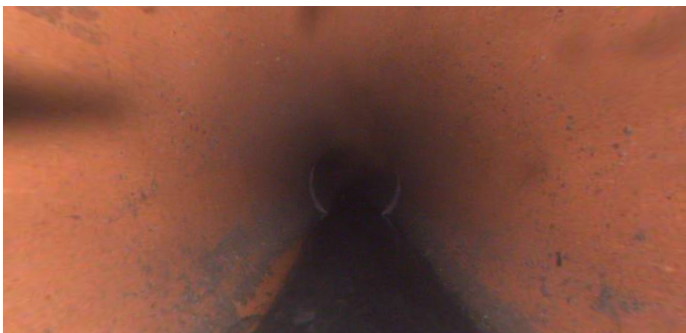
Code: **MSA**  
Description: **Abandoned Survey**

Distance (ft): **239.2**  
Structural Grade: **0**  
O&M Grade: **0**  
Clock Start/From:  
Clock To:  
1st Value:  
2nd Value:  
Value Percent:  
Continuous Index:  
Within 8" of Joint: **NO**  
Remarks: **unknown**
