## Profile/Photo Observation Report

Street:	<b>E RAND ST &amp; N LIBERTY ST</b>	Flow Control:	<b>Not Controlled</b>
City:	<b>Hobart, IN</b>	Year Renewed:	
Location:	<b>Other</b>	Tape/Media #:	
Purpose:	<b>Not Known</b>	Dia/Height:	<b>10"</b>
Use:	<b>Sanitary</b>	Material:	<b>VCP</b>
Drain Area:	<b>NA</b>	Lining:	
Category:	<b>NA</b>		
Comment:

Location Details:		Direction of Survey:	<b>Downstream</b>
US MH:	<b>M-803-028</b>	DS MH:	<b>M-803-027</b>
		Total Length Surveyed (ft):	<b>3.5</b>

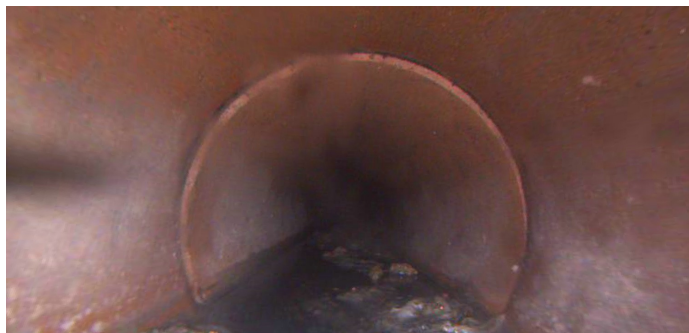
Code: **AMH**  
 Description: **Manhole**  
 Distance (ft): **.0**  
 Structural Grade: **0**  
 O&M Grade: **0**  
 Clock Start/From:  
 Clock To:  
 1st Value:  
 2nd Value:  
 Value Percent:  
 Continuous Index:  
 Within 8" of Joint: **NO**  
 Remarks: **M-803-028**

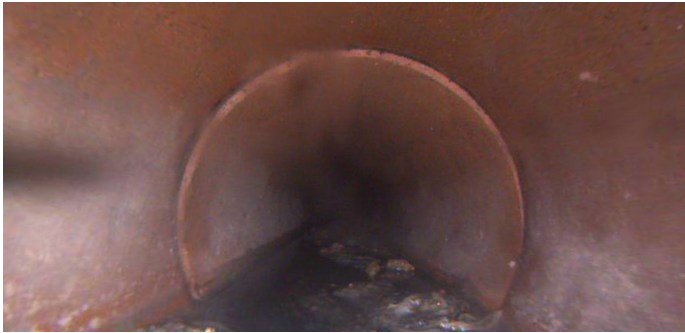
Code:	<b>MWL</b>
Description:	<b>Water Level</b>

Distance (ft):	<b>.0</b>
Structural Grade:	<b>0</b>
O&M Grade:	<b>0</b>
Clock Start/From:	
Clock To:	
1st Value:	
2nd Value:	
Value Percent:	<b>5.000</b>
Continuous Index:	
Within 8" of Joint:	<b>NO</b>
Remarks:

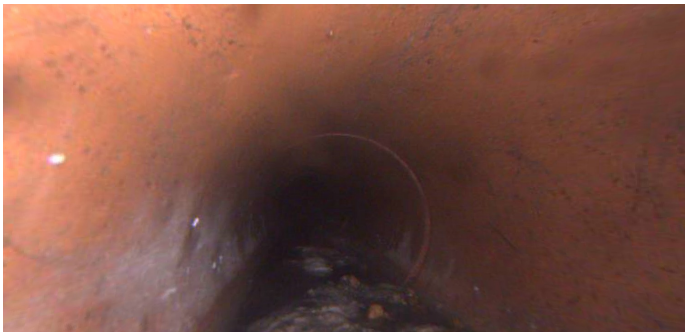
Code:	<b>MSA</b>
Description:	<b>Abandoned Survey</b>

Distance (ft):	<b>3.5</b>
Structural Grade:	<b>0</b>
O&M Grade:	<b>0</b>
Clock Start/From:	
Clock To:	
1st Value:	
2nd Value:	
Value Percent:	
Continuous Index:	
Within 8" of Joint:	<b>NO</b>
Remarks:	<b>debris under water</b>
