Profile/Photo Observation Report						
Date:	10/02/2018	Weather:			Coding:	PACP 6.0
Pipe Length (ft	): <b>297.7</b>	Owner:	NA		Pre Clean:	Not Known
P.O.#:		Surveyor:	Michael C	arlino	PSR:	P-803-027-028
Customer:		Clean Date:	01/01/190	00	Shape:	с
Street:	Rand St.	Flow Control:		Not Controlled		
City:	Hobart, IN		Year Renew	ved:		
Location:	Light Highway		Tape/Media	a #:		
Purpose:	<b>Routine Assessment</b>	t i	Dia/Height:		12"	
Use:	Sanitary		Material:		VCP	
Drain Area:	NA		Lining:			
Category:	NA					
Comment:						
Location Detai	ls:		Direction of	f Survey:	Upstream	
US MH:	M-803-028	DS MH:	M-803-027		Total Length Surveyed (ft)	18.9
0&M Index:	0.00	O&M Quick:		0000	O&M Rating:	0.00
Structural Index:	0.00	 Structural Qu	uick:	0000	Structural Rating:	0.00
Overall Index:	0.00	Overall Quicl	k:	0000	Overall Rating:	0.00

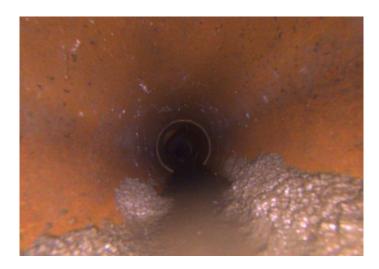
Code: Description:	AMH Manhole
Distance (ft):	.0
Structural Grade:	0
O&M Grade:	0
Clock Start/From:	
Clock To:	
1st Value:	
2nd Value:	
Value Percent:	
Continuous Index:	
Within 8" of Joint:	NO
Remarks:	M-803-027

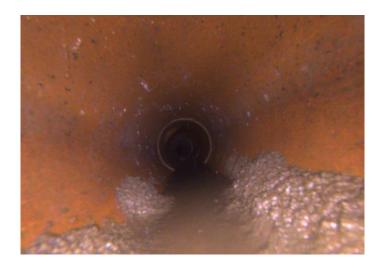
Code:	MWL
Description:	Water Level
Distance (ft):	.0
Structural Grade:	0
O&M Grade:	0
Clock Start/From:	
Clock To:	
1st Value:	
2nd Value:	
Value Percent:	5.000
Continuous Index:	
Within 8" of Joint:	NO
Remarks:

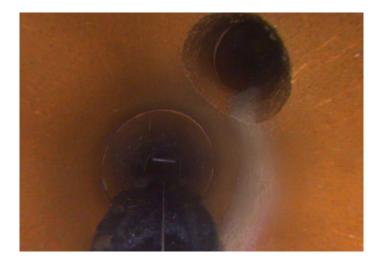
Code: Description:	TF Tap Factory
Distance (ft): Structural Grade: O&M Grade: Clock Start/From: Clock To: 1st Value: 2nd Value: Value Percent: Continuous Index:	5.5 0 1 6.000
Within 8" of Joint: Remarks:

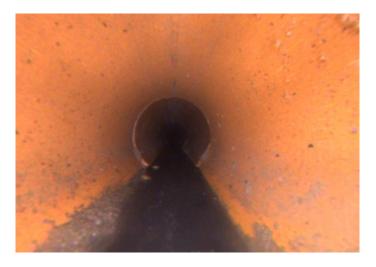
Code: MSA Description: Abandoned Survey Distance (ft): 18.9 Structural Grade: 0 O&M Grade: 0 Clock Start/From: Clock To: 1st Value: 2nd Value: Value Percent: Continuous Index: Within 8" of Joint: NO Remarks: Unknown
