## Profile/Photo Observation Report

Street:	<b>E RAND ST &amp; N LIBERTY ST</b>	Flow Control:	<b>Not Controlled</b>
City:	<b>Hobart, IN</b>	Year Renewed:	
Location:	<b>Light Highway</b>	Tape/Media #:	
Purpose:	<b>Routine Assessment</b>	Dia/Height:	<b>12"</b>
Use:	<b>Sanitary</b>	Material:	<b>VCP</b>
Drain Area:	<b>NA</b>	Lining:	
Category:	<b>NA</b>		
Comment:

Location Details:		Direction of Survey:	<b>Downstream</b>
US MH:	<b>M-803-028</b>	DS MH:	<b>M-803-027</b>
		Total Length Surveyed (ft):	<b>5.2</b>

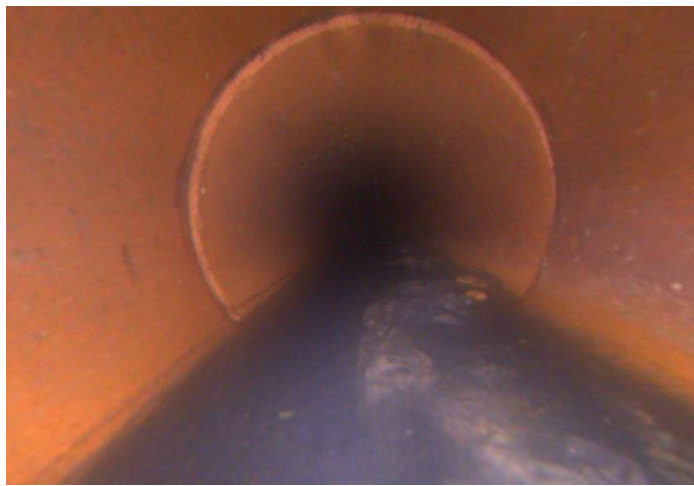
Code: **AMH**  
 Description: **Manhole**

Distance (ft): **.0**  
 Structural Grade: **0**  
 O&M Grade: **0**  
 Clock Start/From:  
 Clock To:  
 1st Value:  
 2nd Value:  
 Value Percent:  
 Continuous Index:  
 Within 8" of Joint: **NO**  
 Remarks: **M-803-028**

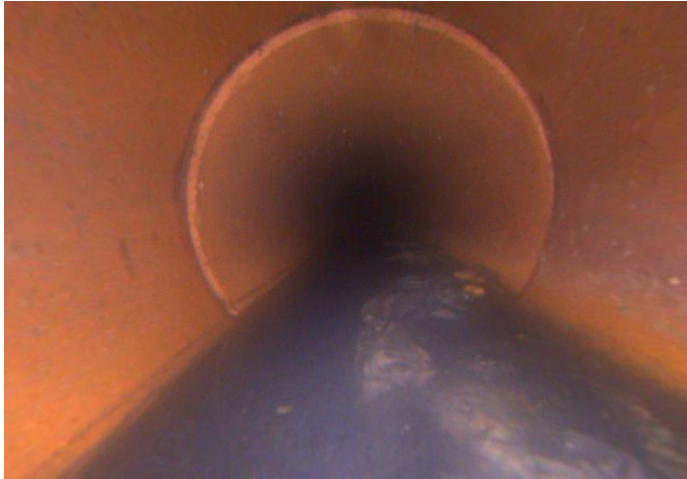
Code: **MWL**  
Description: **Water Level**

Distance (ft): **.0**  
Structural Grade: **0**  
O&M Grade: **0**  
Clock Start/From:  
Clock To:  
1st Value:  
2nd Value:  
Value Percent: **15.000**  
Continuous Index:  
Within 8" of Joint: **NO**  
Remarks:

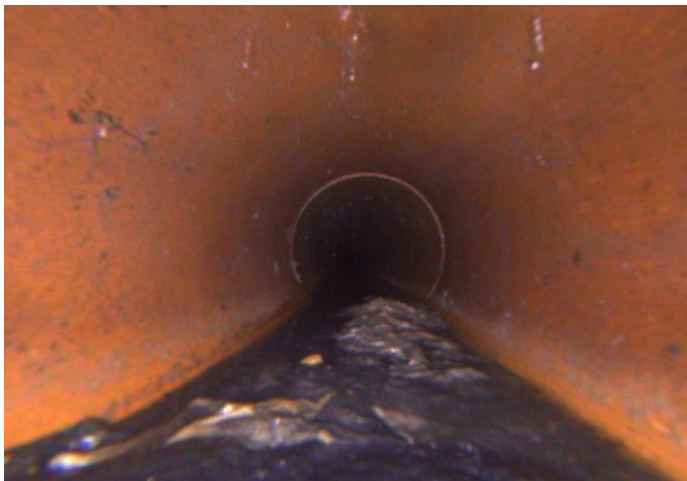
Code: **MSA**  
Description: **Abandoned Survey**

Distance (ft): **5.2**  
Structural Grade: **0**  
O&M Grade: **0**  
Clock Start/From:  
Clock To:  
1st Value:  
2nd Value:  
Value Percent:  
Continuous Index:  
Within 8" of Joint: **NO**  
Remarks: **Unknown**
