Profile/Photo Observation Report

Street:	E RAND ST	Flow Control:	Not Controlled
City:	Hobart, IN	Year Renewed:	
Location:	Other	Tape/Media #:	
Purpose:	Not Known	Dia/Height:	10"
Use:	Sanitary	Material:	VCP
Drain Area:	NA	Lining:	
Category:	NA		
Comment:

Location Details:		Direction of Survey:	Upstream
US MH:	M-803-029	DS MH:	M-803-030
		Total Length Surveyed (ft):	119.5

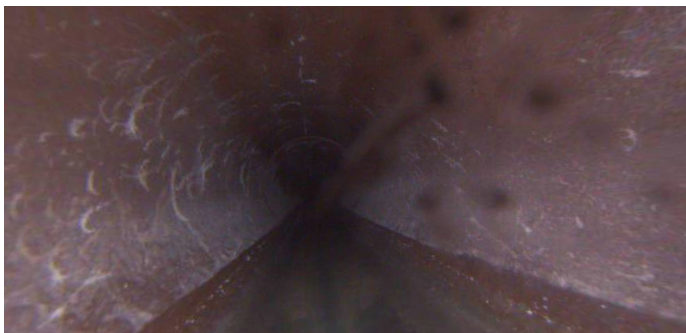
Code: **AMH**
Description: **Manhole**

Distance (ft): **.0**
Structural Grade: **0**
O&M Grade: **0**
Clock Start/From:
Clock To:
1st Value:
2nd Value:
Value Percent:
Continuous Index:
Within 8" of Joint: **NO**
Remarks: **M-803-030**

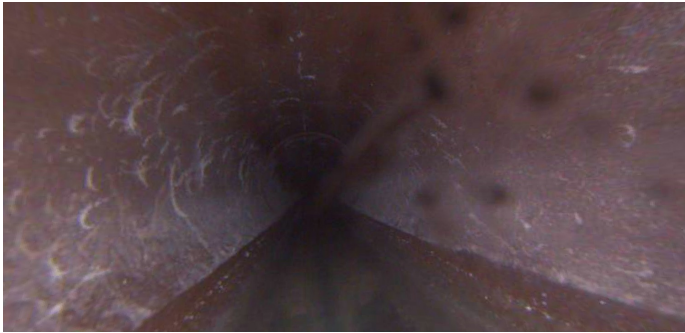
Code:	MWL
Description:	Water Level

Distance (ft):	.0
Structural Grade:	0
O&M Grade:	0
Clock Start/From:	
Clock To:	
1st Value:	
2nd Value:	
Value Percent:	5.000
Continuous Index:	
Within 8" of Joint:	NO
Remarks:

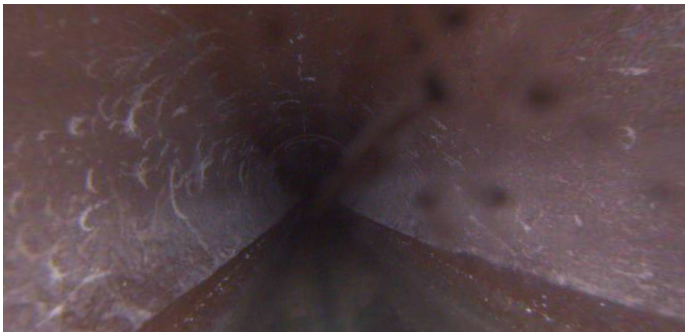
Code:	CM
Description:	Crack Multiple

Distance (ft):	.0
Structural Grade:	3
O&M Grade:	0
Clock Start/From:	8
Clock To:	4
1st Value:	
2nd Value:	
Value Percent:	
Continuous Index:	S01
Within 8" of Joint:	
Remarks:

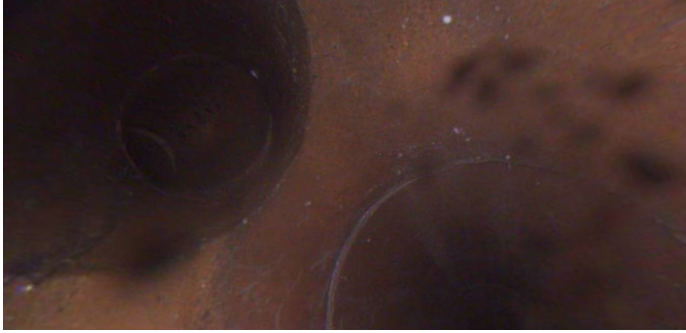
Code: **TF**
Description: **Tap Factory**

Distance (ft): **44.0**
Structural Grade: **0**
O&M Grade: **0**
Clock Start/From: **10**
Clock To:
1st Value: **4.000**
2nd Value:
Value Percent:
Continuous Index:
Within 8" of Joint:
Remarks:

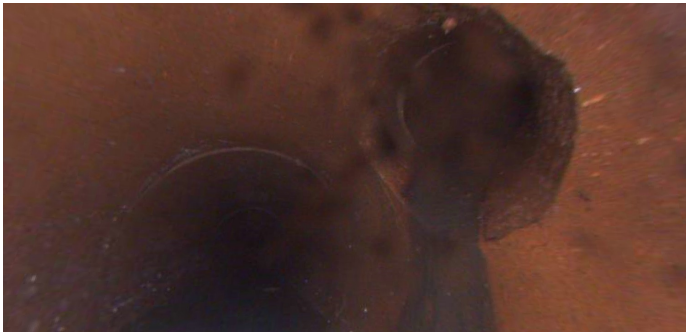
Code: **TF**
Description: **Tap Factory**

Distance (ft): **112.5**
Structural Grade: **0**
O&M Grade: **0**
Clock Start/From: **2**
Clock To:
1st Value: **4.000**
2nd Value:
Value Percent:
Continuous Index:
Within 8" of Joint:
Remarks:

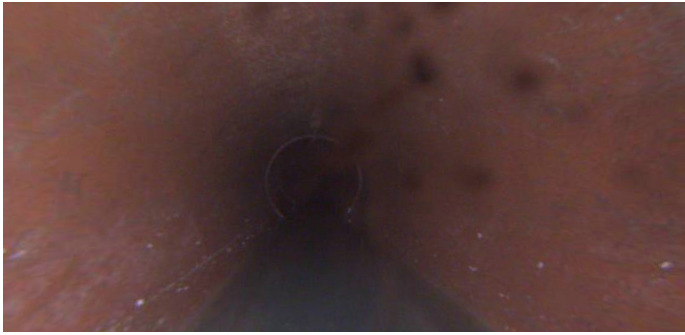
Code: **MSA**
Description: **Abandoned Survey**

Distance (ft): **119.5**
Structural Grade: **0**
O&M Grade: **0**
Clock Start/From:
Clock To:
1st Value:
2nd Value:
Value Percent:
Continuous Index:
Within 8" of Joint: **NO**
Remarks: **unknown**

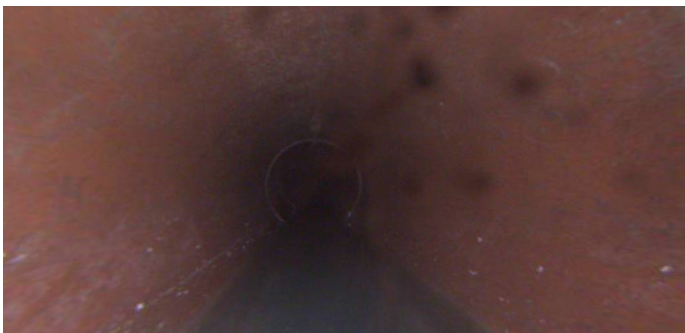
Code: **CM**
Description: **Crack Multiple**

Distance (ft): **119.5**
Structural Grade: **3**
O&M Grade: **0**
Clock Start/From: **8**
Clock To: **4**
1st Value:
2nd Value:
Value Percent:
Continuous Index: **F01**
Within 8" of Joint:
Remarks:
