Profile/Photo Observation Report

Street:	E RAND ST	Flow Control:	Not Controlled
City:	Hobart, IN	Year Renewed:	
Location:	Other	Tape/Media #:	
Purpose:	Not Known	Dia/Height:	10"
Use:	Sanitary	Material:	VCP
Drain Area:	NA	Lining:	
Category:	NA		
Comment:

Location Details:		Direction of Survey:	Downstream
US MH:	M-803-029	DS MH:	M-803-030
		Total Length Surveyed (ft):	8.1

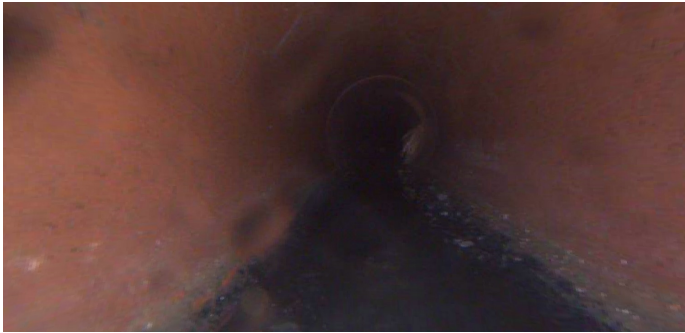
Code:	MWL
Description:	Water Level

Distance (ft):	.0
Structural Grade:	0
O&M Grade:	0
Clock Start/From:	
Clock To:	
1st Value:	
2nd Value:	
Value Percent:	5.000
Continuous Index:	
Within 8" of Joint:	NO
Remarks:

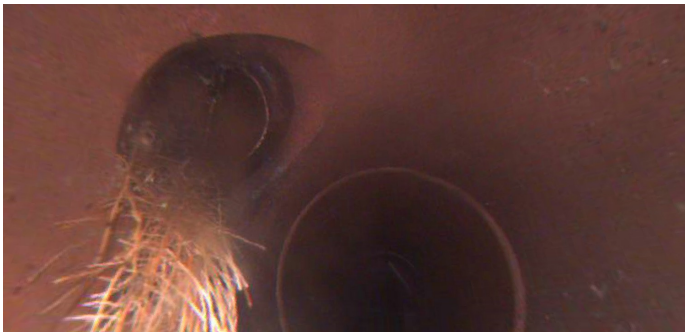
Code:	TFD
Description:	Tap Factory Defective

Distance (ft):	4.9
Structural Grade:	0
O&M Grade:	2
Clock Start/From:	2
Clock To:	
1st Value:	4.000
2nd Value:	
Value Percent:	
Continuous Index:	
Within 8" of Joint:	
Remarks:	roots

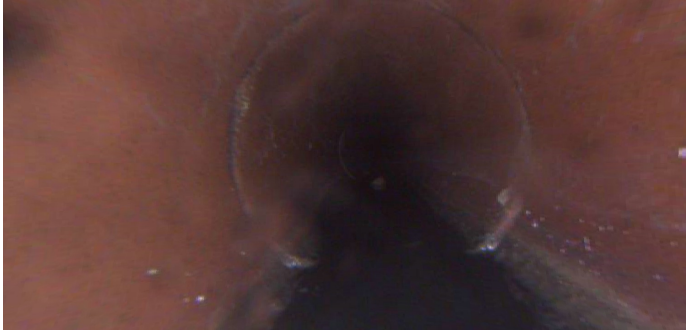
Code: **RFJ**
Description: **Roots Fine Joint**

Distance (ft): **5.6**
Structural Grade: **0**
O&M Grade: **1**
Clock Start/From: **10**
Clock To: **4**
1st Value:
2nd Value:
Value Percent:
Continuous Index:
Within 8" of Joint: **YES**
Remarks:

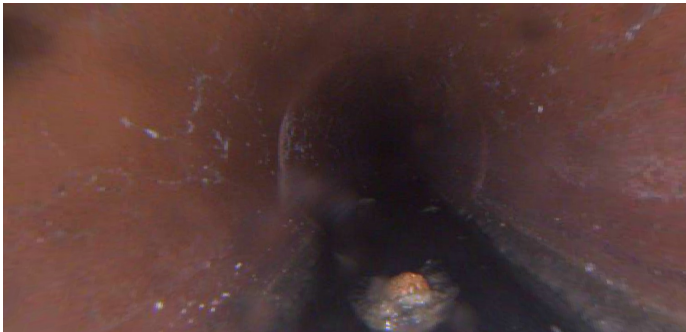
Code: **MSA**
Description: **Abandoned Survey**

Distance (ft): **8.1**
Structural Grade: **0**
O&M Grade: **0**
Clock Start/From:
Clock To:
1st Value:
2nd Value:
Value Percent:
Continuous Index:
Within 8" of Joint: **NO**
Remarks: **camera stopped**
