Profile/Photo Observation Report

Date:	10/02/2018	Weather:		Coding:	PACP 6.0
Pipe Length (ft):	273.0	Owner:	NA	Pre Clean:	Not Known
P.O.#:		Surveyor:	Justin Gonzales	PSR:	P-803-029-030
Customer:		Clean Date:	01/01/1900	Shape:	C

Street:	E RAND ST	Flow Control:	Not Controlled
City:	Hobart, IN	Year Renewed:	
Location:	Light Highway	Tape/Media #:	
Purpose:	Routine Assessment	Dia/Height:	12"
Use:	Sanitary	Material:	VCP
Drain Area:	NA	Lining:	
Category:	NA		
Comment:

Location Details:		Direction of Survey:	Upstream
US MH:	M-803-029	DS MH:	M-803-030
		Total Length Surveyed (ft):	265.5

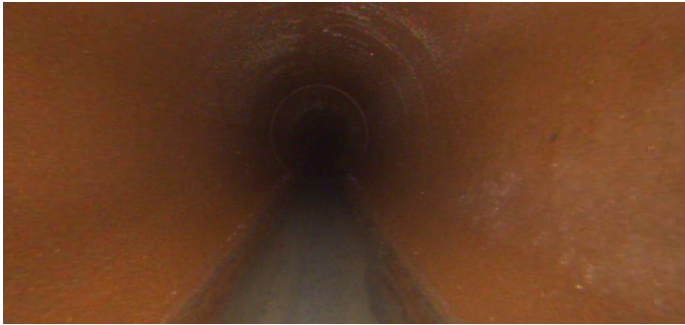
Code:	MWL
Description:	Water Level

Distance (ft):	.0
Structural Grade:	0
O&M Grade:	0
Clock Start/From:	
Clock To:	
1st Value:	
2nd Value:	
Value Percent:	5.000
Continuous Index:	
Within 8" of Joint:	NO
Remarks:

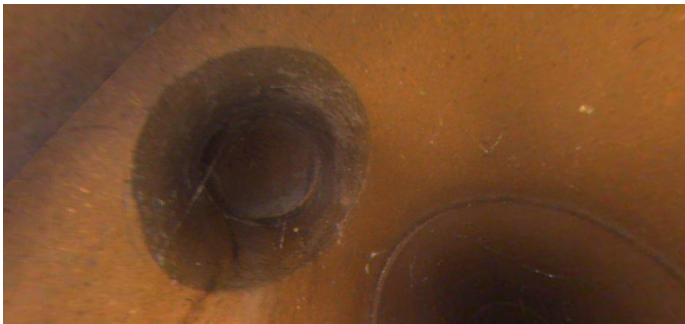
Code:	TF
Description:	Tap Factory

Distance (ft):	43.3
Structural Grade:	0
O&M Grade:	0
Clock Start/From:	10
Clock To:	
1st Value:	4.000
2nd Value:	
Value Percent:	
Continuous Index:	
Within 8" of Joint:	
Remarks:

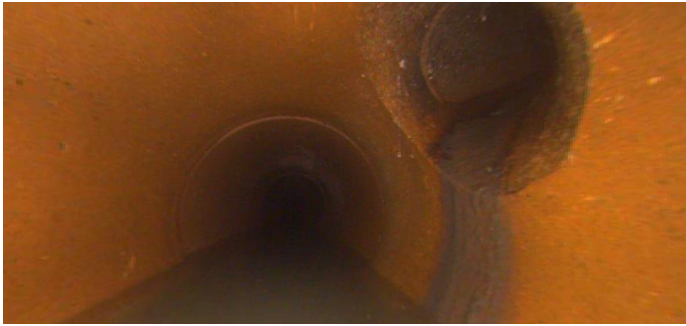
Code: **TF**
Description: **Tap Factory**

Distance (ft): **112.7**
Structural Grade: **0**
O&M Grade: **0**
Clock Start/From: **2**
Clock To:
1st Value: **4.000**
2nd Value:
Value Percent:
Continuous Index:
Within 8" of Joint:
Remarks:

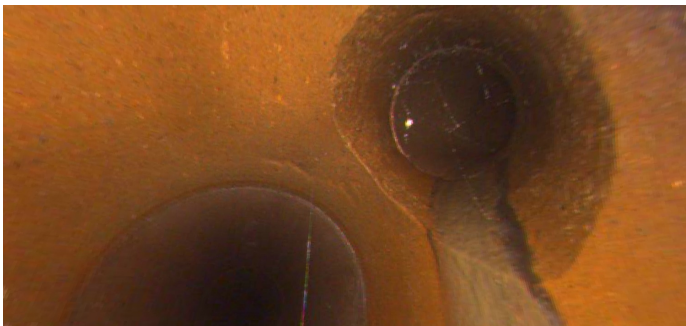
Code: **TF**
Description: **Tap Factory**

Distance (ft): **123.7**
Structural Grade: **0**
O&M Grade: **0**
Clock Start/From: **2**
Clock To:
1st Value: **4.000**
2nd Value:
Value Percent:
Continuous Index:
Within 8" of Joint:
Remarks:

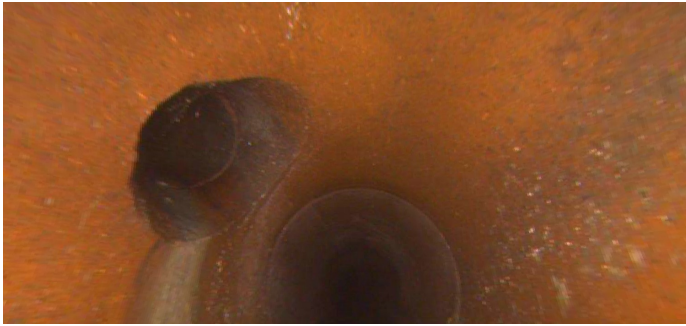
Code: **TF**
Description: **Tap Factory**

Distance (ft): **163.6**
Structural Grade: **0**
O&M Grade: **0**
Clock Start/From: **10**
Clock To:
1st Value: **4.000**
2nd Value:
Value Percent:
Continuous Index:
Within 8" of Joint:
Remarks:

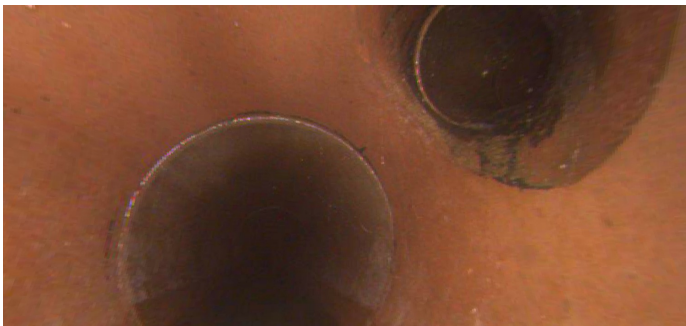
Code: **TF**
Description: **Tap Factory**

Distance (ft): **225.9**
Structural Grade: **0**
O&M Grade: **0**
Clock Start/From: **2**
Clock To:
1st Value: **4.000**
2nd Value:
Value Percent:
Continuous Index:
Within 8" of Joint:
Remarks:

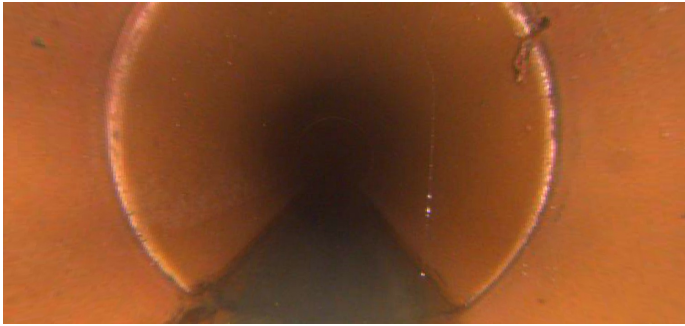
Code: **RFJ**
Description: **Roots Fine Joint**

Distance (ft): **235.3**
Structural Grade: **0**
O&M Grade: **1**
Clock Start/From: **2**
Clock To:
1st Value:
2nd Value:
Value Percent:
Continuous Index:
Within 8" of Joint: **YES**
Remarks:

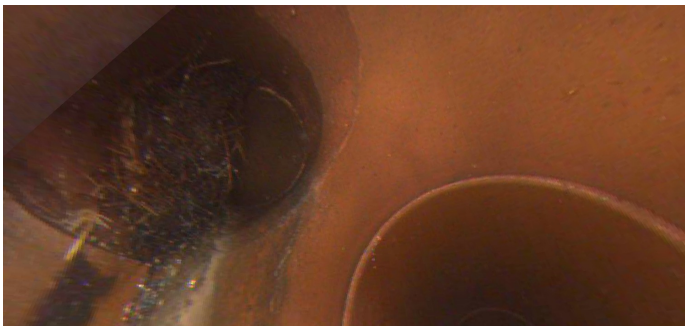
Code: **TFD**
Description: **Tap Factory Defective**

Distance (ft): **258.4**
Structural Grade: **0**
O&M Grade: **2**
Clock Start/From: **10**
Clock To:
1st Value: **4.000**
2nd Value:
Value Percent:
Continuous Index:
Within 8" of Joint:
Remarks: **ROOTS COMING FROM TAP**

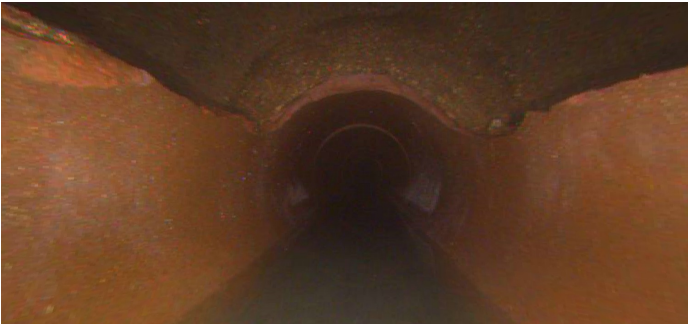
Code:	AMH
Description:	Manhole
Distance (ft):	265.5
Structural Grade:	0
O&M Grade:	0
Clock Start/From:	
Clock To:	
1st Value:	
2nd Value:	
Value Percent:	
Continuous Index:	
Within 8" of Joint:	NO
Remarks:	M-803-029
