Profile/Photo Observation Report

Date:	10/02/2018	Weather:		Coding:	PACP 6.0
Pipe Length (ft):	273.0	Owner:	NA	Pre Clean:	Not Known
P.O.#:		Surveyor:	Justin Gonzales	PSR:	P-803-029-030
Customer:		Clean Date:	01/01/1900	Shape:	C

Street:	Rand St.	Flow Control:	Not Controlled
City:	Hobart, IN	Year Renewed:	
Location:	Light Highway	Tape/Media #:	
Purpose:	Routine Assessment	Dia/Height:	12"
Use:	Sanitary	Material:	VCP
Drain Area:	NA	Lining:	
Category:	NA		
Comment:

Location Details:		Direction of Survey:	Upstream
US MH:	M-803-029	DS MH:	M-803-030
		Total Length Surveyed (ft):	265.5

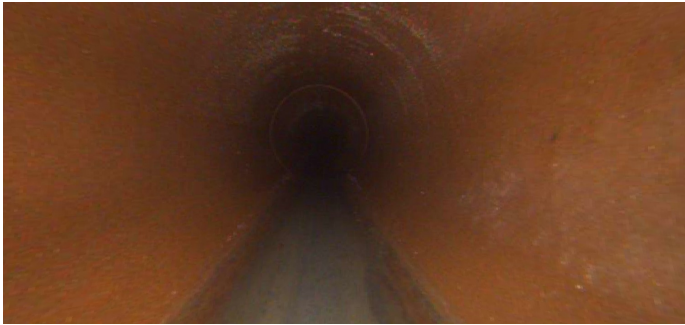
Code:	MWL
Description:	Water Level

Distance (ft):	.0
Structural Grade:	0
O&M Grade:	0
Clock Start/From:	
Clock To:	
1st Value:	
2nd Value:	
Value Percent:	5.000
Continuous Index:	
Within 8" of Joint:	NO
Remarks:

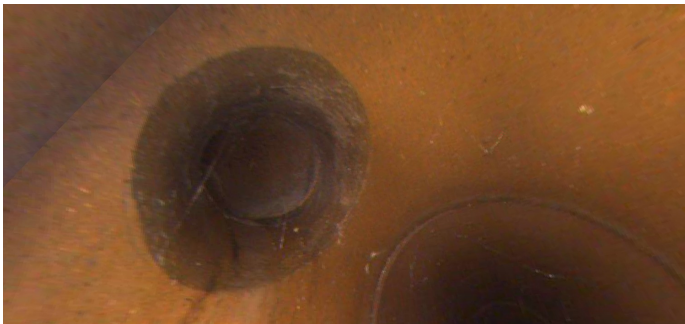
Code:	TF
Description:	Tap Factory

Distance (ft):	43.3
Structural Grade:	0
O&M Grade:	0
Clock Start/From:	10
Clock To:	
1st Value:	4.000
2nd Value:	
Value Percent:	
Continuous Index:	
Within 8" of Joint:	
Remarks:

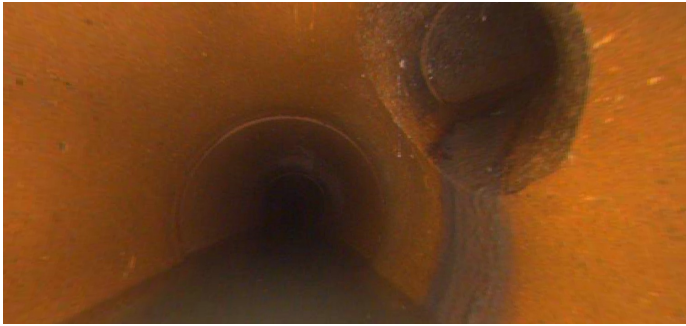
Code: **TF**
Description: **Tap Factory**

Distance (ft): **112.7**
Structural Grade: **0**
O&M Grade: **0**
Clock Start/From: **2**
Clock To:
1st Value: **4.000**
2nd Value:
Value Percent:
Continuous Index:
Within 8" of Joint:
Remarks:

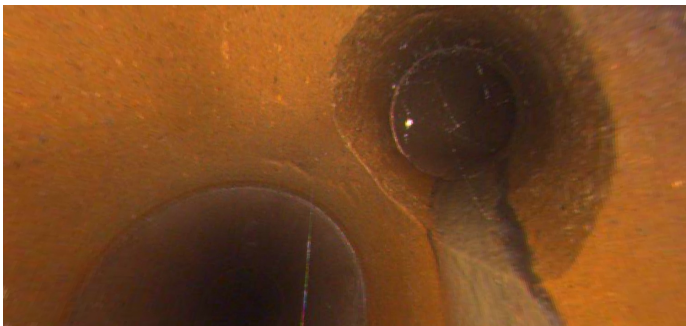
Code: **TF**
Description: **Tap Factory**

Distance (ft): **123.7**
Structural Grade: **0**
O&M Grade: **0**
Clock Start/From: **2**
Clock To:
1st Value: **4.000**
2nd Value:
Value Percent:
Continuous Index:
Within 8" of Joint:
Remarks:

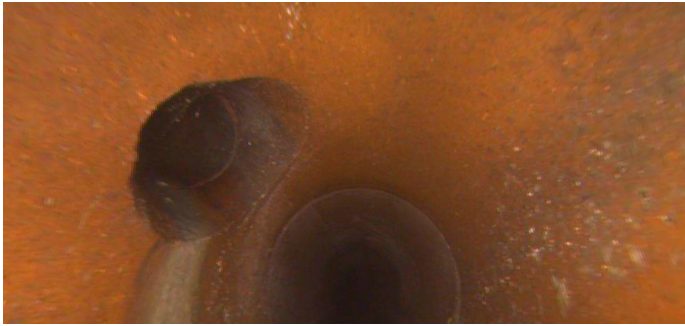
Code: **TF**
Description: **Tap Factory**

Distance (ft): **163.6**
Structural Grade: **0**
O&M Grade: **0**
Clock Start/From: **10**
Clock To:
1st Value: **4.000**
2nd Value:
Value Percent:
Continuous Index:
Within 8" of Joint:
Remarks:

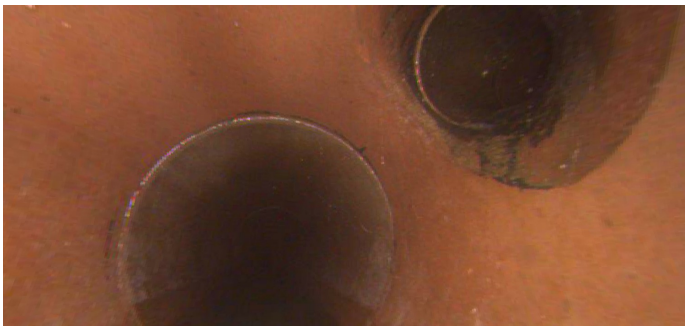
Code: **TF**
Description: **Tap Factory**

Distance (ft): **225.9**
Structural Grade: **0**
O&M Grade: **0**
Clock Start/From: **2**
Clock To:
1st Value: **4.000**
2nd Value:
Value Percent:
Continuous Index:
Within 8" of Joint:
Remarks:

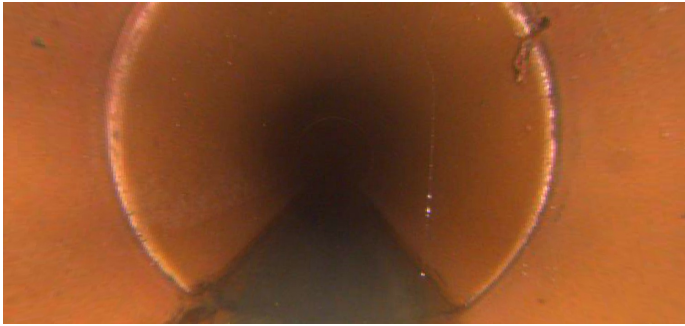
Code: **RFJ**
Description: **Roots Fine Joint**

Distance (ft): **235.3**
Structural Grade: **0**
O&M Grade: **1**
Clock Start/From: **2**
Clock To:
1st Value:
2nd Value:
Value Percent:
Continuous Index:
Within 8" of Joint: **YES**
Remarks:

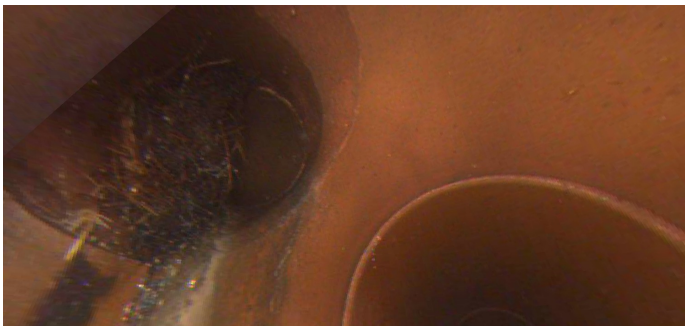
Code: **TFD**
Description: **Tap Factory Defective**

Distance (ft): **258.4**
Structural Grade: **0**
O&M Grade: **2**
Clock Start/From: **10**
Clock To:
1st Value: **4.000**
2nd Value:
Value Percent:
Continuous Index:
Within 8" of Joint:
Remarks: **ROOTS COMING FROM TAP**
