Profile/Photo Observation Report

Street:	HIGH ST	Flow Control:	Not Controlled
City:	Hobart, IN	Year Renewed:	
Location:	Other	Tape/Media #:	
Purpose:	Not Known	Dia/Height:	10"
Use:	Sanitary	Material:	VCP
Drain Area:	NA	Lining:	Cured in Place
Category:	NA		
Comment:

Location Details:		Direction of Survey:	Downstream
US MH:	M-803-032	DS MH:	M-804-073
		Total Length Surveyed (ft):	10.8

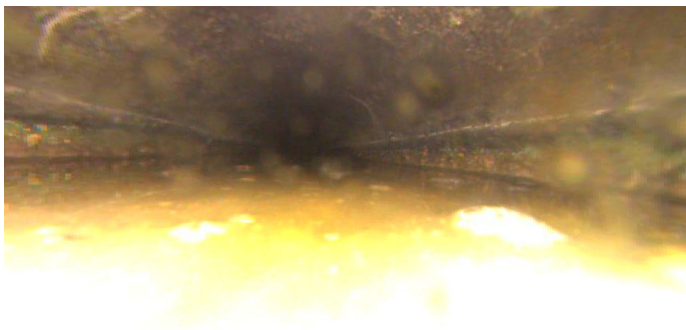
Code: **AMH**
Description: **Manhole**

Distance (ft): **.0**
Structural Grade: **0**
O&M Grade: **0**
Clock Start/From:
Clock To:
1st Value:
2nd Value:
Value Percent:
Continuous Index:
Within 8" of Joint: **NO**
Remarks: **M-803-032**

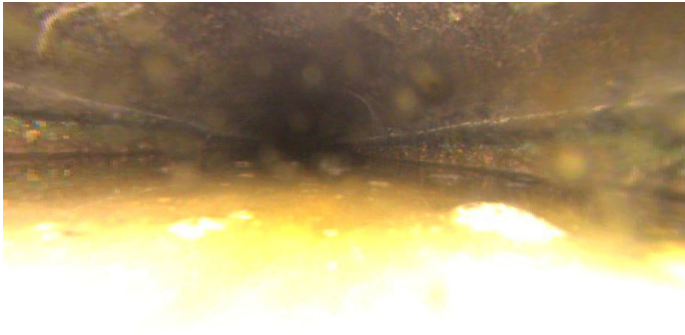
Code:	MWL
Description:	Water Level

Distance (ft):	.0
Structural Grade:	0
O&M Grade:	0
Clock Start/From:	
Clock To:	
1st Value:	
2nd Value:	
Value Percent:	5.000
Continuous Index:	
Within 8" of Joint:	NO
Remarks:

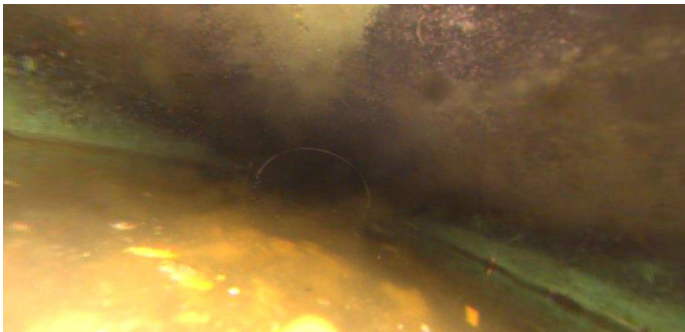
Code:	MSA
Description:	Abandoned Survey

Distance (ft):	10.8
Structural Grade:	0
O&M Grade:	0
Clock Start/From:	
Clock To:	
1st Value:	
2nd Value:	
Value Percent:	
Continuous Index:	
Within 8" of Joint:	NO
Remarks:	camera stopped
