Profile/Photo Observation Report

Street:	N INDIANA ST	Flow Control:	Not Controlled
City:	Hobart, IN	Year Renewed:	
Location:	Other	Tape/Media #:	
Purpose:	Not Known	Dia/Height:	10"
Use:	Sanitary	Material:	VCP
Drain Area:	NA	Lining:	Cured in Place
Category:	NA		
Comment:

Location Details:		Direction of Survey:	Downstream
US MH:	M-803-032	DS MH:	M-804-073
		Total Length Surveyed (ft):	10.8

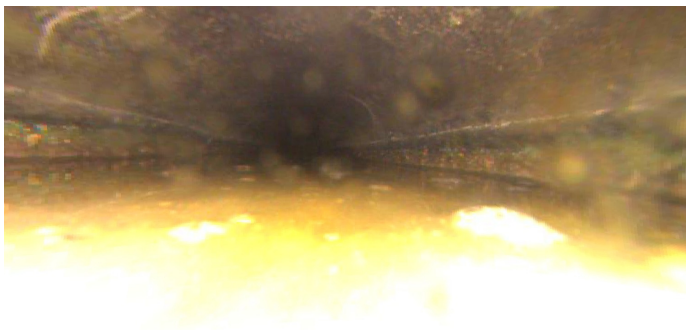
Code: **AMH**
Description: **Manhole**

Distance (ft): **.0**
Structural Grade: **0**
O&M Grade: **0**
Clock Start/From:
Clock To:
1st Value:
2nd Value:
Value Percent:
Continuous Index:
Within 8" of Joint: **NO**
Remarks: **M-803-032**

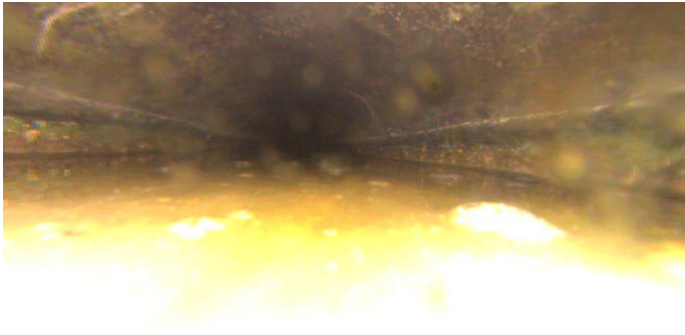
Code:	MWL
Description:	Water Level

Distance (ft):	.0
Structural Grade:	0
O&M Grade:	0
Clock Start/From:	
Clock To:	
1st Value:	
2nd Value:	
Value Percent:	5.000
Continuous Index:	
Within 8" of Joint:	NO
Remarks:

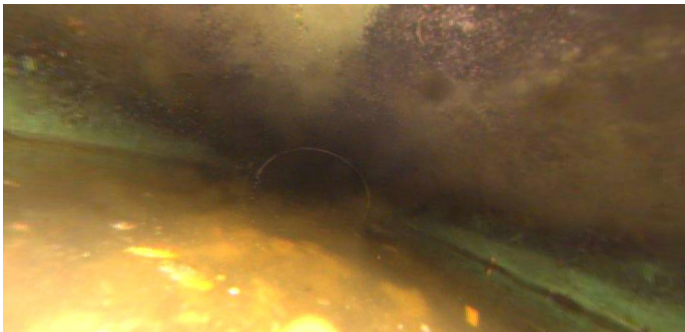
Code:	MSA
Description:	Abandoned Survey

Distance (ft):	10.8
Structural Grade:	0
O&M Grade:	0
Clock Start/From:	
Clock To:	
1st Value:	
2nd Value:	
Value Percent:	
Continuous Index:	
Within 8" of Joint:	NO
Remarks:	camera stopped
